# BUILDING CONDITION ASSESSMENT & RESERVE FUND STUDY

## **Sunnyhill Housing Co-operative 787 - 3rd Street NW Calgary, AB**

June 13, 2018

IRC CB18-037CR-15052

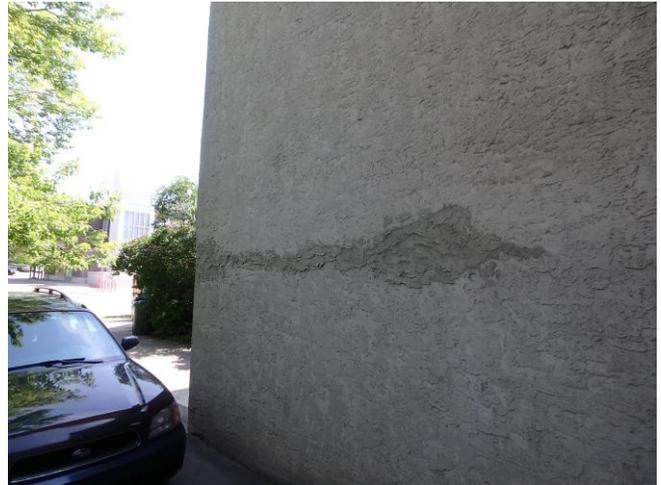
Evidence of historic parking repairs noted on concrete foundation.

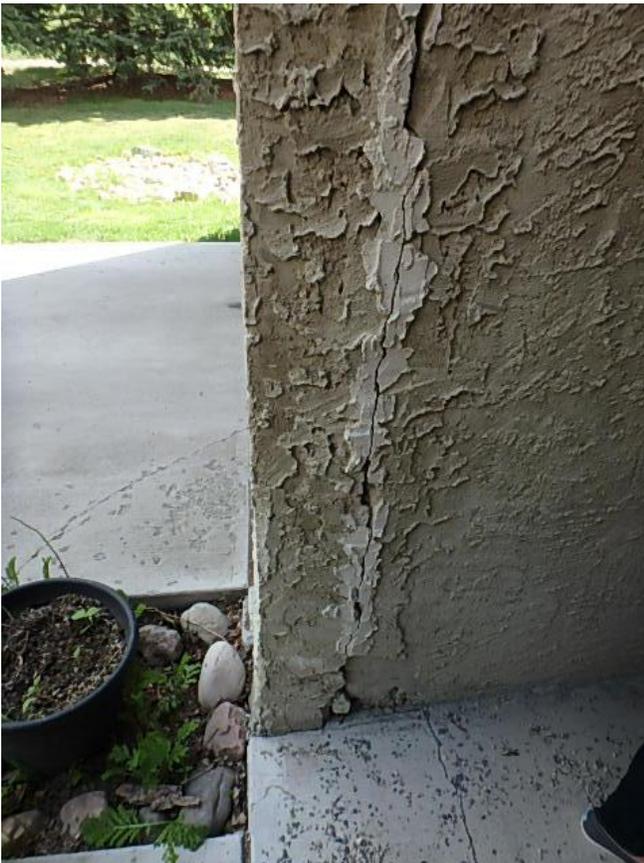
Isolated delaminated concrete section.

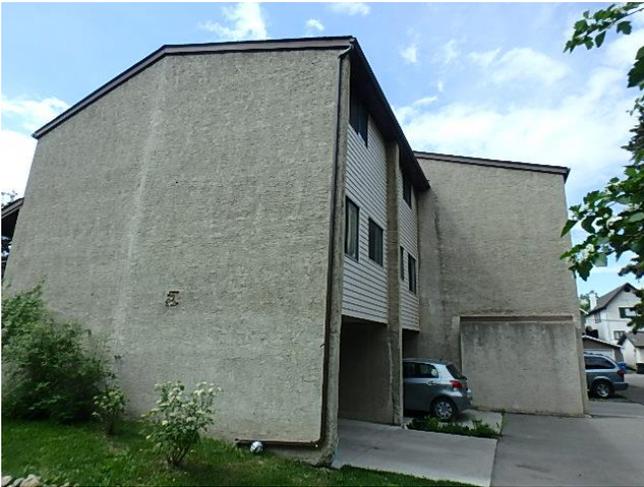
Damaged Stucco located at end wall for unit 44 (or block 8).

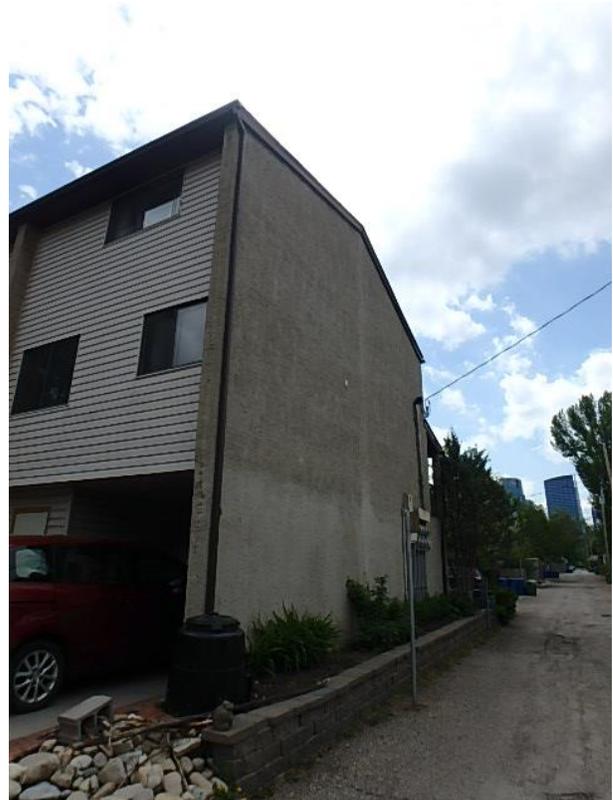
Typical patch repairs at end wall areas at concrete to wood frame transitions.

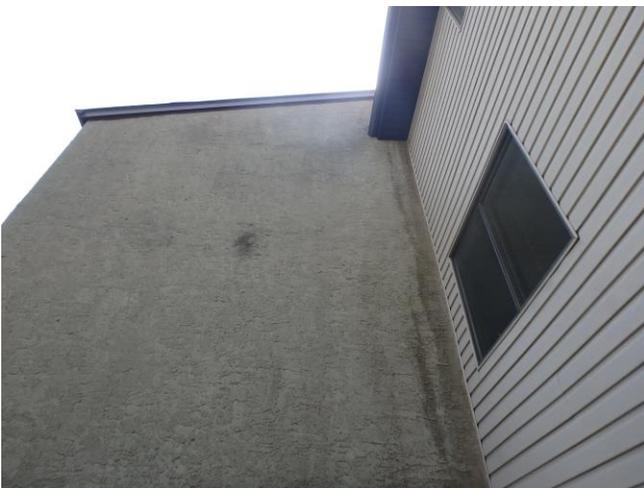
Water staining noted on end wall areas under eaves troughs

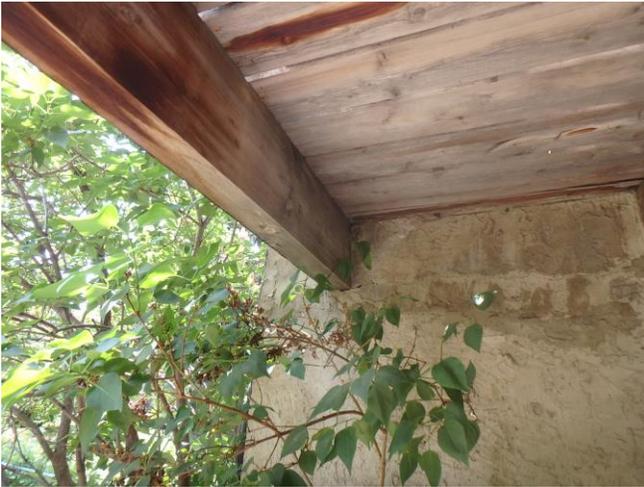
Typical water staining on stucco under balcony areas.

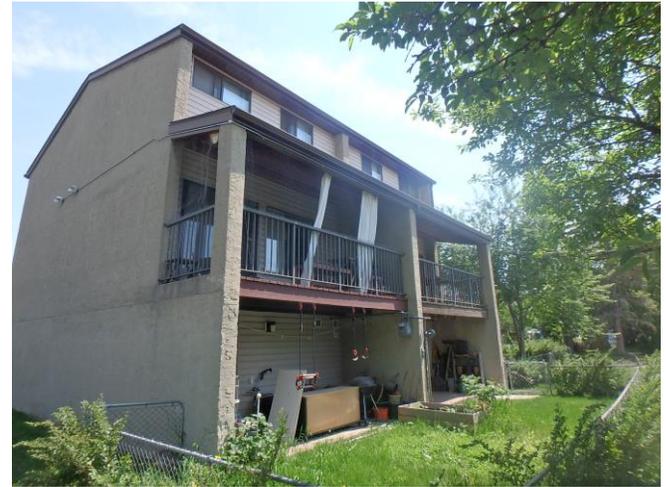
Typical water staining and moisture damage on stucco at balcony to end wall locations

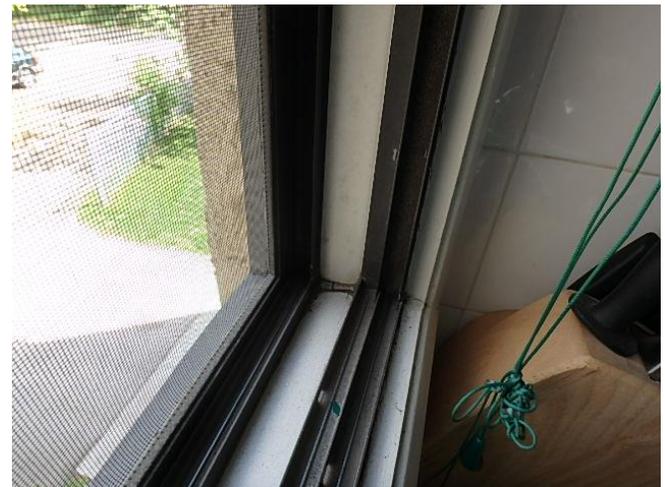
Typical sliding window track configuration and condition..

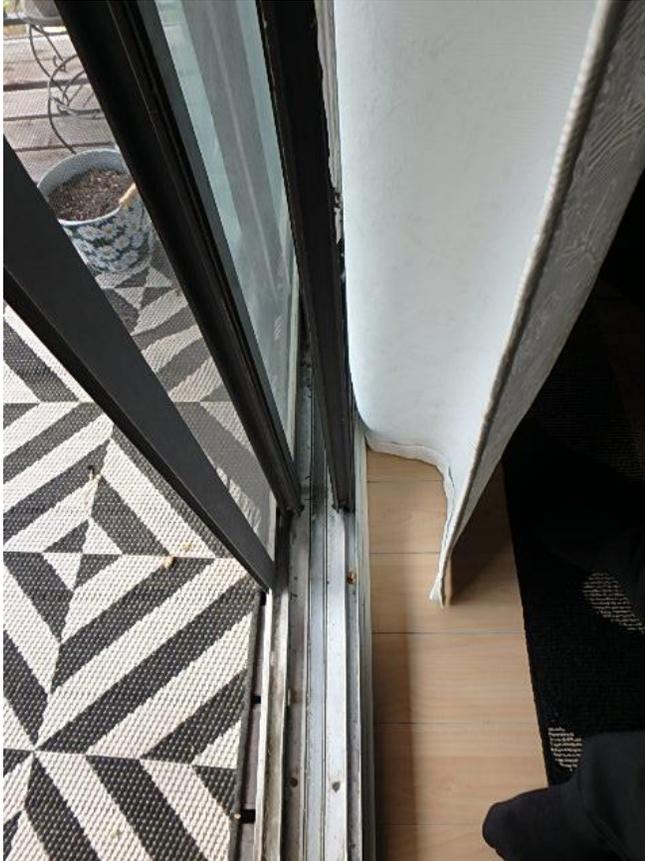
Typical sediment build-up and glider wear on balcony sliding door track

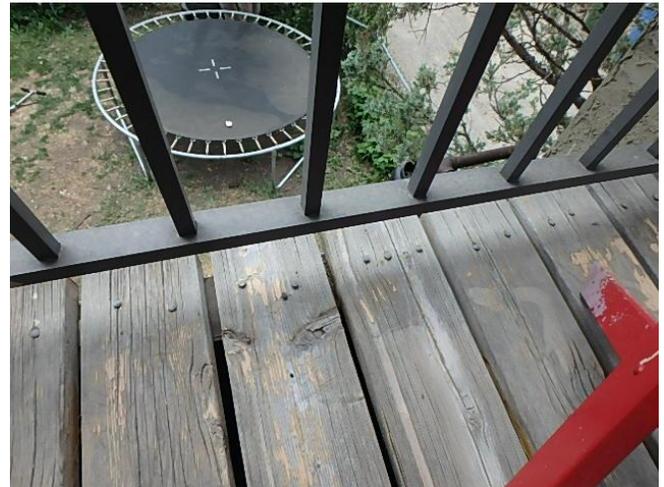
Unsecured/backed out nails observed at the balcony wood planks & cracked & minor rot at townhouse unit 811 of Block 2.

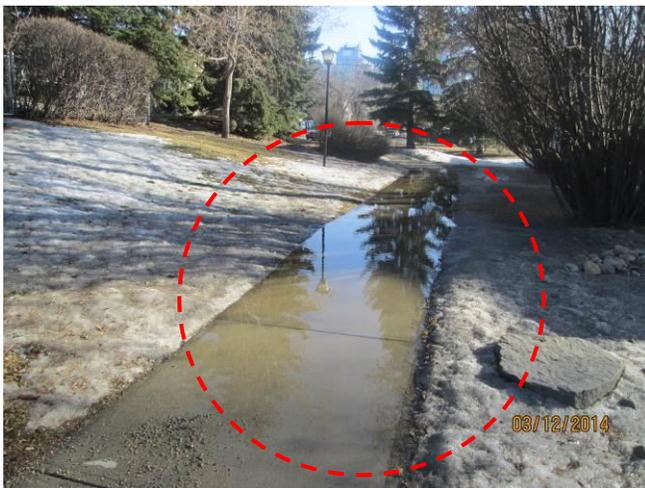
Ponding water observed at the concrete walkway between Blocks 6 & 7.

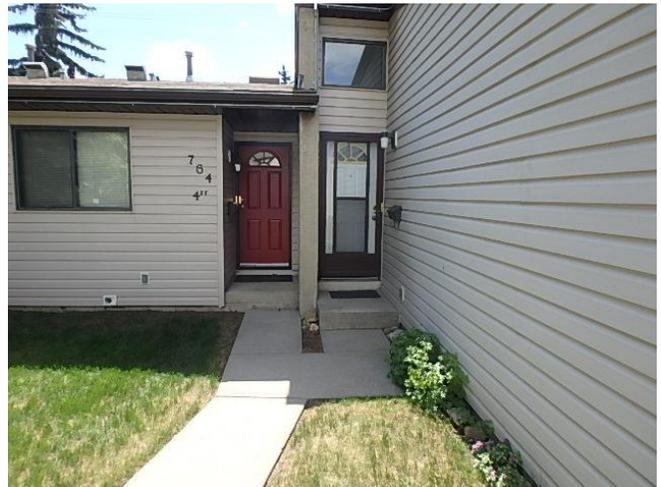
Concrete steps & walkways with localized cracks.
