Facility Assessment and Recommendations

Sunnyhill Housing Co-op: 787 – 3rd Street NW, Calgary, BC

Project Managed by: Urban Matters CCC | September 2019

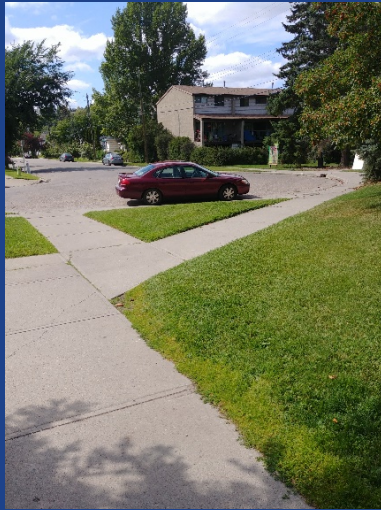
Figure 1: Possible location for on-street designated accessible parking

- Request the City to create an additional designated accessible parking stall on the street in front of the co-op with blue paint applied to the curb and vertical signage indicating it as a short-term designated accessible parking stall.

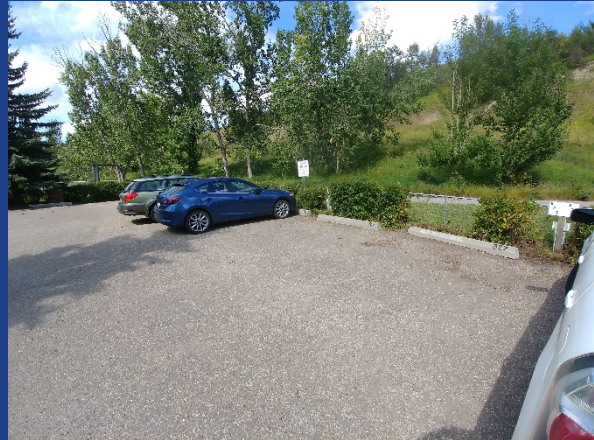
Figure 2: Ideal location for off-street designated accessible guest parking stall

- Add at least one designated accessible guest parking stall of adequate size. Ensure that is located on level ground with minimal slope and cross-slope to allow for safe transfer to/from vehicles with a wheelchair.

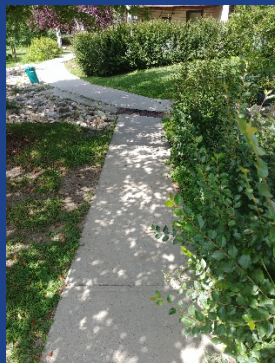
- Exterior pathways have sufficient clear width, free from obstructions, for people using mobility devices.
- Some sections of exterior pathways have encroaching growth of weeds and flowers from adjacent garden beds that obstruct some of the pathway, making it effectively too narrow to safely use for a person using a mobility device.

Figure 3:
Encroaching Shrub growth

- Pull back landscape features (shrubs/flowers) from pathways and instruct maintenance crews to add edging of the lawn areas to their regular lawn mowing schedule so weeds do not encroach onto the pathway surfaces.
- Cut back overhead branches from pathways to ensure overhead height clearance of 2m above surface everywhere along the pathways.
- Ensure that a snow clearing protocol is in place along all exterior pathways and common parking areas.
- Replace staircase at office with a ramp that is compliant to current City of Calgary building code.
- Replace maze entrance gate at rear of the complex with one that is wide enough to allow the passage of a wheelchair (minimum 920mm at narrowest point).
- Cut back overgrowth of shrubs that are hanging over the bench at the play area.

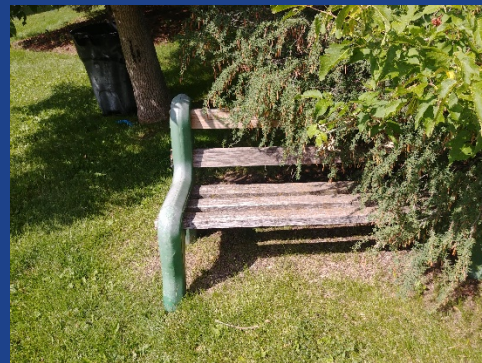
- Exterior benches have a variety of designs. One of them at the playground area is significantly obstructed by overgrowing shrubs. No shelter is provided on any of the benches.

Figure 4:
Overgrown shrubs on play area bench

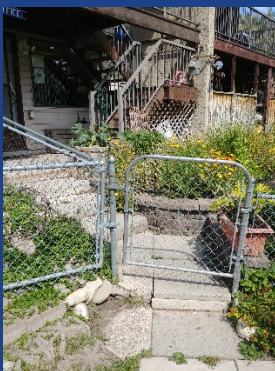
- The entrance to the office has a narrow pathway with stairs, the gate hardware requires good manual

- dexterity to operate, and the stairs have irregular rise and run with multiple direction changes through the garden area.
 - Backyard gates on all residential units are not useable by people with limited dexterity.

Figure 5:
Problematic office entrance

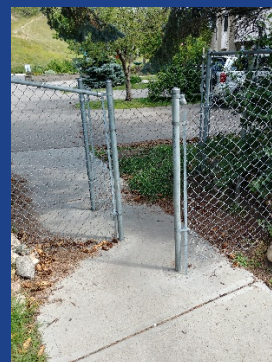
- One of the gates has a maze entrance with openings too narrow to accommodate a mobility device.
- Units 827 and 839 have staircases which are unprotected along one side and have a steep dropoff.

Figure 3:
Maze entrance at rear gate

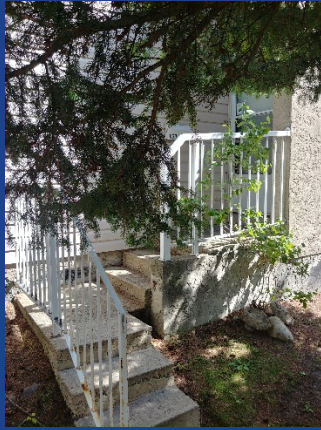
- With railings included, exterior staircases are too narrow.
- There is no tactile or high visibility indication on top of stairs or ramps, and no tactile indication on stair nosings.

Figure 7:
 Staircase non-compliant to
 current building code

- Replace exterior staircases on units 827 and 839. Ensure that new staircases are compliant to current City of Calgary building code for width and that they have handrails along both sides.
- Replace all gate hardware with a type of closure that can be operated by people with limited dexterity, e.g. a flip latch.

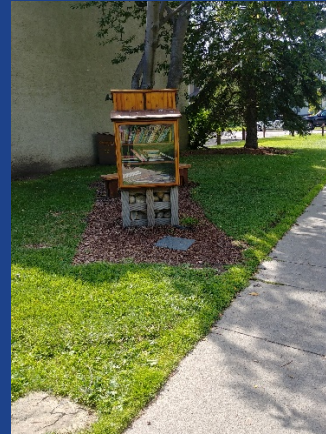
- The book exchange box is at an appropriate height but lacks signage and the handle requires good dexterity.
 - Where there are two benches in one location, e.g. at the play area, replace one so that there is one bench that has armrests and one that does not. Ensure both benches can be approached across firm, level ground with a mobility device.

Figure 8:
 Book exchange box

- Add signage at the book exchange box with large font and high contrast. Replace door hardware on the book box with a type operable by a person with limited dexterity.

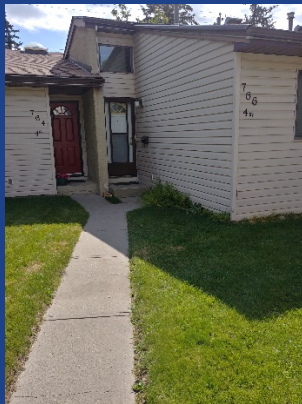
- The units all have covered entry doors.
- Every unit has either stairs or significant thresholds at all the entry points.
- Exterior doorways for one bedroom units are less than 800mm clear width; entry doors for two and three bedroom units vary from 700 to 850mm. All entry doors are

Figure 4:
Entry doors with steps

- Add short ramps to all exterior doors with thresholds; ensure ramps are marked with high visibility edging and have slopes of 1:20.
- Replace exterior staircase approaches to main entry doors with ramps that have slopes of 1:20 and have handrails on both sides which comply to accessibility best practices.

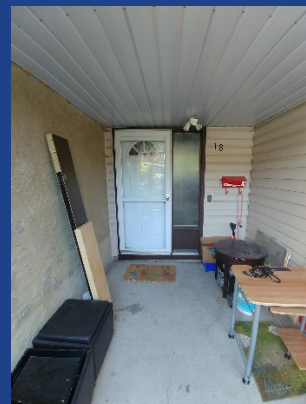
Figure 10:
Covered entrances

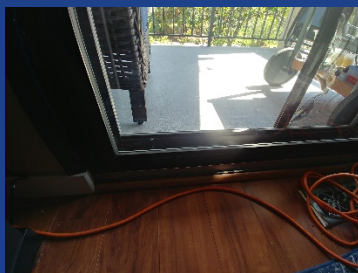
- Sliding glass patio doors have slight thresholds on interior side.
 - Sliding door hardware is difficult to use for people with limited dexterity.
- Replace all door knobs with lever-style handles.

Figure 11:
Threshold on glass patio doors

- Inclusive Access Requirements:**
- Install ramp hardware with clear contrast to interior and exterior of sliding patio doors.
- Full Access Strategy:**

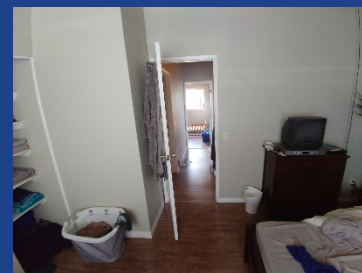
- narrower than accessibility best practice.
- Interior doorways are all built to old building codes and are all far narrower than accessibility best practices and current standards.

- Door hardware on all doors is difficult for people with limited dexterity to use (knob handles).
 - Sliding glass patio doors have not contrasting or high visibility markings at eye level.

Figure 5:
Typical interior door

- Replace doors with ones that are wide enough to comply with accessibility best practices.

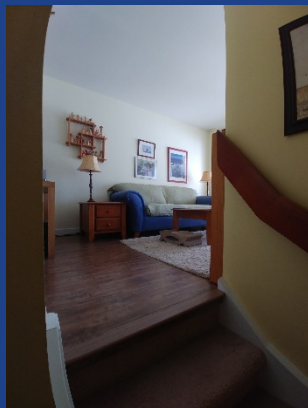
Figure 6:
Living areas open directly
to stairs and hallways

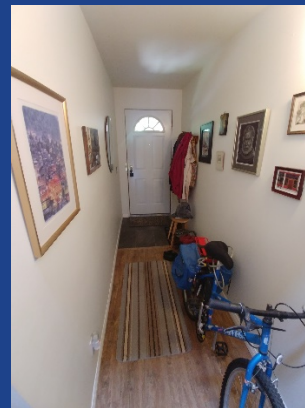
- The paths of travel in the main service areas are not kept clear of obstructions in most units.
- The paths of travel have firm, stable, non-slip surfaces and can be traveled by persons using mobility devices without excessive effort or hazard.

Figure 7:
Most hallways are
used for storage

- Main paths of travel should be kept clear of obstructions, but this is an issue which is outside of the control of the housing co-op. A reminder could be given to residents to keep paths of travel clear for fire and safety reasons.

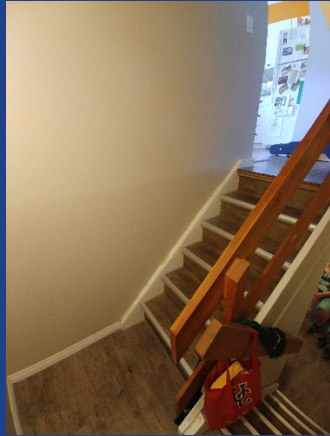
Figure 15:

Example of staircase with firm surface material and high contrast tactile nosings.

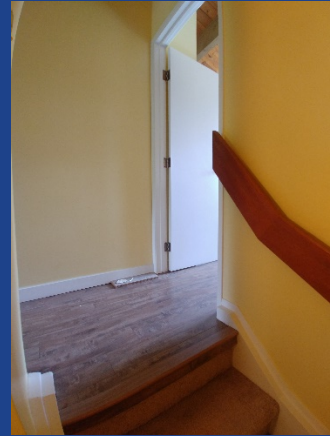
Figure 16:

- The two and three bedrooms all have staircases that are too narrow.
- Handrails have a design which is not graspable by people with limited dexterity.
- Handrails are only mounted on one side of the staircase.
- Most of the staircases are carpeted, which creates a greater slip hazard for people with limited mobility than firmer floor material. Unit 759 is an exception to this and has firm surface material with high contrast and tactile stair nosings.
- Stairs all have closed risers.
- Some stair risers have a slight abrupt underside on the tread which can create a tripping hazard for people with limited mobility.
- There is adequate colour contrast between stair surfaces and walls, and between handrails and the walls.

Staircase with problematic handrail and carpeted surface with no contrast/tactile nosings.

- Replace handrails with the round/tubular style that can be easily and firmly grasped.

- Replace carpeting on staircase with firm floor material such as the one in Unit 759.
- Replace staircase treatment for ones with abrupt undersides on the nosings with ones that do not have abrupt undersides.

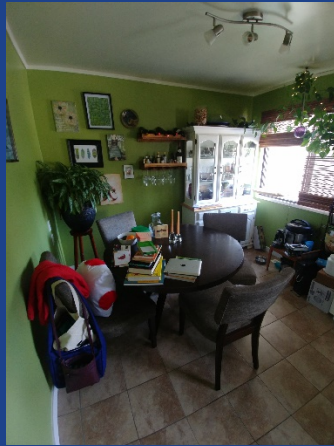
Figure 17:
Windows provide natural lighting.

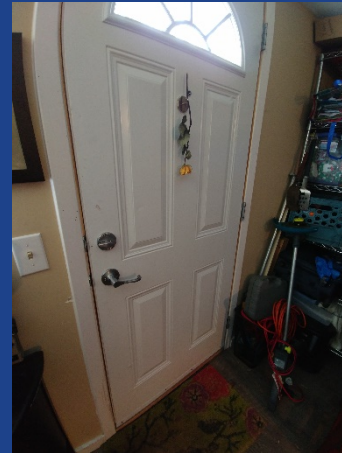
Figure 18:
Window at top of door reduces lighting transition from interior to exterior.

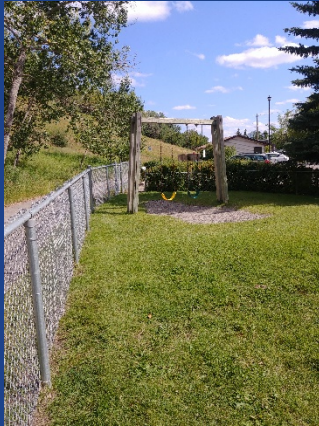
- The playground does not have accessible play equipment.
- The surface material of the play area is “pea” gravel which is very soft.
- There is a variety of seating types at or near the play area. Recommendations for this are covered elsewhere in the report.

Figure 25:
Swingset

- Replace surface material with material that is firm enough to allow people with limited mobility or mobility devices to enter the play area (e.g. recycled rubber mats)
- Add some accessible play equipment, e.g. by replacing one of the swings with an accessible one.

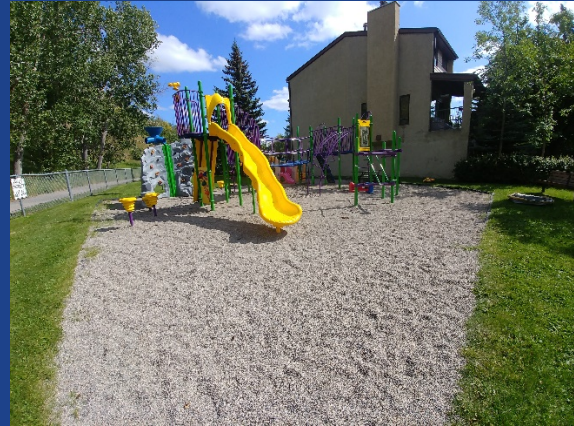
Figure 26:
Play Area
