# BUILDING CONDITION ASSESSMENT & RESERVE FUND STUDY

## **Sunnyhill Housing Co-operative 787 - 3rd Street NW Calgary, AB**

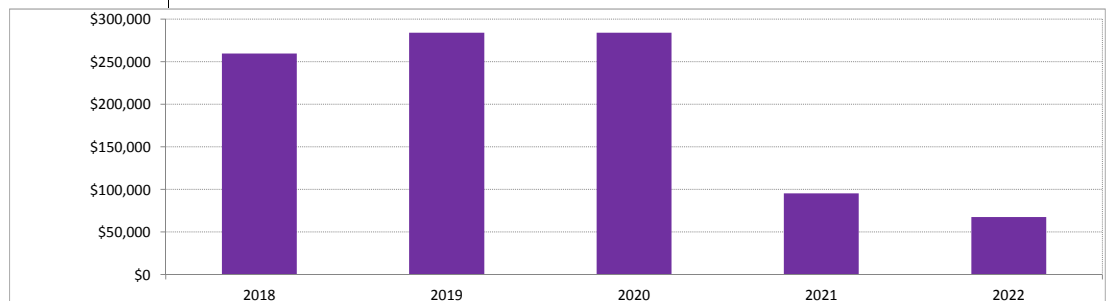
**THIS PAGE INTENTIONALLY BLANK**

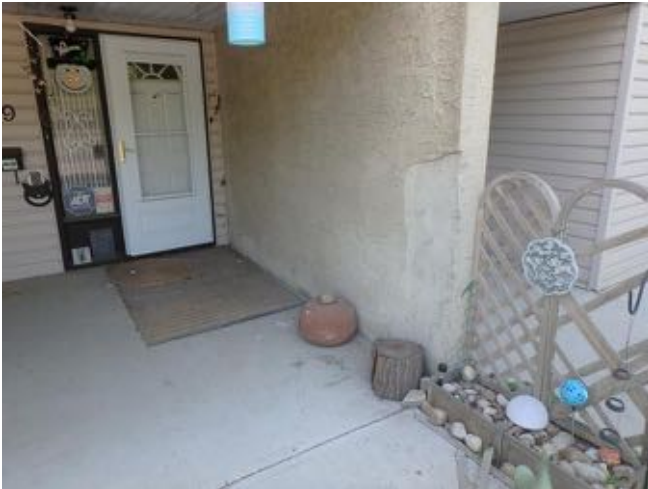
Parging noted to be delaminating from Concrete foundation (non-structural concern).

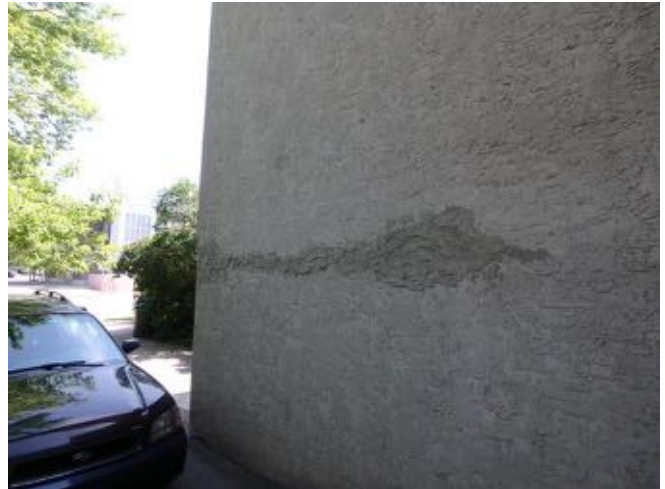
Evidence of historic parking repairs noted on concrete foundation.

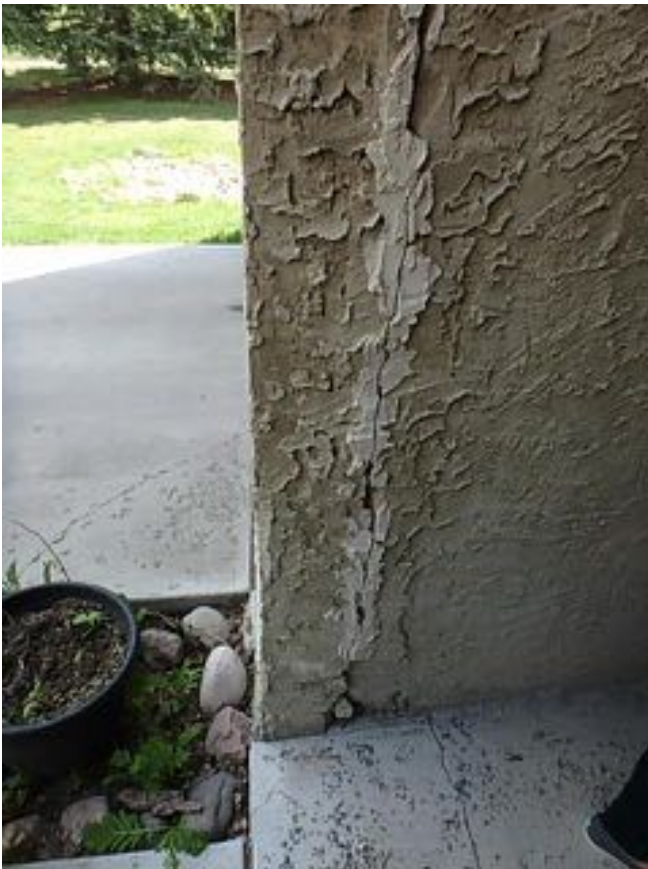
Isolated delaminated concrete section.

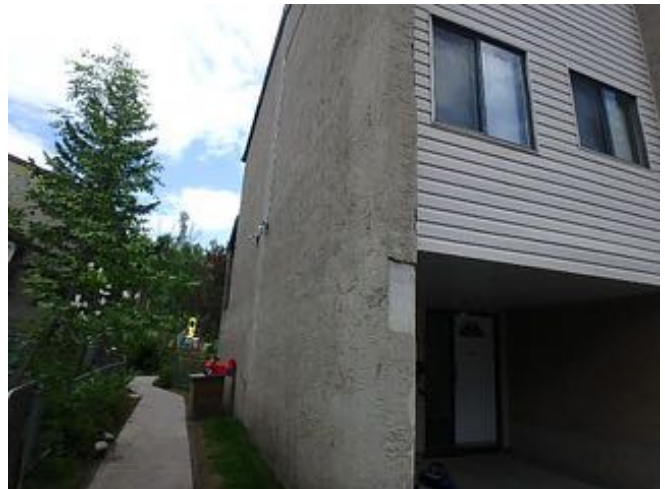
Typical end wall elevation view of ground floor reinforce concrete foundation wall.

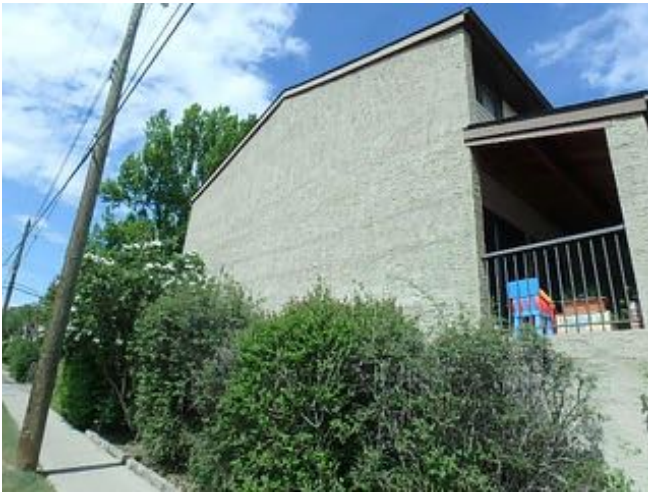
Typical low to moderately sloped roof area.

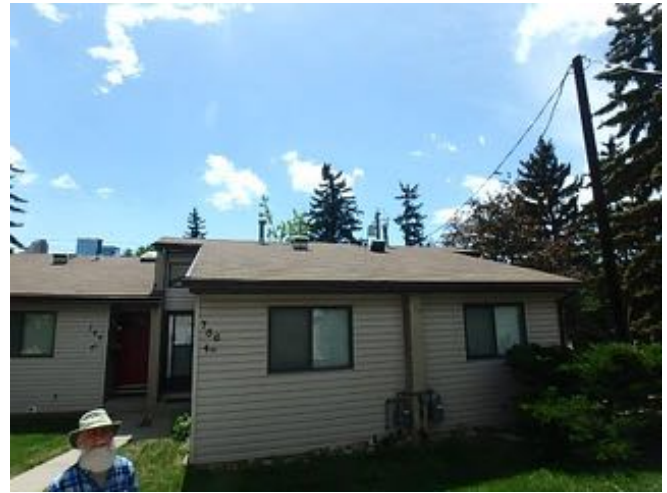
Typical Asphalt roof condition on single storey units.

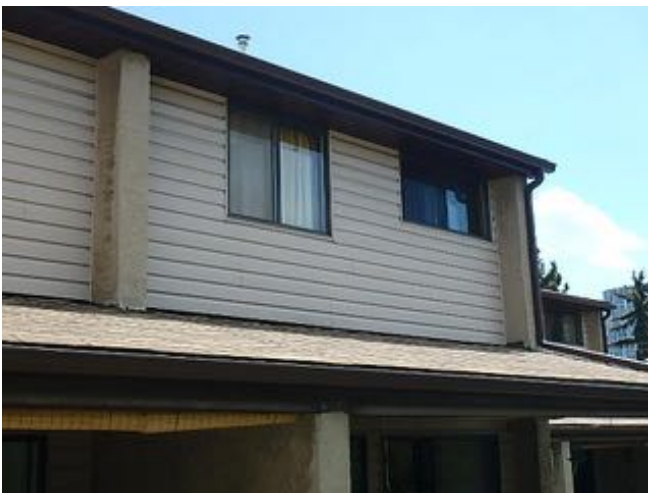
Typical Asphalt condition over balcony areas

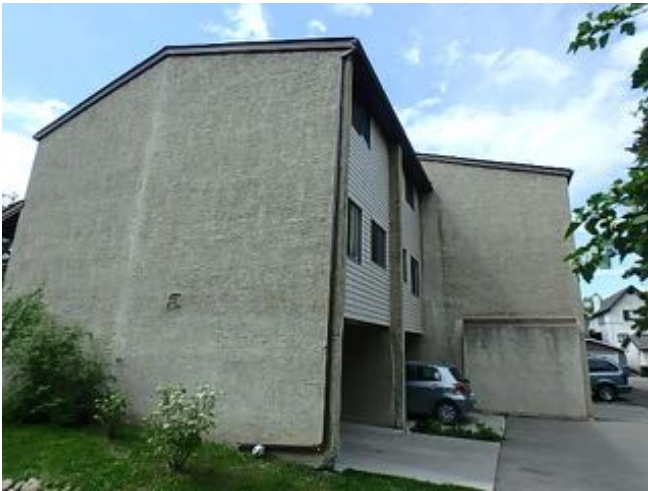
Damaged Stucco located at end wall for unit 44 (or block 8).

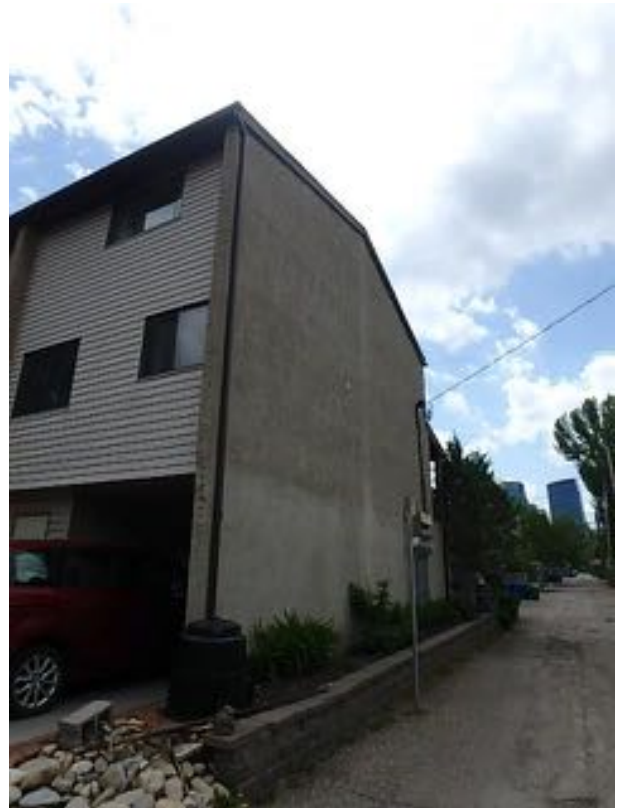
Typical patch repairs at end wall areas at concrete to wood frame transitions.

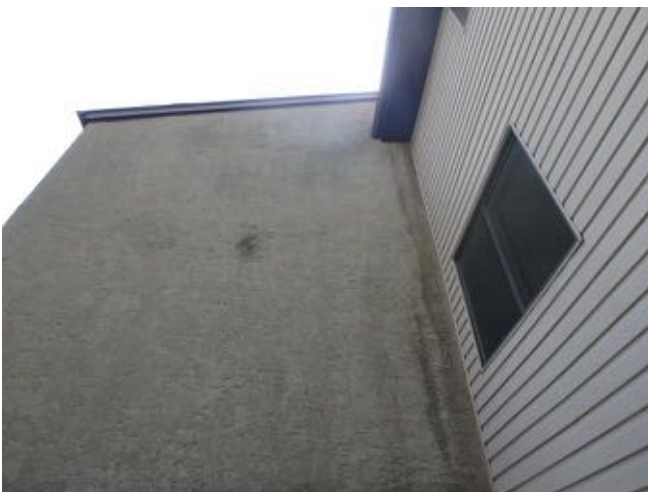
Water staining noted on end wall areas under eaves troughs

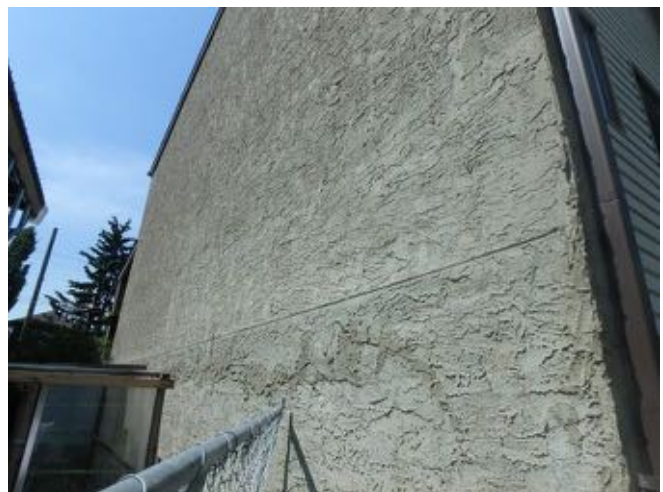
Typical Stucco Repair at end wall area.

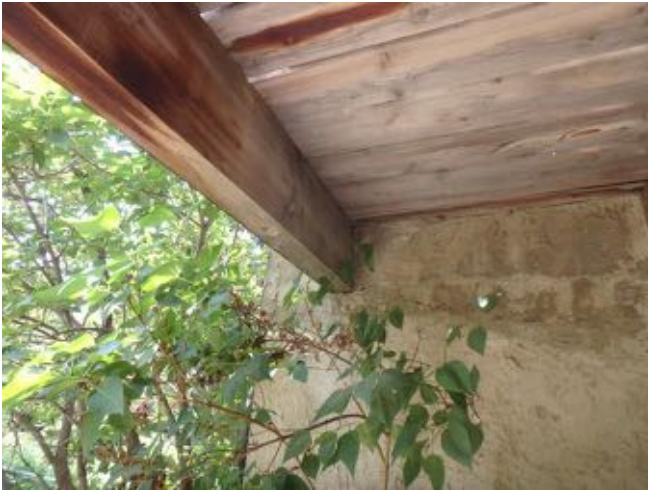
Typical water staining on stucco under balcony areas.

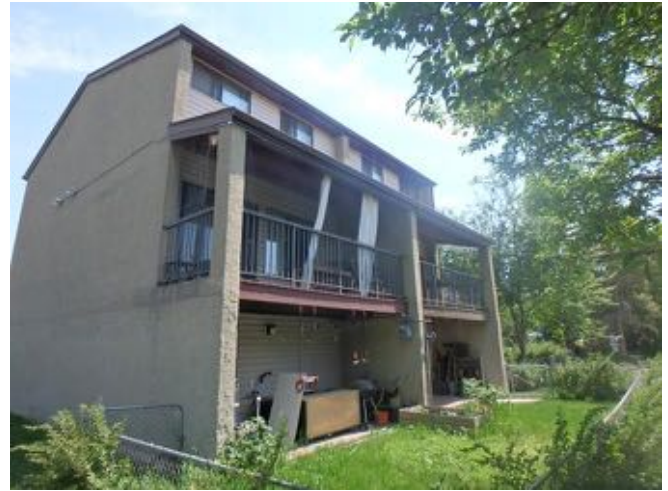
Typical water staining and moisture damage on stucco at balcony to end wall locations

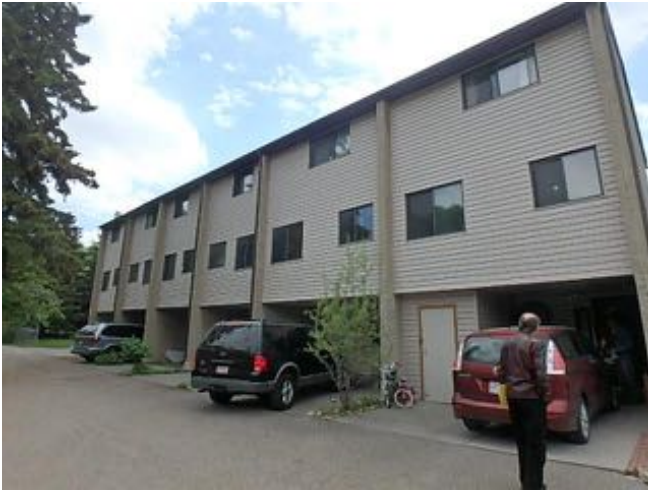
Typical siding configuration / Condition.

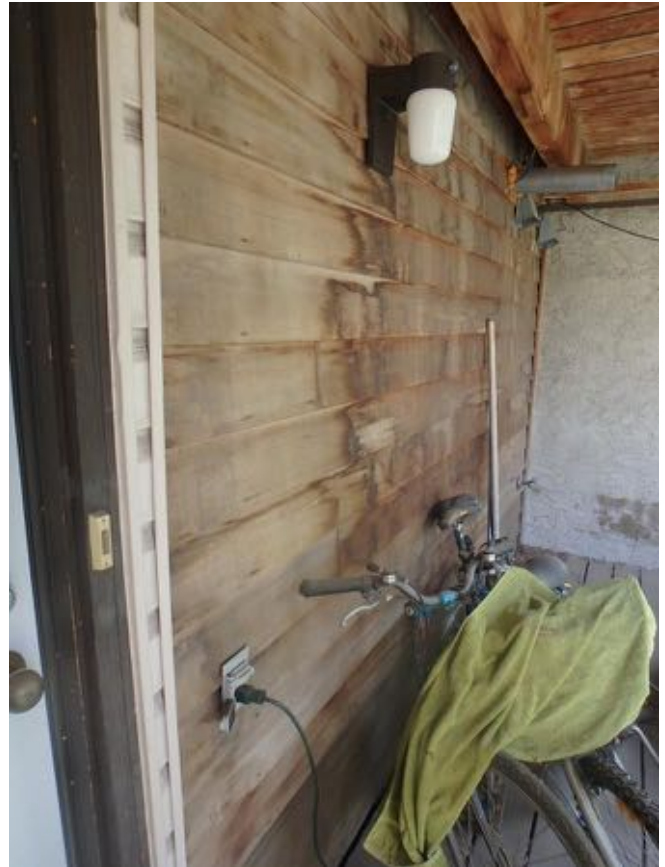
Close up view of exposed original cedar siding found on Block 1.

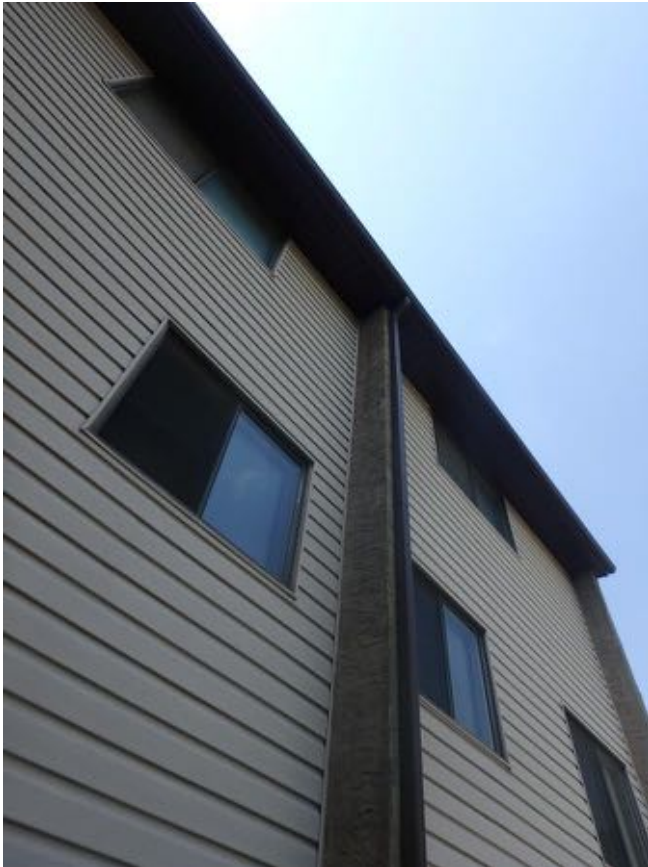
Typical siding configuration around window penetrations.

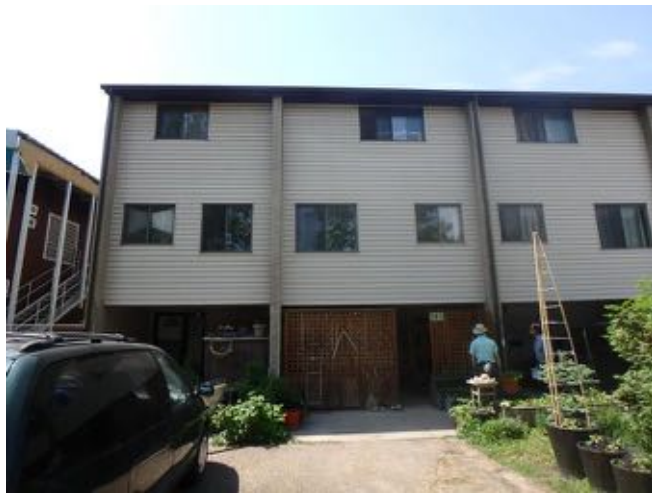
Typical overall sliding window configuration.

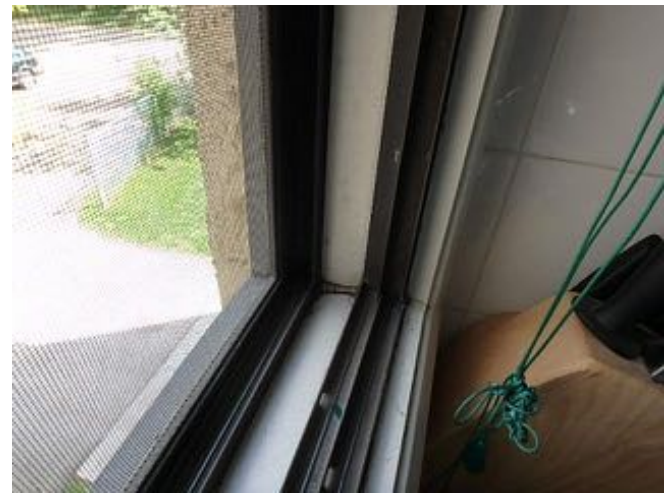
Typical sliding window track configuration and condition..

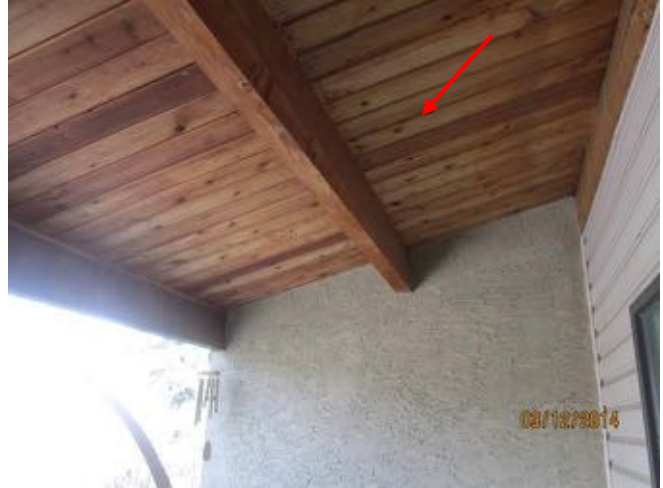
Typical tongue & groove cedar wood soffit above the townhouse unit balcony observed.

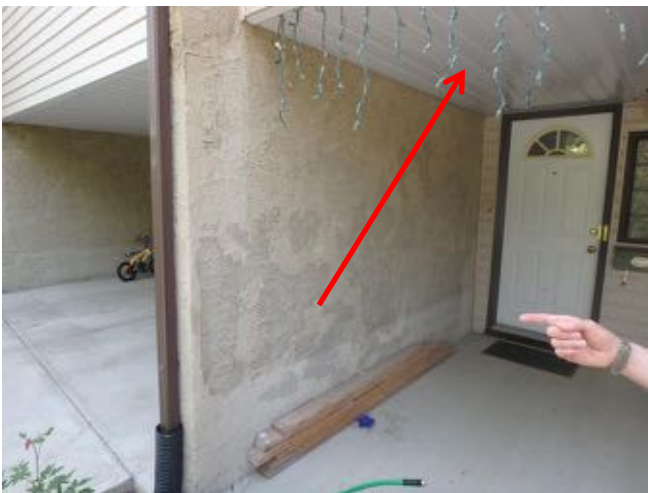
Typical pre-finished aluminum soffit at the main entrance & carport area of a townhouse

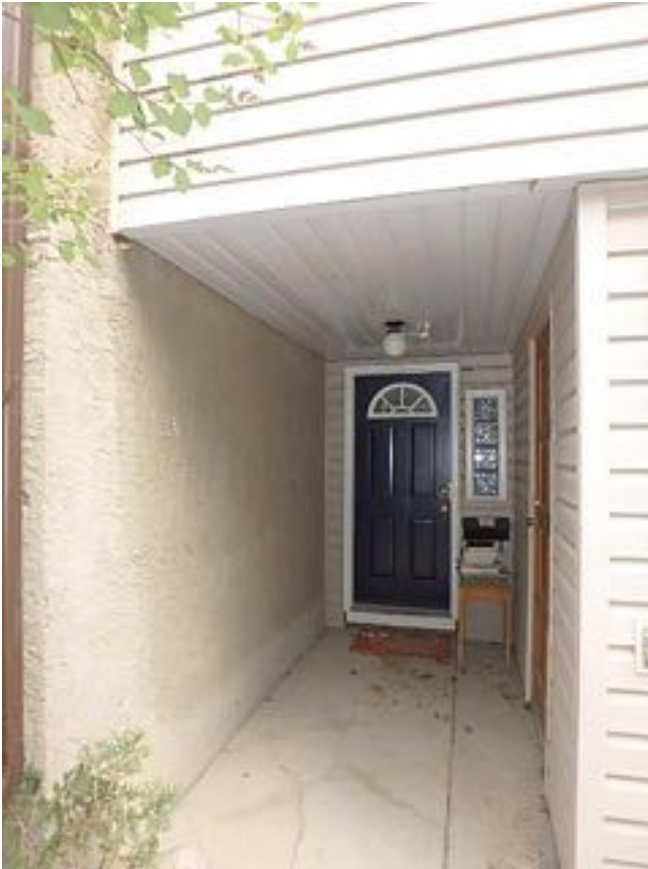
Typical townhouse unit main entrance door.

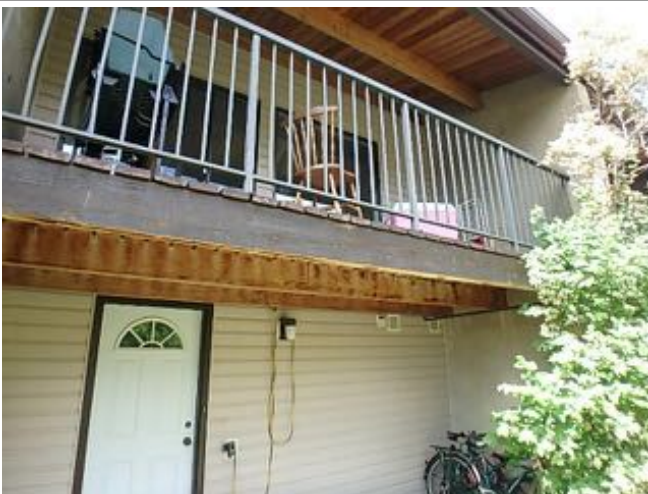
Typical replaced rear entrance door.

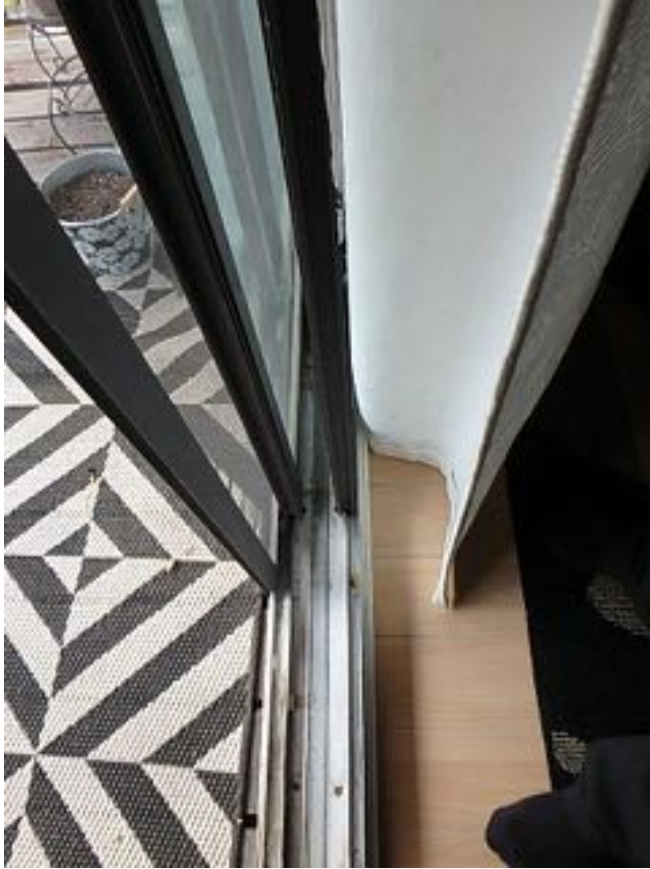
Typical sediment build-up and glider wear on balcony sliding door track

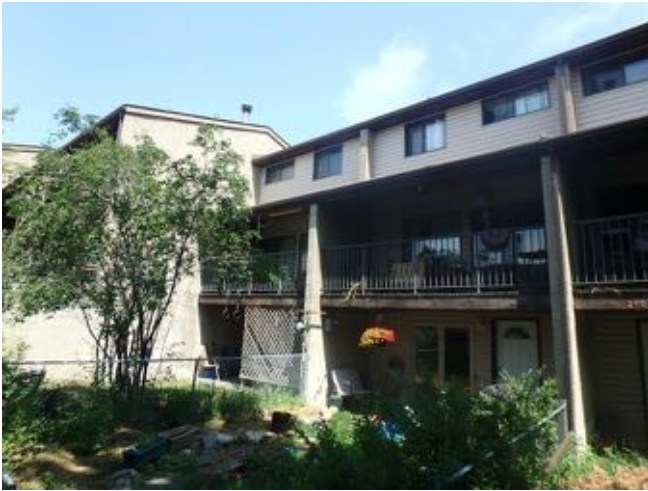
Exterior view of townhouse unit balcony.

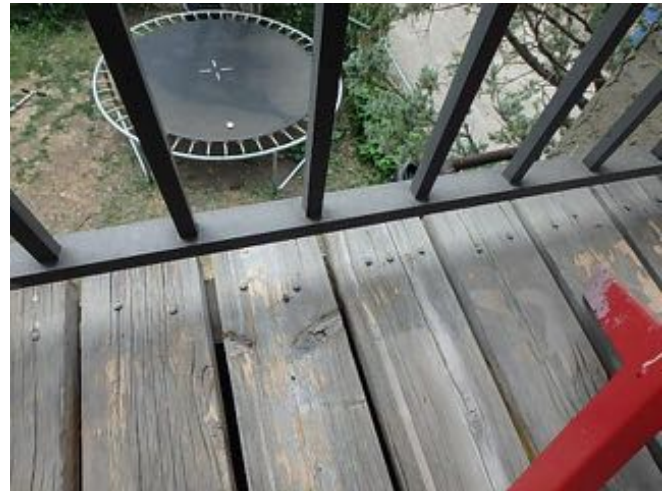
Unsecured/backed out nails observed at the balcony wood planks & cracked & minor rot at townhouse unit 811 of Block 2.

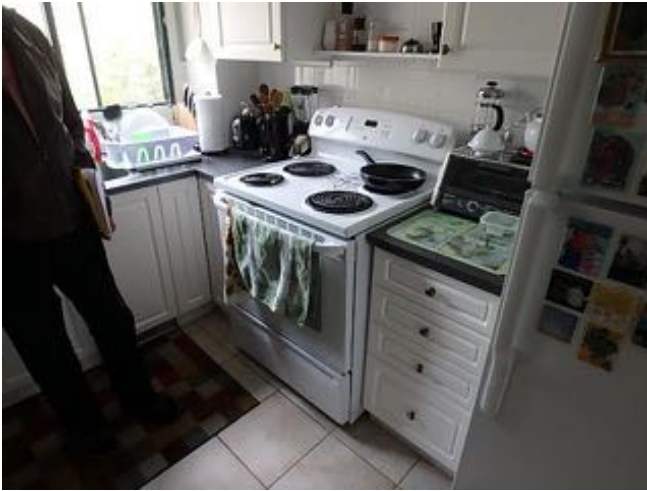
Townhouse kitchen appeared to be in good to fair condition with new cabinetry

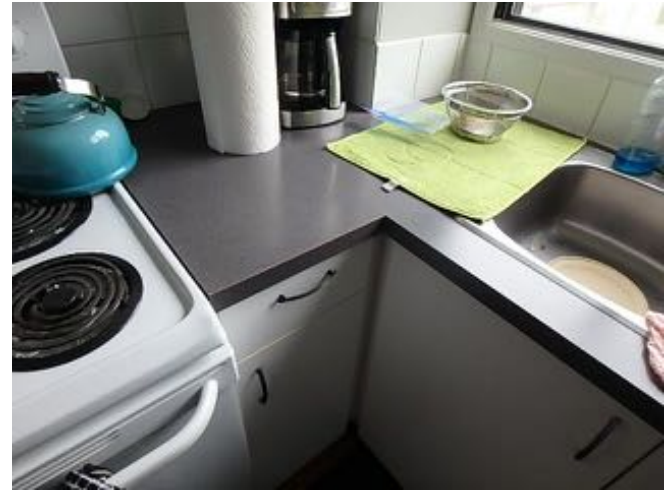
Kitchen Counter tops in some units appeared to be upgraded

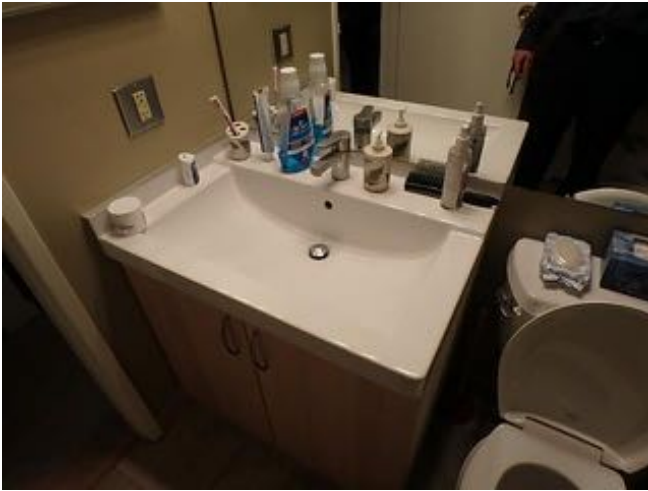
Recently upgraded bathroom components included newer counter top and faucet

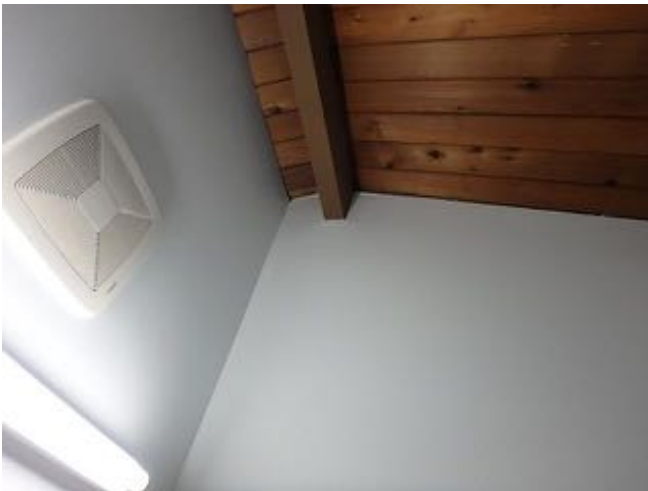
Wall Mounted Bathroom Fan noted in upstairs bathroom under vaulted ceiling.

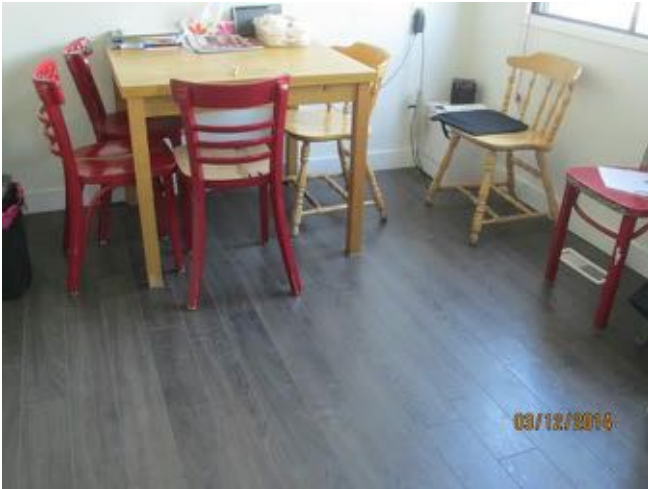
New laminate flooring observed in multiple units reviewed.

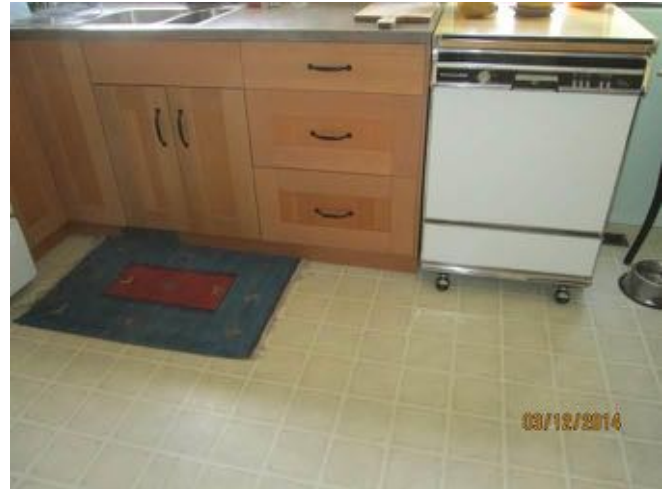
Vinyl sheet flooring in the kitchen of a unit observed.

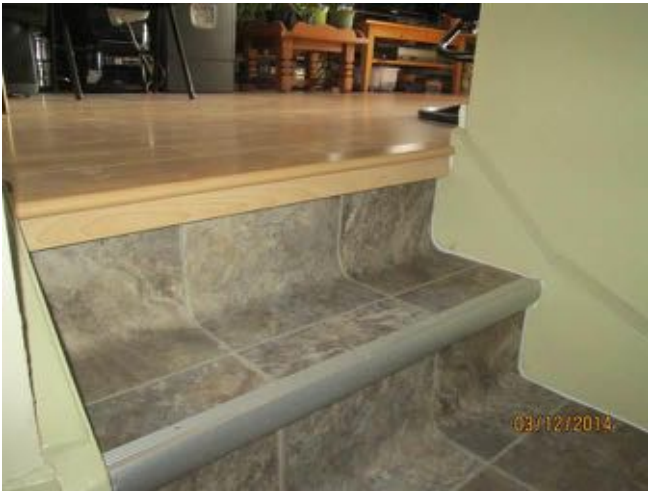
Typical recently upgraded flooring in a townhouse unit.

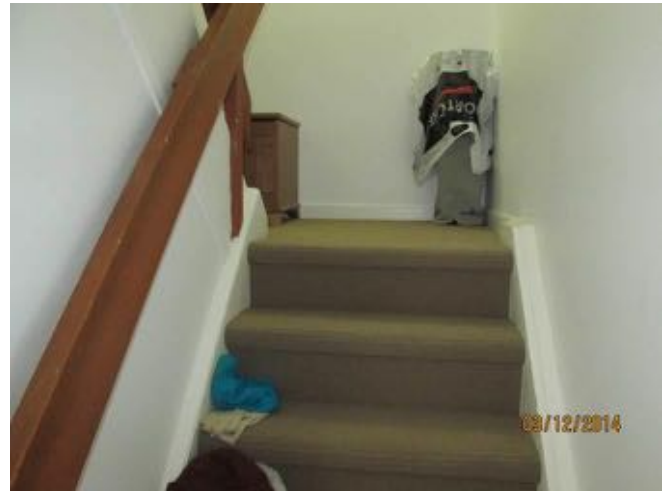
Carpet flooring observed in the unit's staircase at Block 6.

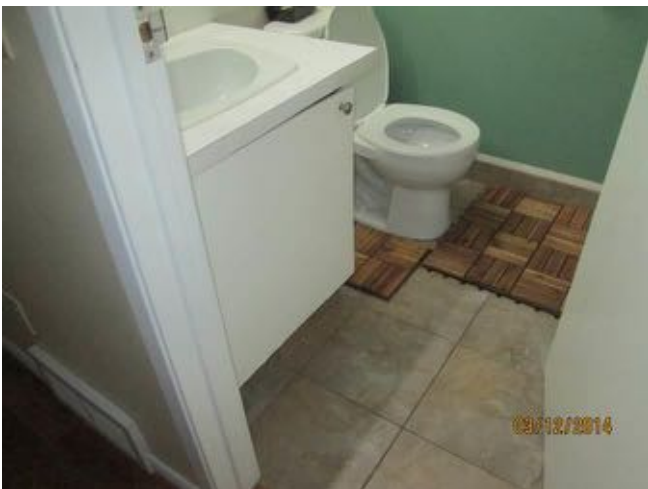
Typical ceramic tile flooring observed in a townhouse unit's bathroom at Block 1.

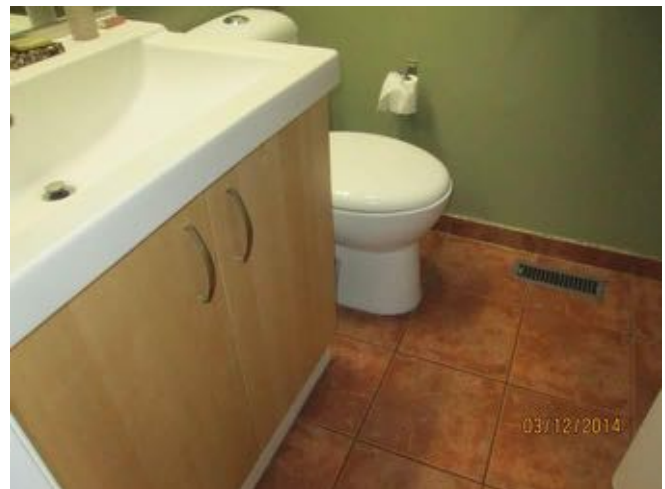
Ceramic floor tiling observed in the bathroom of a townhouse at Block 2.

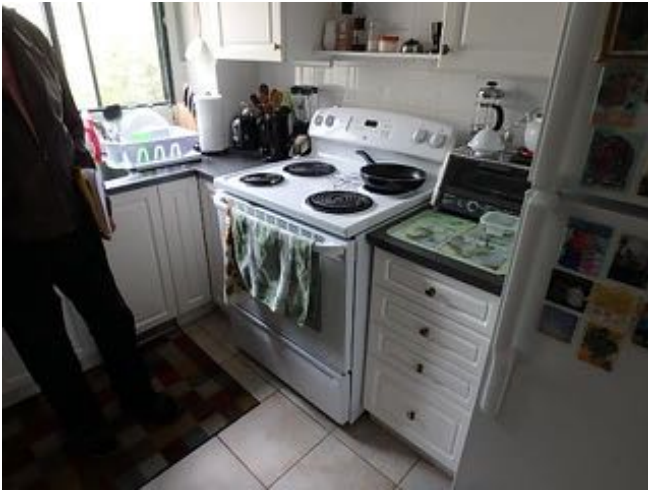
Typical Replacement electrical stove.

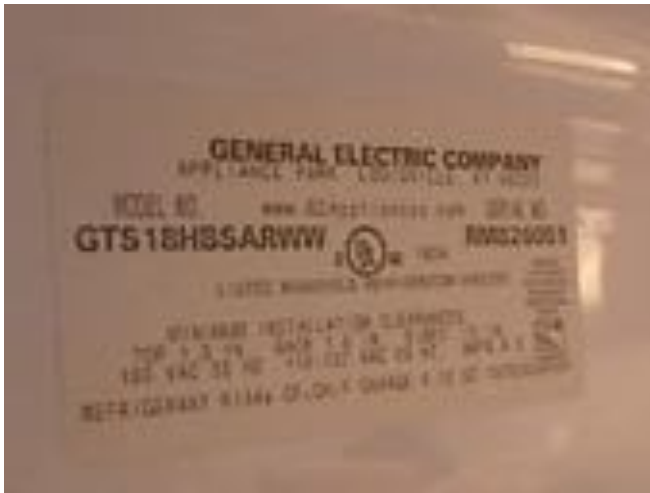
Replacement GE model refrigerator.

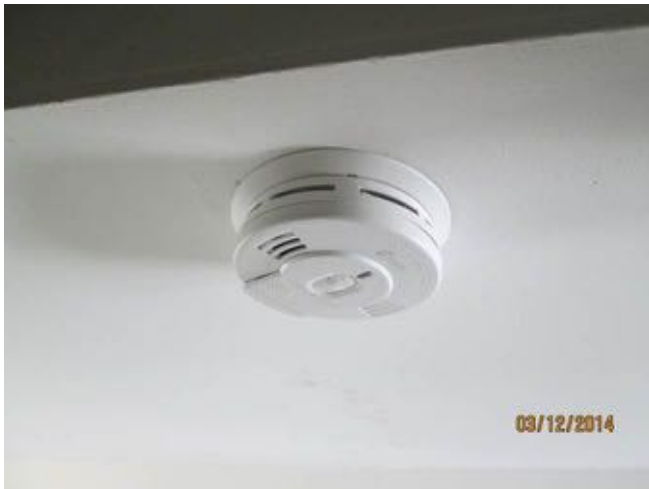
Typical battery operated smoke alarm observed in working condition.

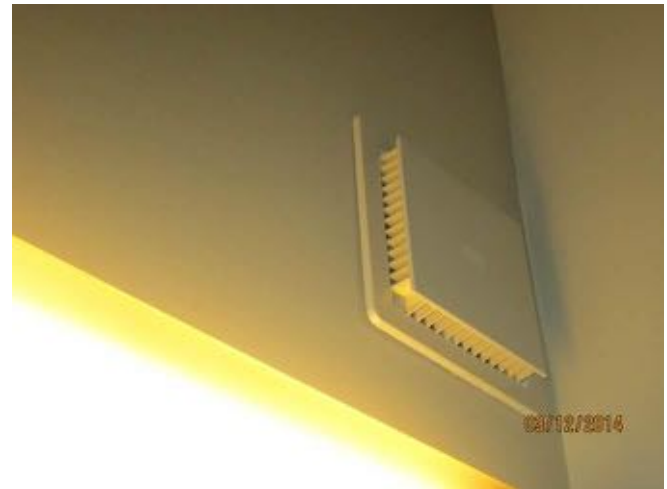
Typical wall mounted bathroom exhaust fan observed in working condition.

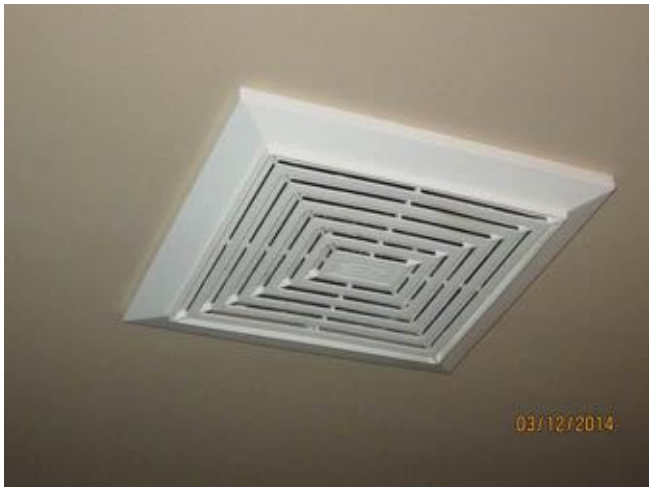
Close up view of soffit mounted bathroom exhaust fan.

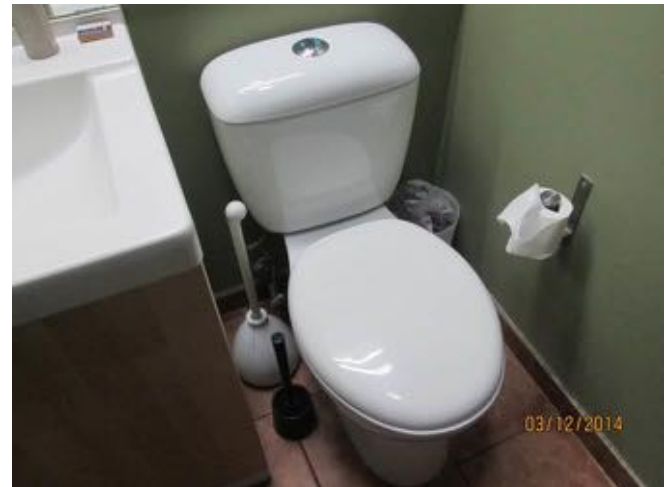
Typical dual flush type toilet observed in a townhouse unit.

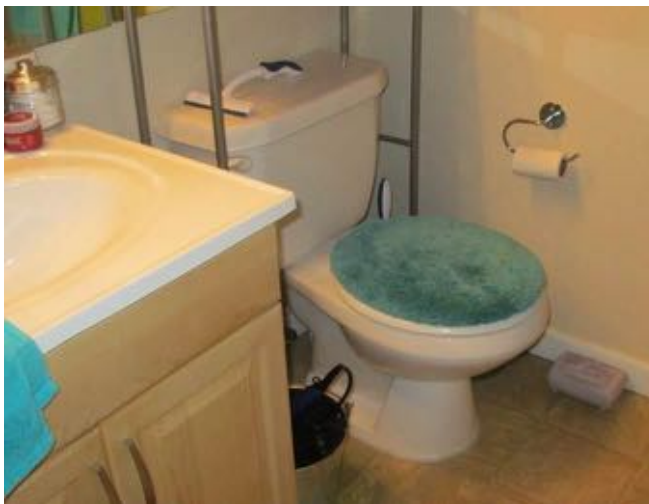
Typical standard flush toilet observed.

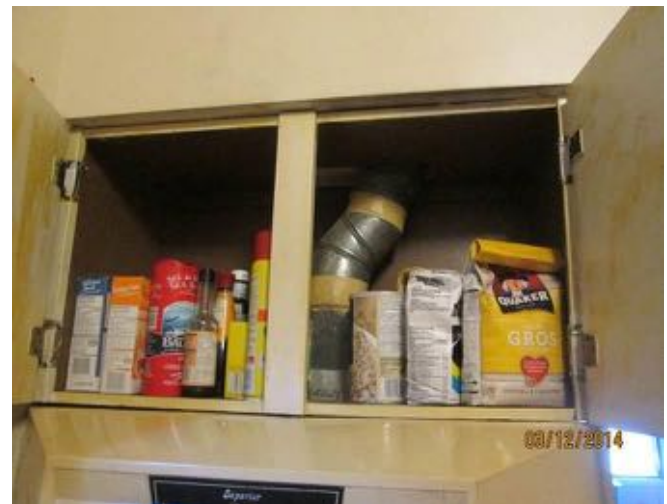
Typical kitchen range hood and ducting observed at a townhouse unit.

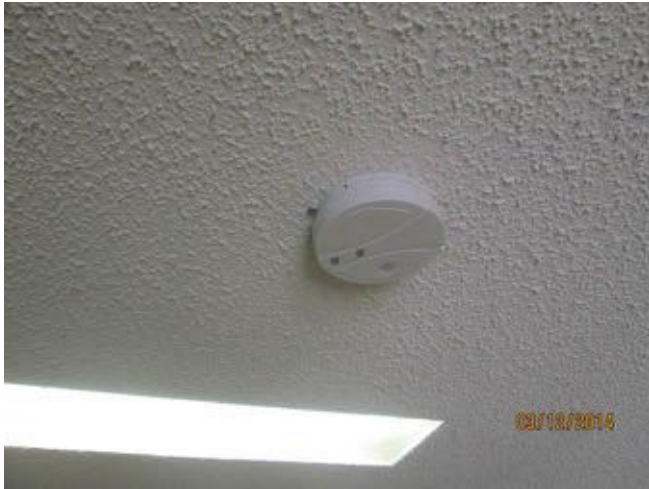
Battery operated Kidde smoke alarm in the Sunnyhill Co-op's office at Block 2.

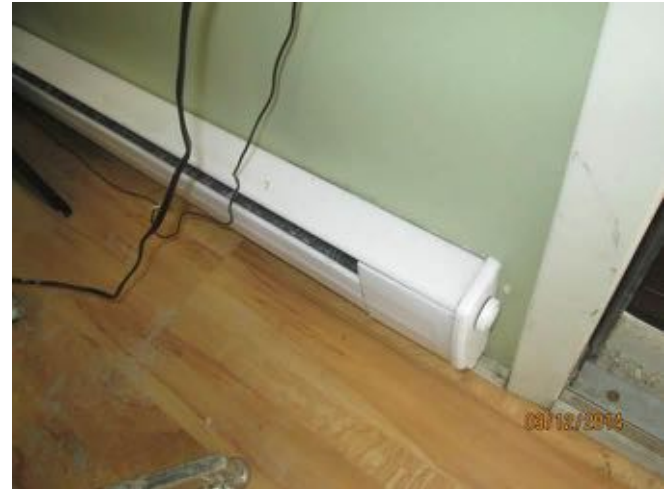
Electric baseboard heater in the office at Block 2 observed.

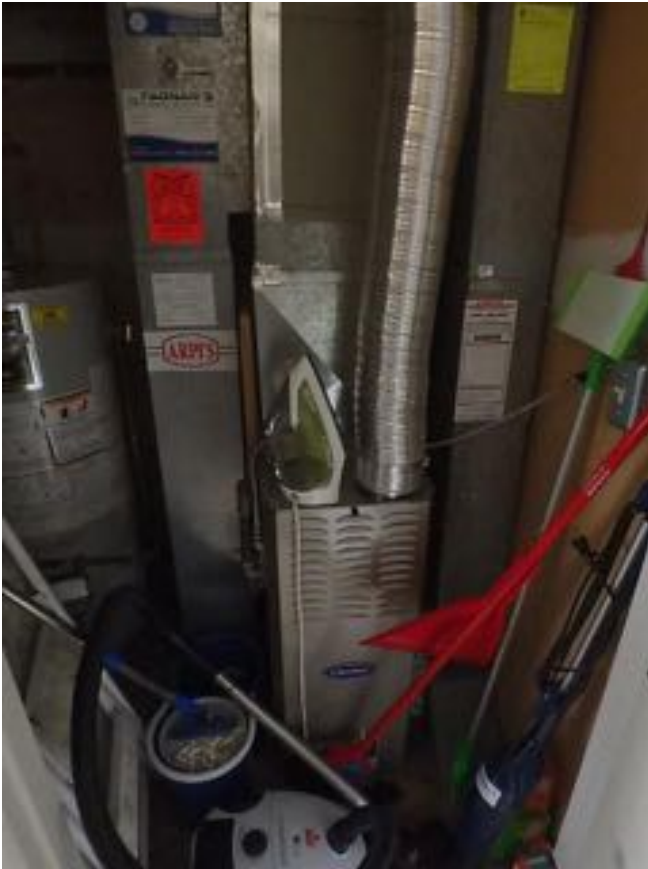
Typical gas-fired Carrier furnace observed at the 2<sup>nd</sup> floor level of the townhouse unit.

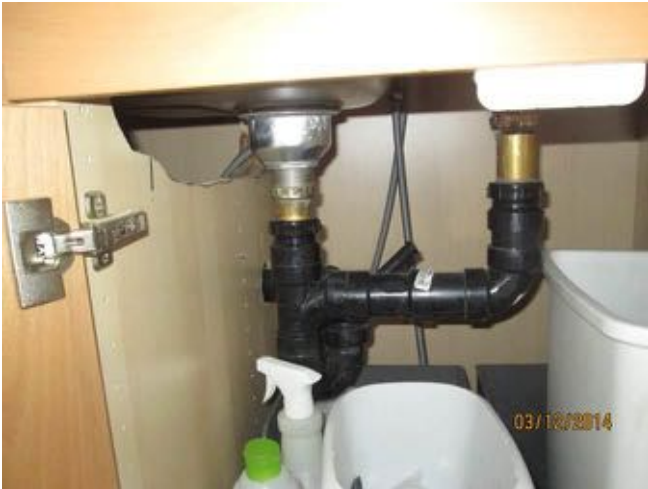
Typical piping layout servicing a kitchen sink.

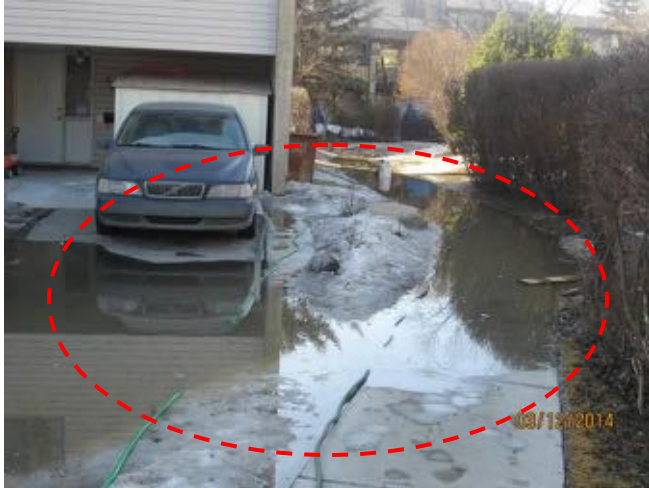
Ponding water observed at the driveway & concrete walkway between Blocks 1 & 2.

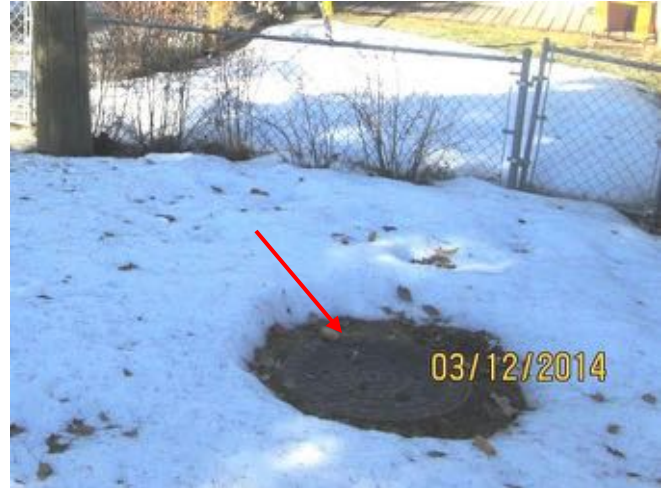
Typical catch basin to storm sewer system observed near Block 4.

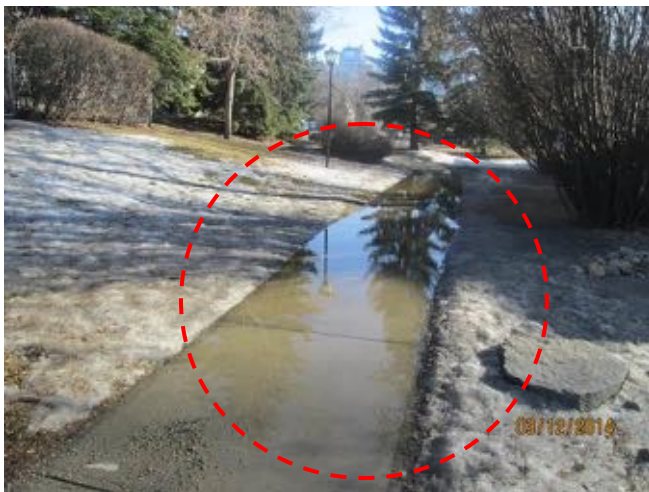
Ponding water observed at the concrete walkway between Blocks 6 & 7.

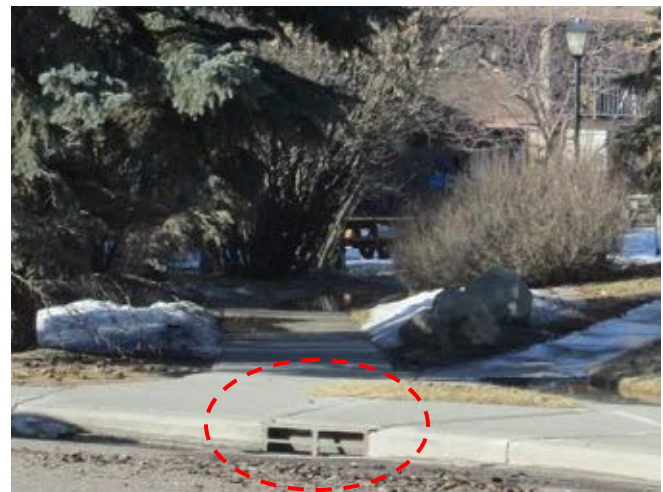
Typical storm sewer system throughout the property.

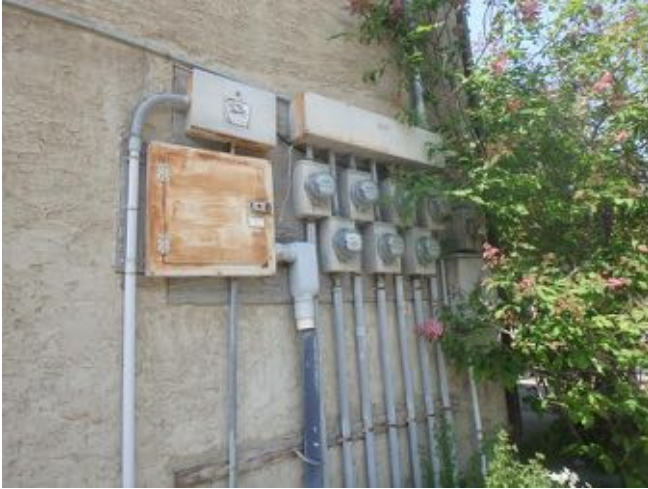
Typical electric meters & electrical panel observed.

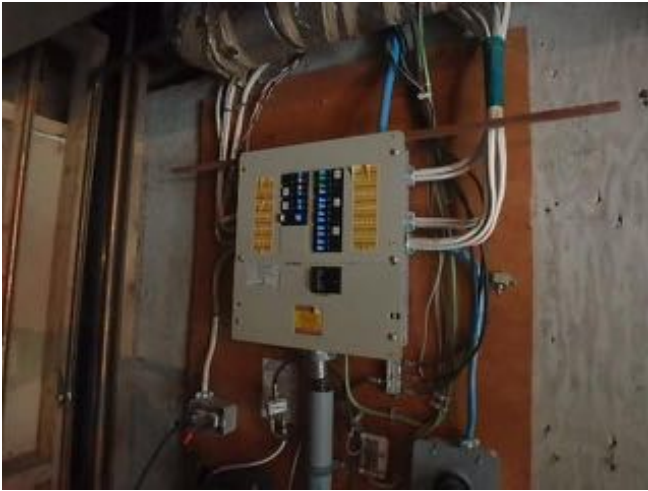
Typical circuit breaker in the townhouse unit reviewed.

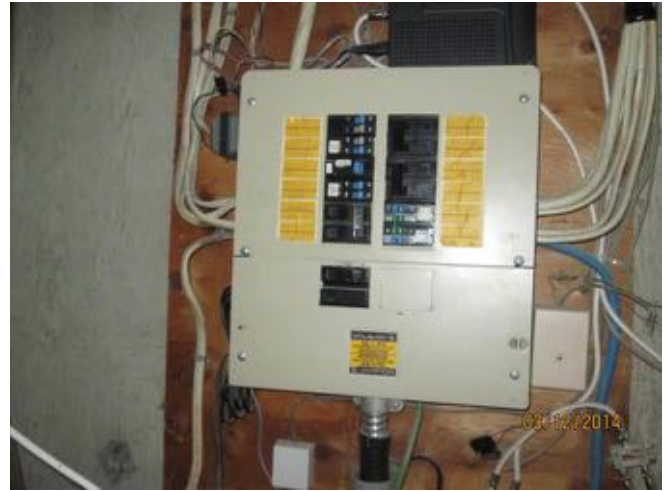
Typical NOVA Line NLC 24 circuit breaker observed.

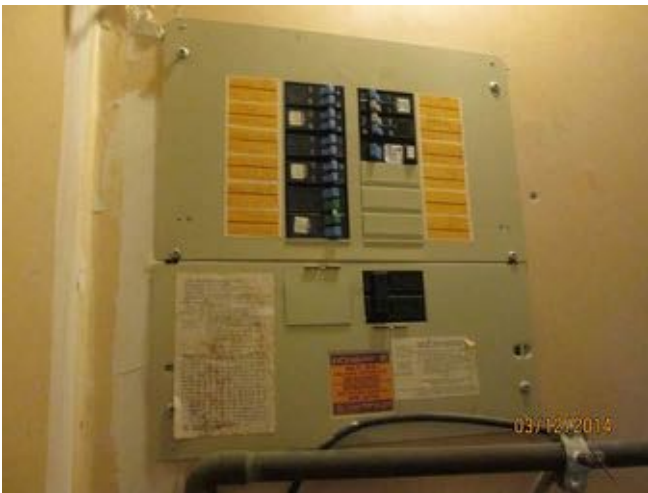
Typical surface mounted Westinghouse NOVA Line circuit breaker observed.

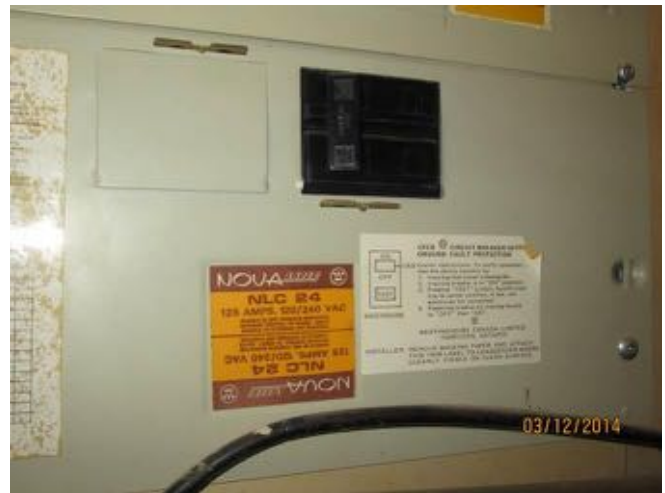
Manufacturer's label observed.

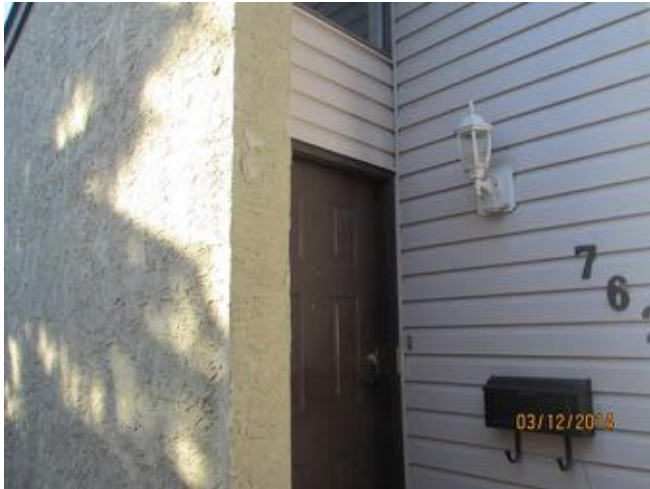
Typical wall mounted light fixture at unit 762 observed.

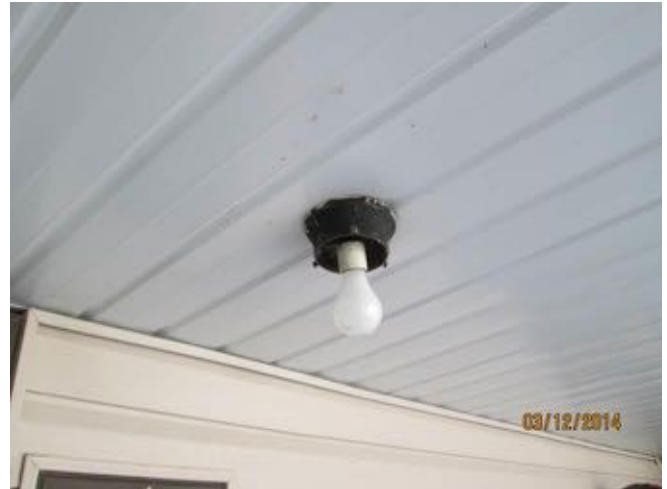
Soffit mounted incandescent light fixture observed at unit 22.

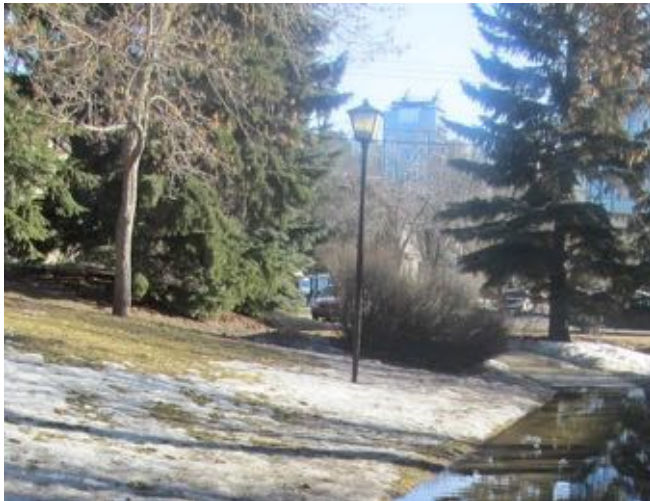
Typical lamp pole with concrete base observed between Block 6 & 7.

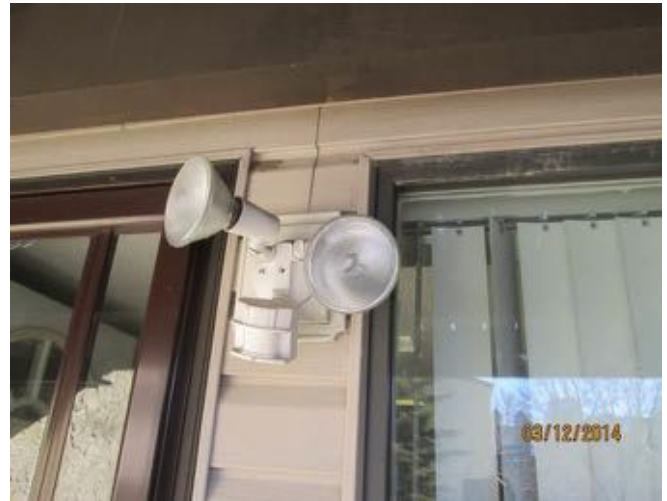
Wall mounted light fixture at with motion sensor observed at the common office at Block 2 observed.

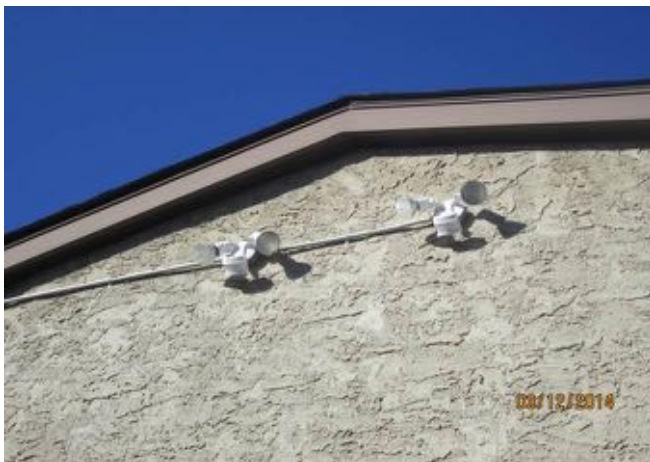
Typical wall mounted building light fixtures with motion sensors observed at Block 6.

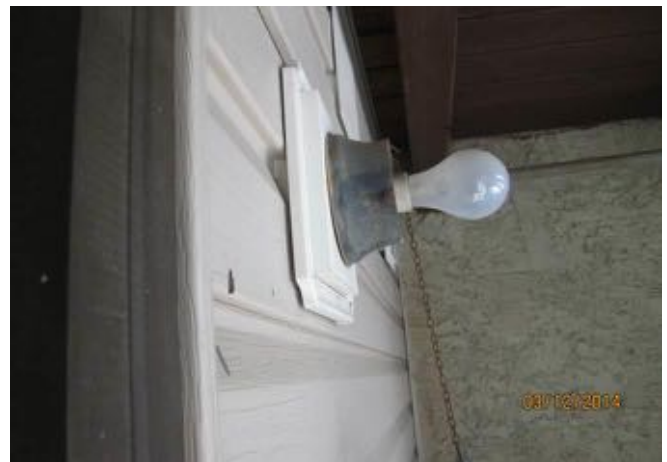
Typical incandescent light fixture at Unit 42 observed.
