# BUILDING CONDITION ASSESSMENT & RESERVE FUND STUDY

## **Sunnyhill Housing Co-operative 787 - 3rd Street NW Calgary, AB**

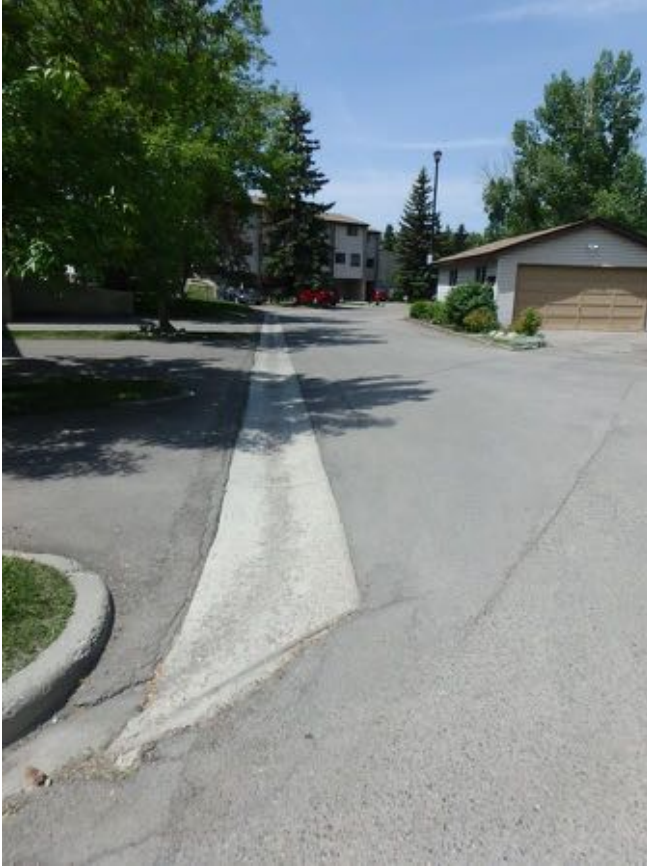
Overview of asphalt paving adjacent Common Garage.

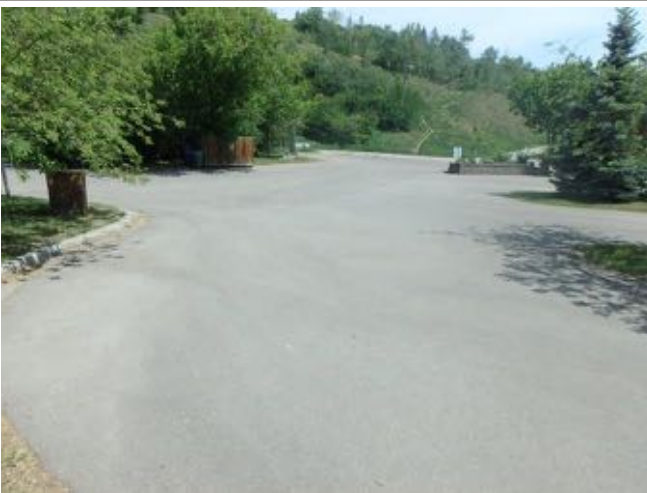
Typical Asphalt condition of main drive lane 6.

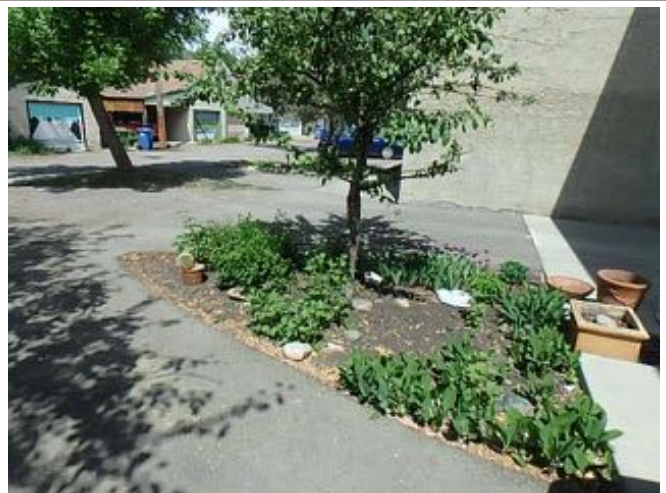
Drive way condition adjacent back city lane way

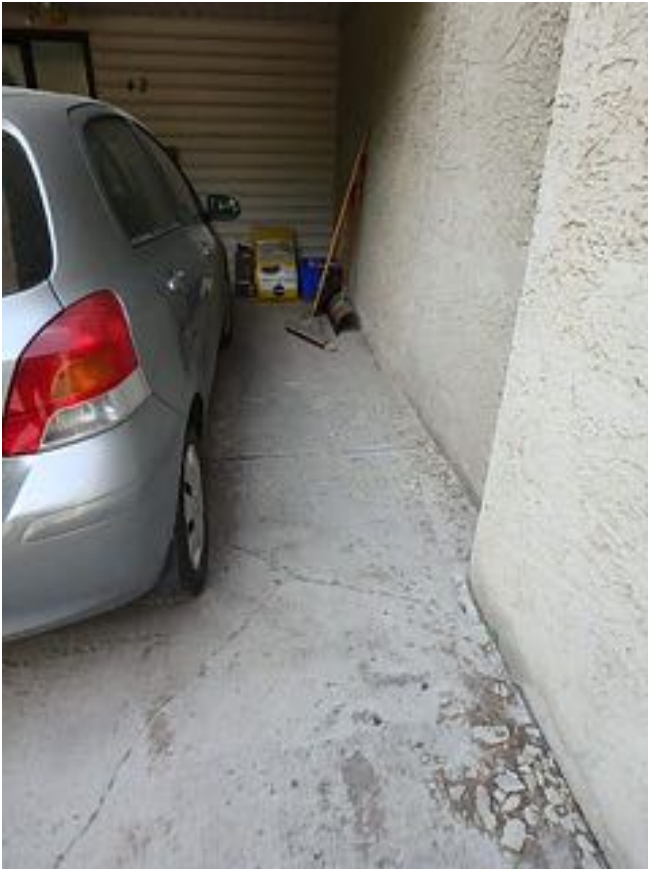
Typical concrete slab at the carport.

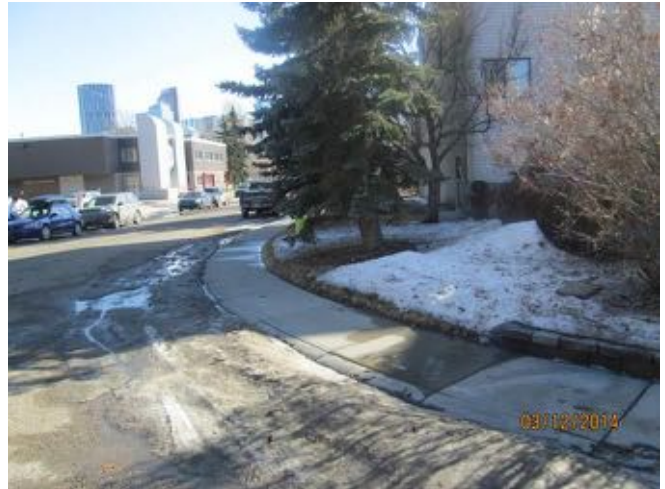
Typical concrete walkways & curbs near Block 2 observed.

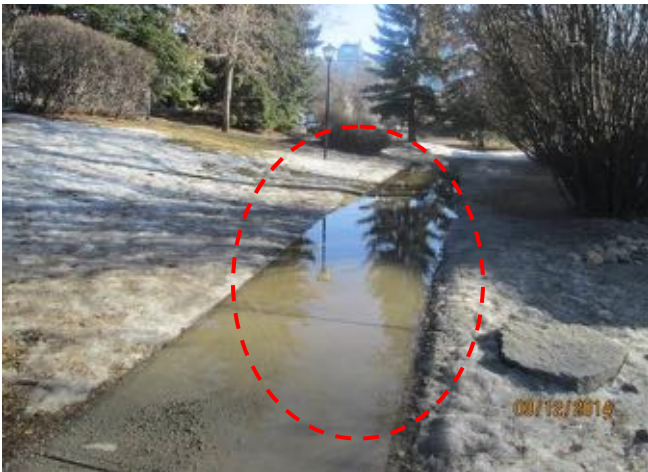
Ponding water on concrete walkway observed between Blocks 6 & 7.

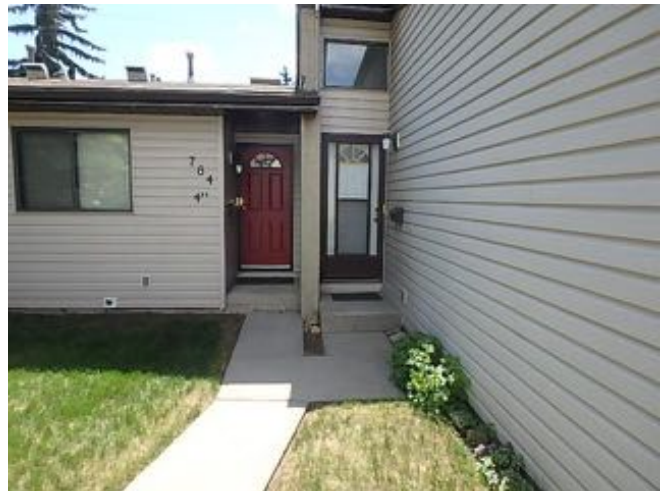
Concrete steps & walkways with localized cracks.

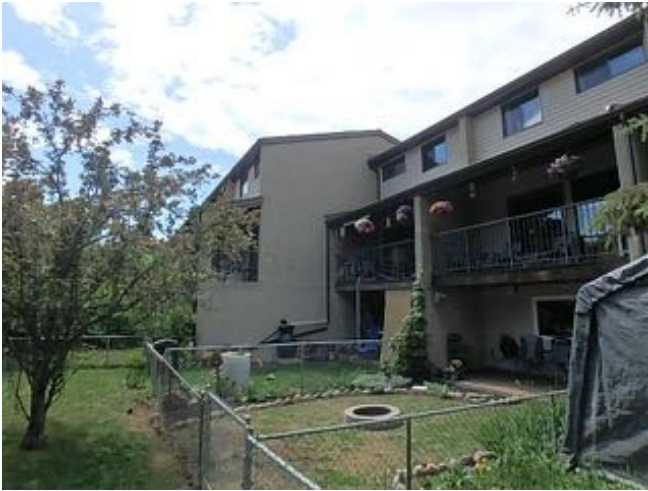
Chain link fencing & gate forming the back yard.

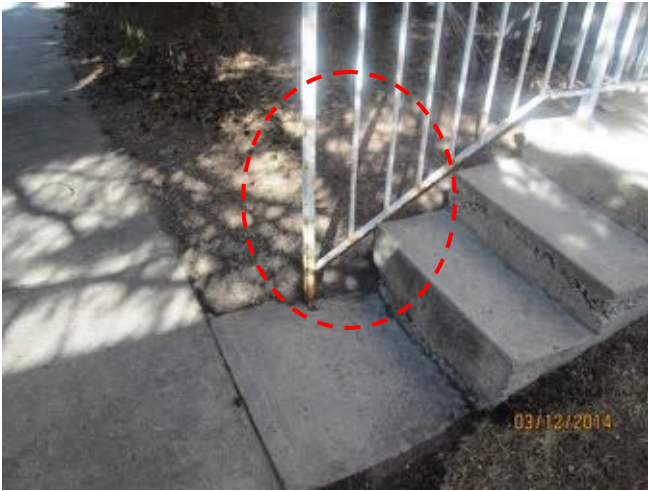
Metal guardrail exhibit corrosion at a townhouse unit entry steps.

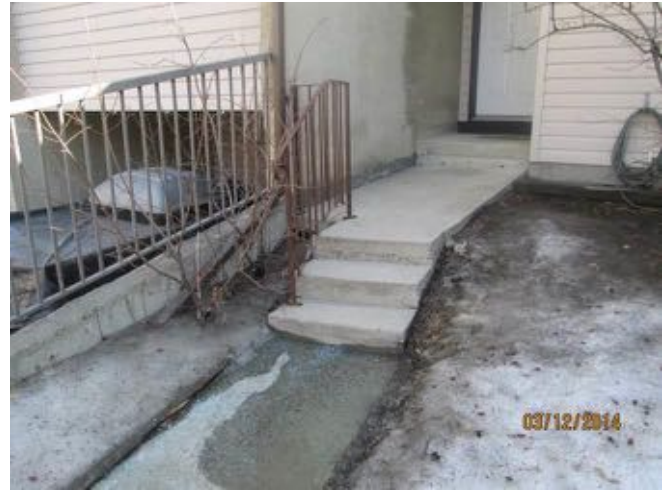
Metal guardrails on top of retaining wall & concrete entry steps at Block 4 observed.

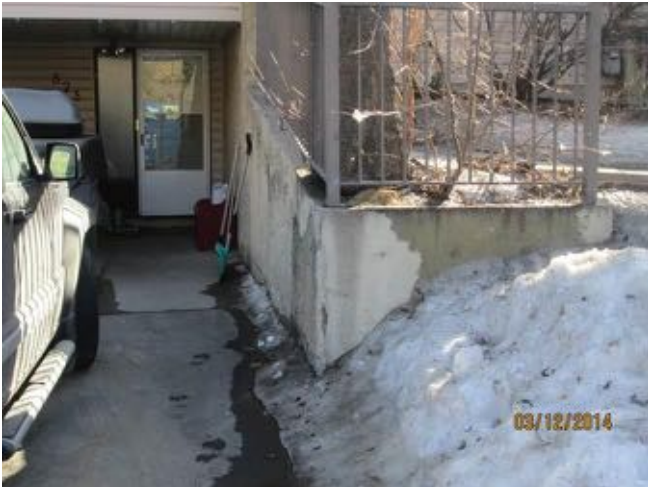
Close up view of metal guardrail on top retaining wall at Block 4.

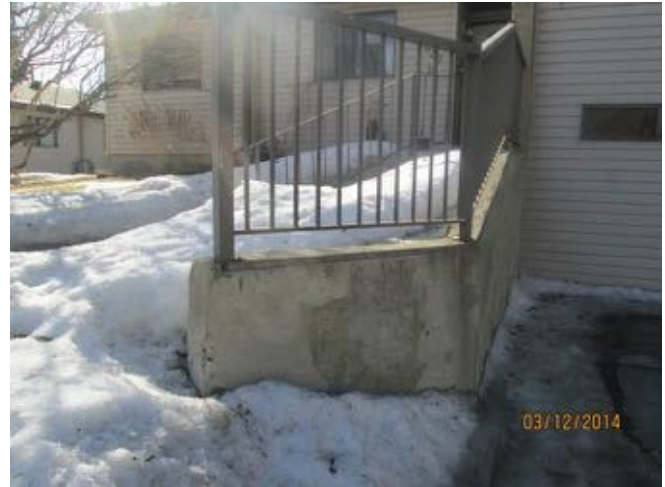
Typical metal guardrail on top retaining wall at Block 6 observed.

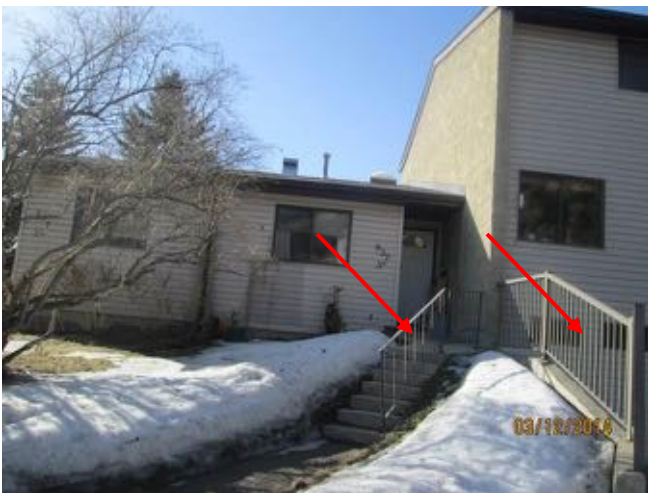
End of Guardrails & Handrails Section

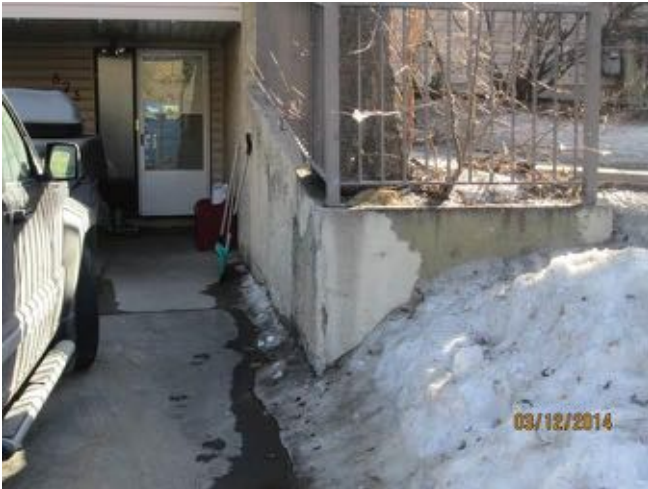
Concrete retaining walls at Block 4 between townhouse units.

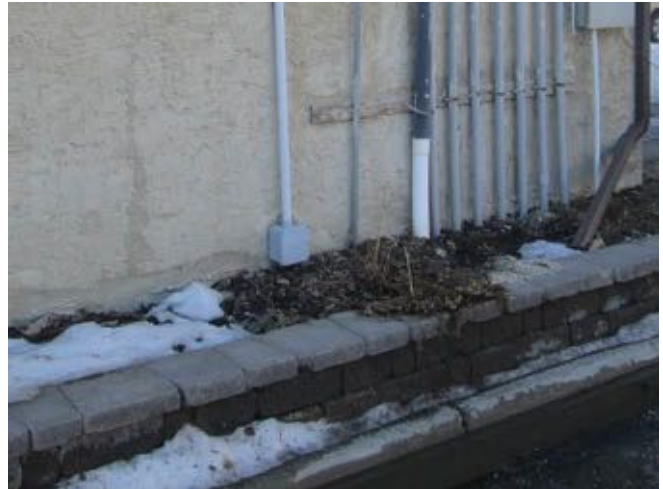
Interlocking block retaining wall around planters at Block 4 observed.

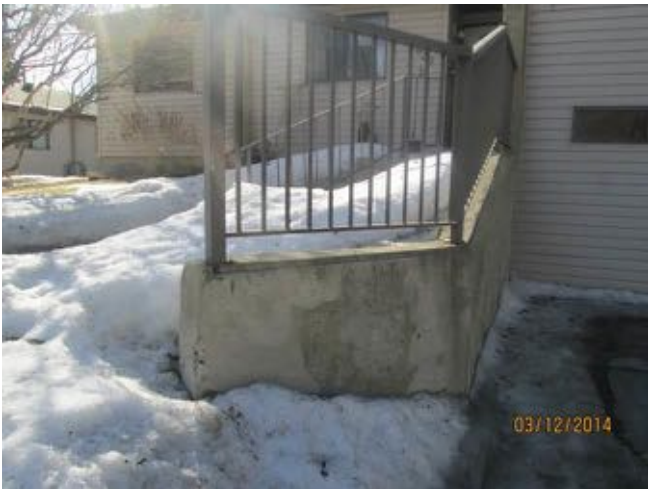
Concrete retaining wall with metal guardrails at Block 6.

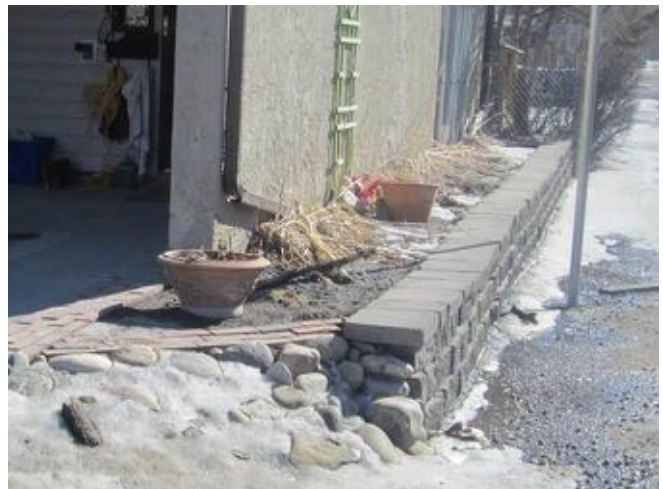
Interlocking block retaining wall around planters at Block 8 observed.

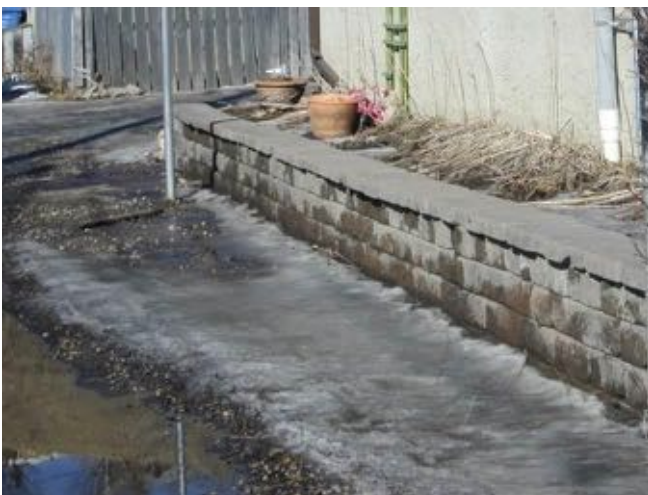
Retaining wall around planter at West end of Block 8 observed.

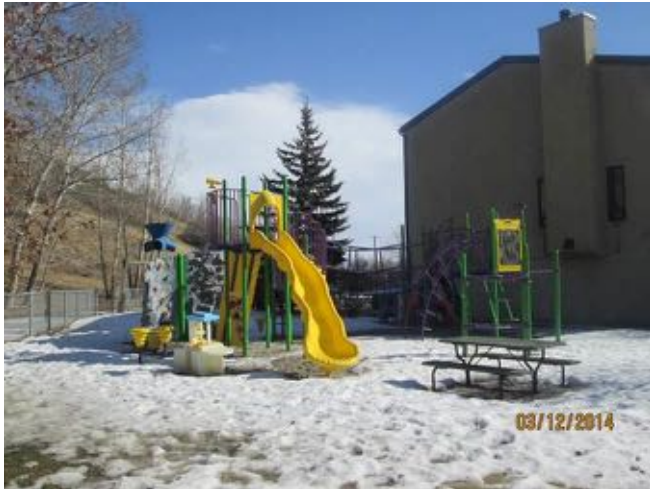
Overall view of playground area with Block 6 in the background.

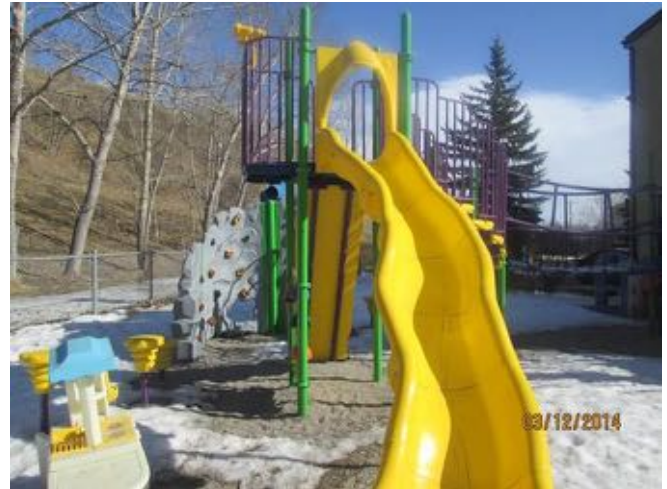
Playground equipment observed.

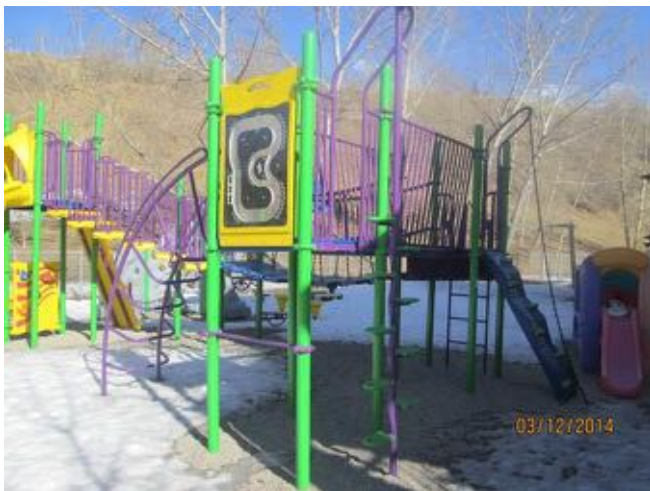
Multi-activity climber at the playground area observed.

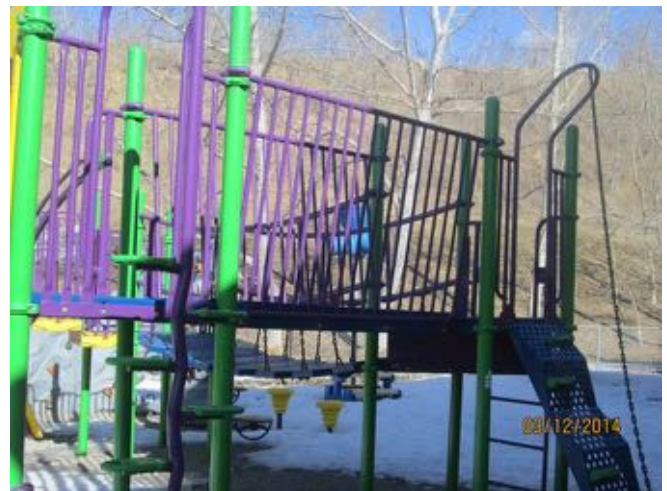
Close up view of playground equipment.

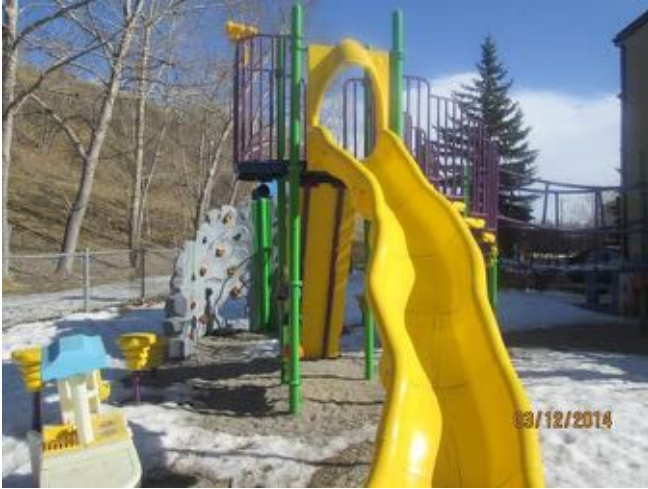
Overall view of playground area with pea gravel surfacing.

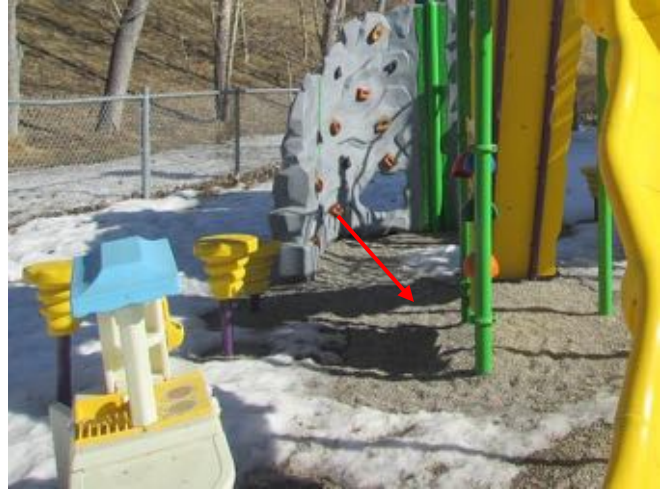
Playground pea gravel surfacing observed.

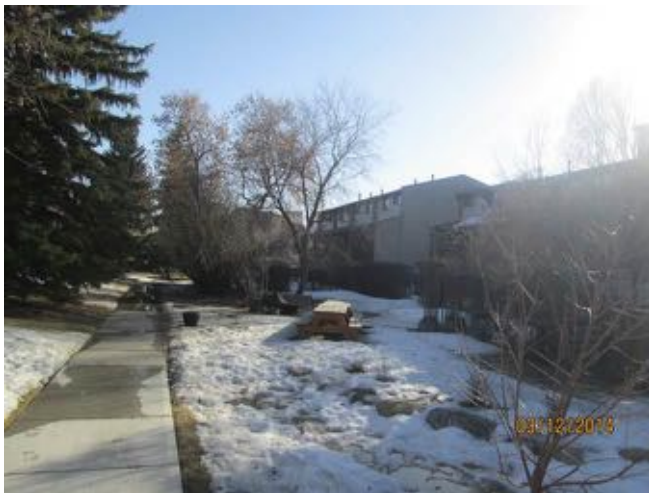
Landscaping at the courtyard of the property observed.

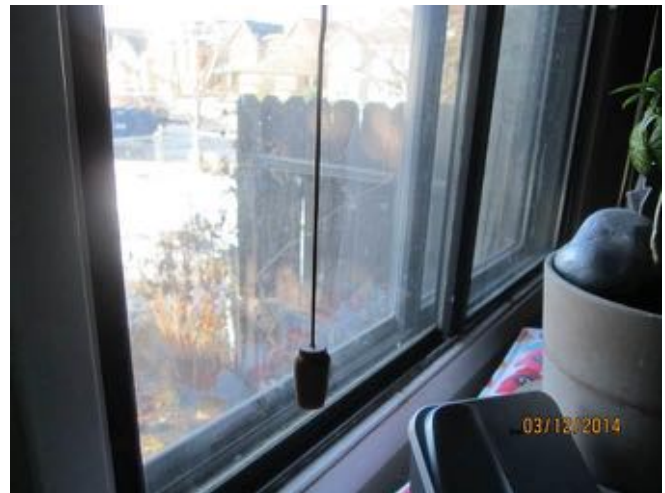
Typical Glazing observed in a townhouse unit.

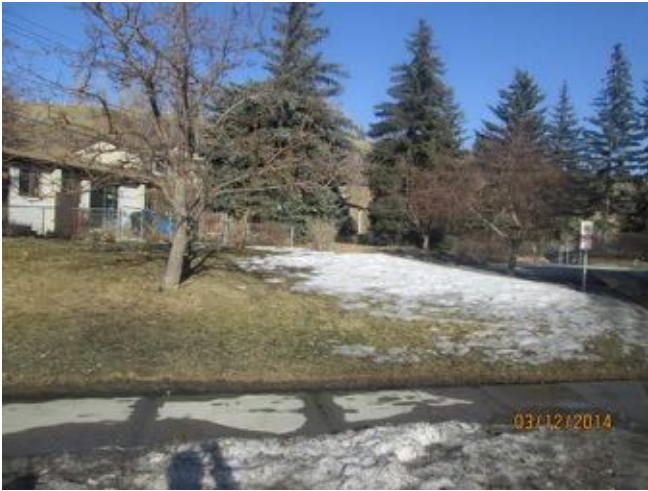
Typical landscaping observed near Block 4.

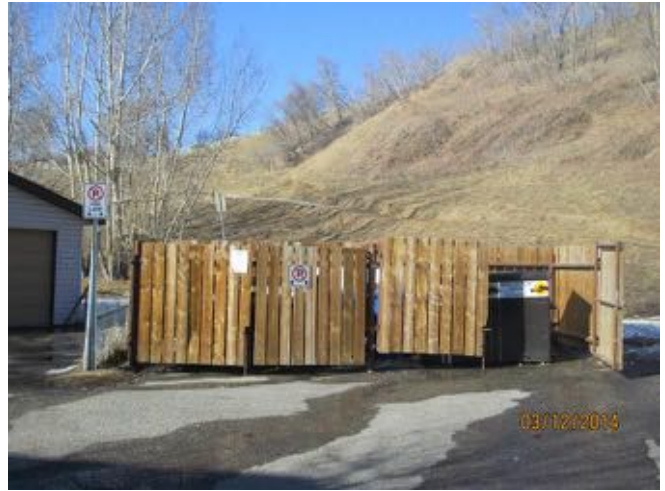
Garbage bin enclosure at the North end of Block 4 observed.

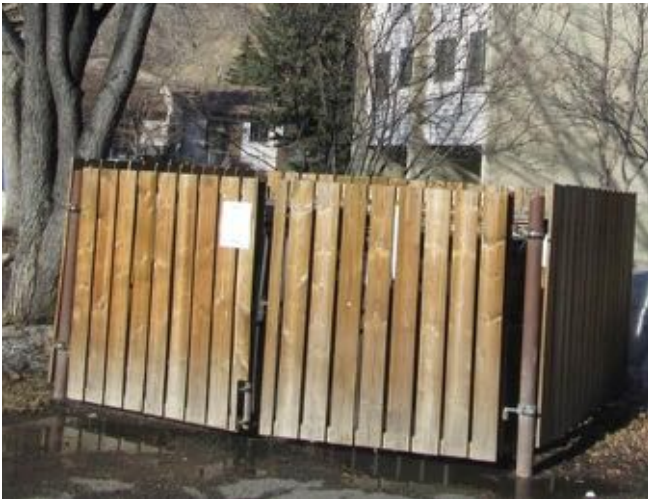
Garbage bin enclosure near Block 3.

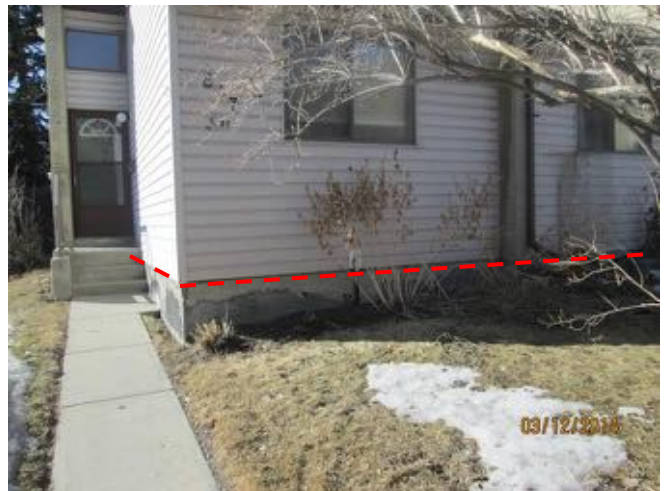
Typical foundation walls of a townhouse unit reviewed.
