## **EXISTING CONDITION:**

OPTION 1: WHITEWASHED CEDAR SIDING & STANDING SEAM ROOF

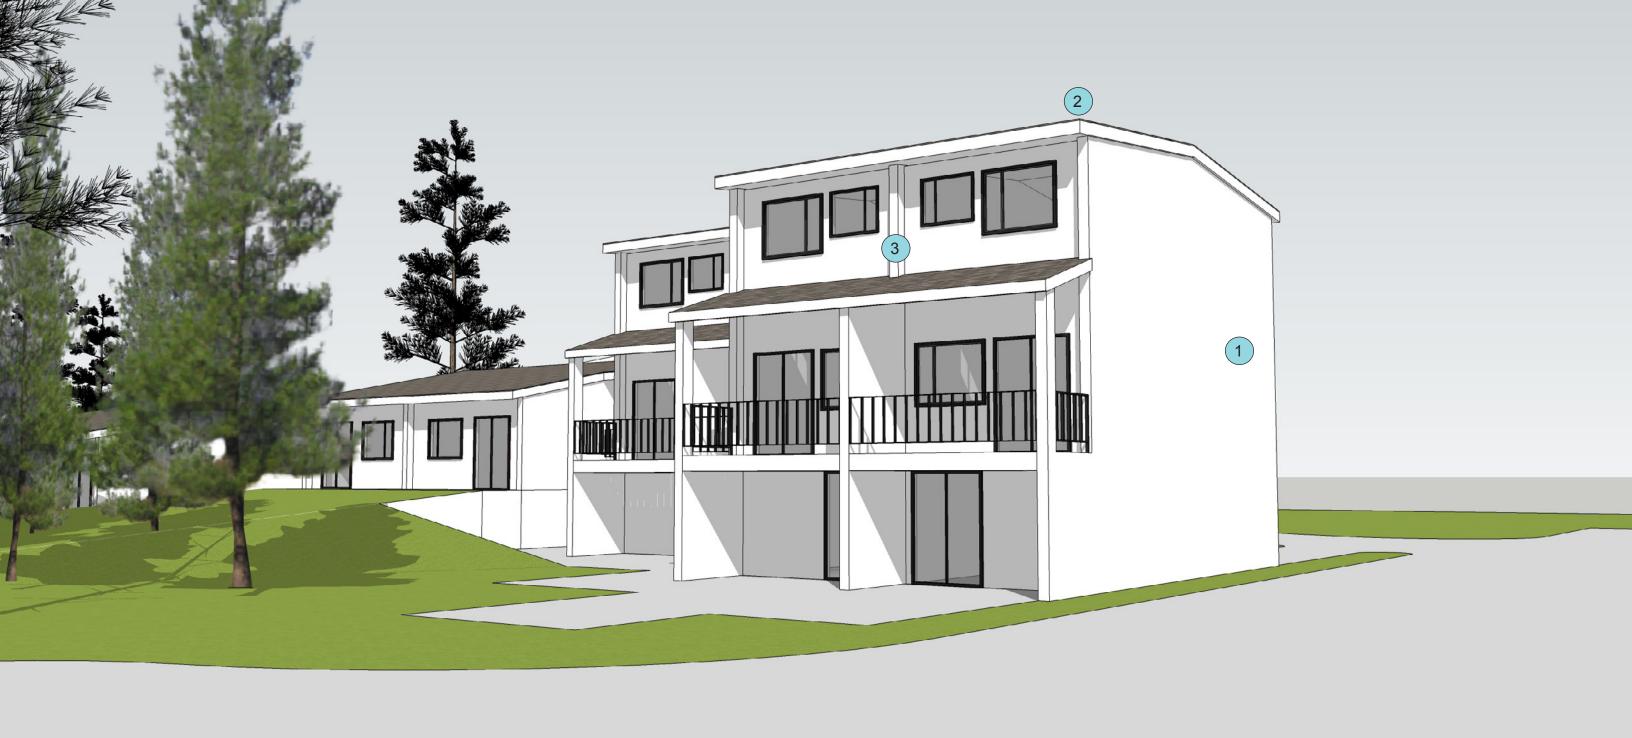
- 1 Blank stucco face feels monolithic, drab.
- 2 Existing fascia and gable overhangs feel dated, and place emphasis on an unappealing roofline.
- Dividing bump-outs between units create detailing challenge and potential for envelope failure.

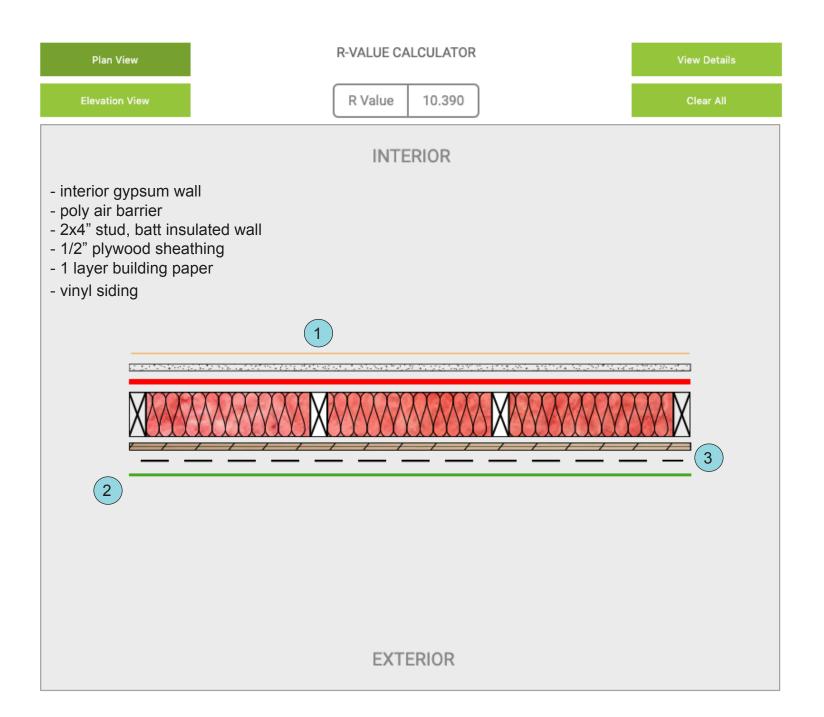
#### **EXISTING CONDITION: WALL SECTION**

- 1 current wall assembly only achieves R-11, and has many thermal breaks.
- 2 Existing vinyl and stucco siding in need of repair
- Need to determine condition of existing building paper. We would like to not have to re-paper the building or affect anything behind the sheathing.

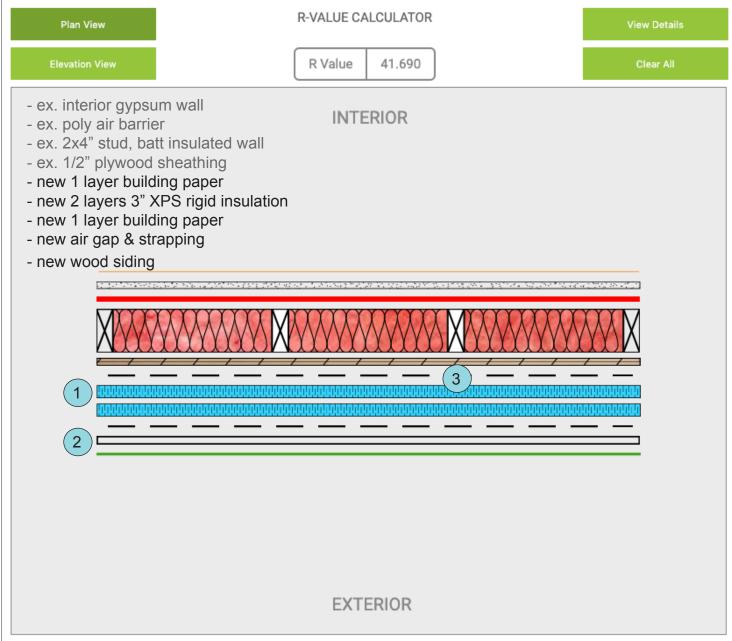
#### PROPOSED WALL SECTION

- adding 6 inches of rigid insulation on top of existing building paper will allow the wall to achieve R-41
- 2 Strapping for new siding introduces larger air gap
- Continuous insulation over wood framing eliminates thermal bridging

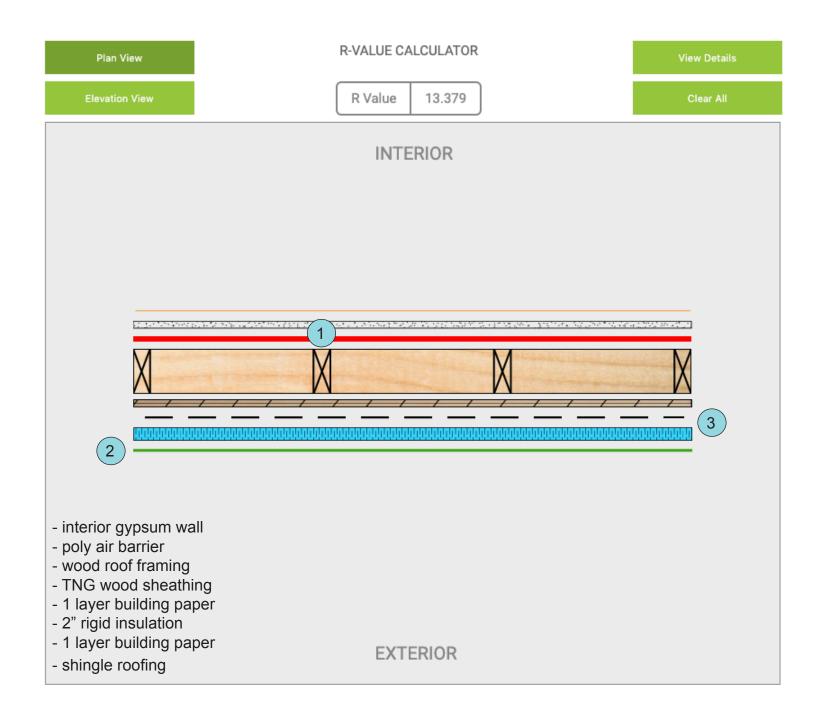
#### **EXISTING ROOF SECTION**

- 1 current roof assembly only achieves R-13, and has many thermal breaks.
- 2 Existing shingles are in good condition, but will need to be replaced when applying new insulation.
- Need to determine condition of existing building paper. We would like to not have to re-paper the building or affect anything behind the sheathing.

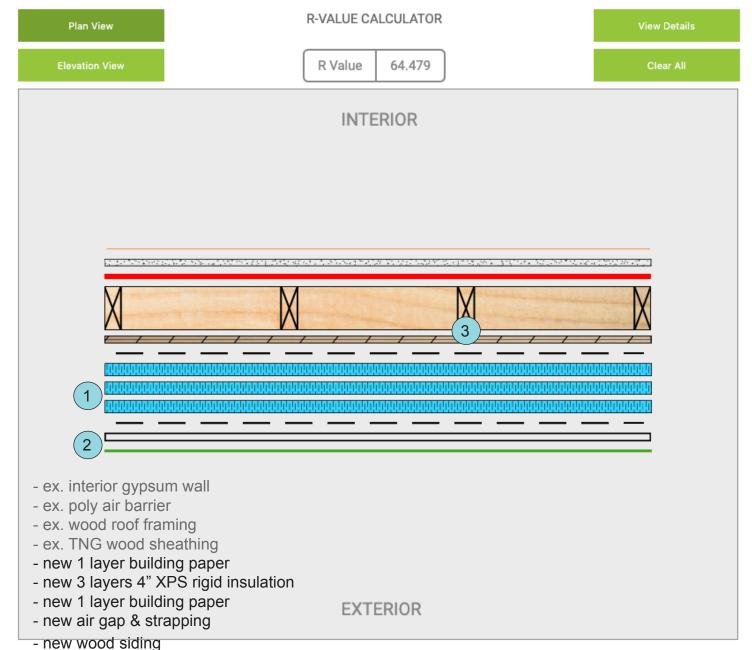
#### PROPOSED ROOF SECTION

- adding 10 inches of rigid insulation on top of existing building paper will allow the wall to achieve R-64
- 2 Strapping for new siding introduces larger air gap
- Continuous insulation over wood framing eliminates thermal bridging

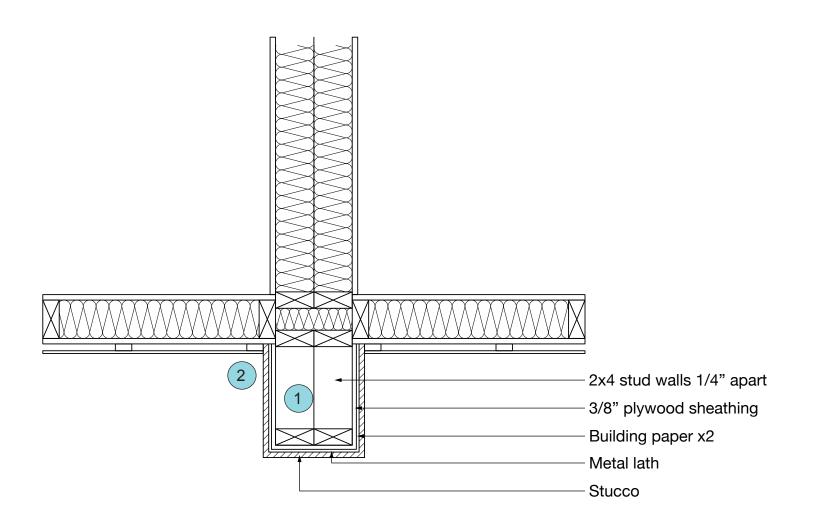
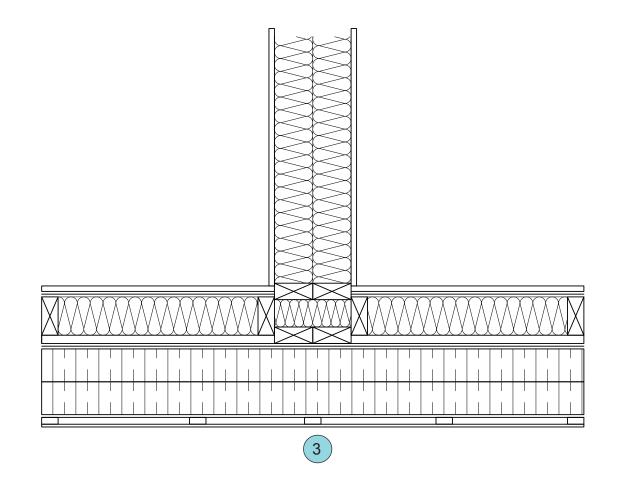
## **EXISTING STUCCO BUMP OUTS**

- Existing stucco bump outs are non-structural, aesthetic tack-ons.
- the interface between stucco and siding provides an opportunity for water ingress
- Removing the bump-outs allows for a cleaner wall with continuous insulation and easier maintenance.

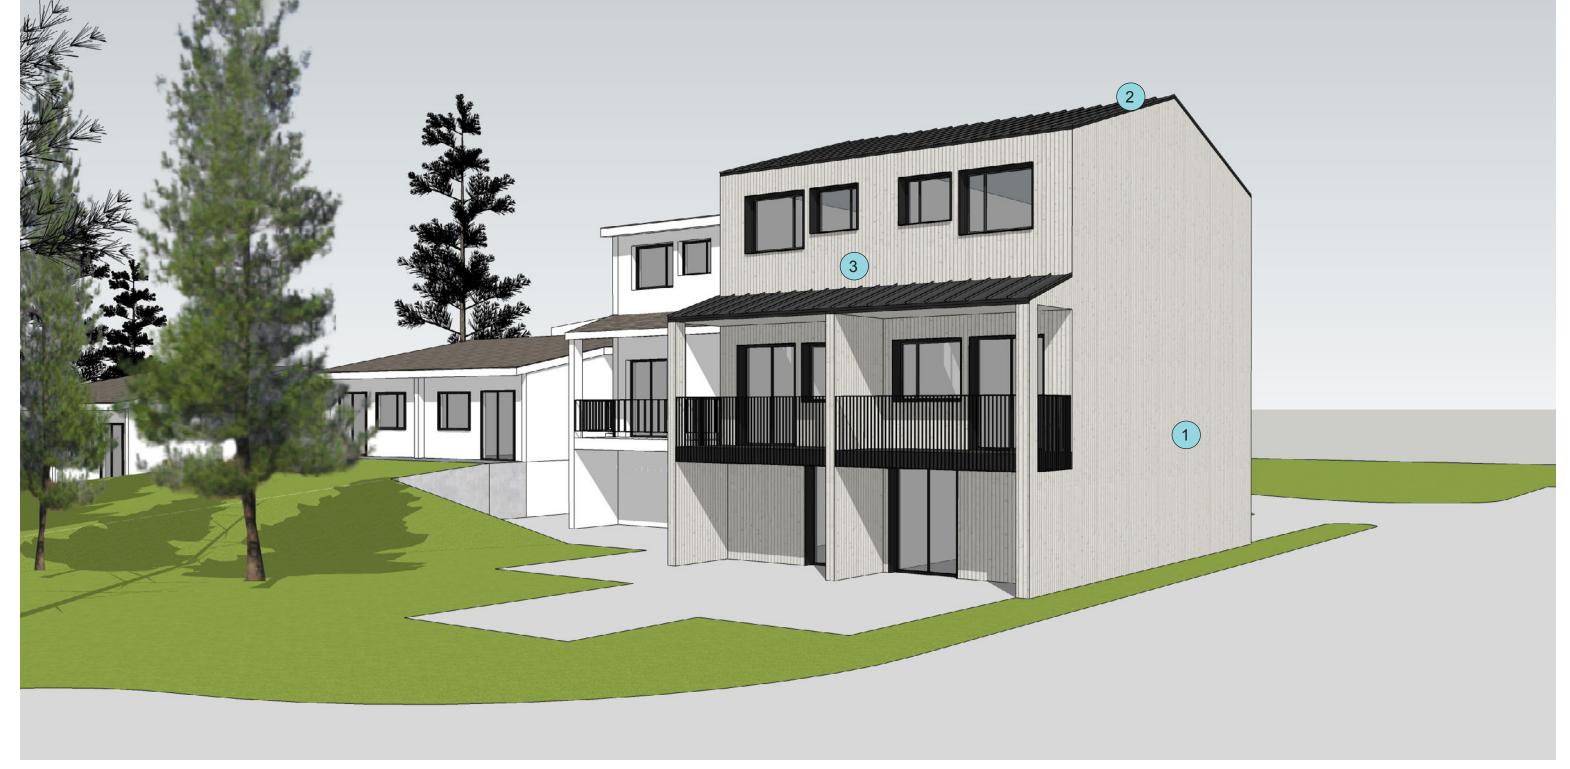
## **OPTION 1: WHITEWASHED CEDAR SIDING**

- The entire volume is clad in whitewashed cedar open-joint siding, cleaning up messy geometry.
- the existing fascia and gable ends are removed, allowing for a much cleaner, contemporary roofline detail. The existing balcony roof is re-worked.
- The bump-outs between units are removed (they're not structural, just for decoration), allowing for a more simplified form.

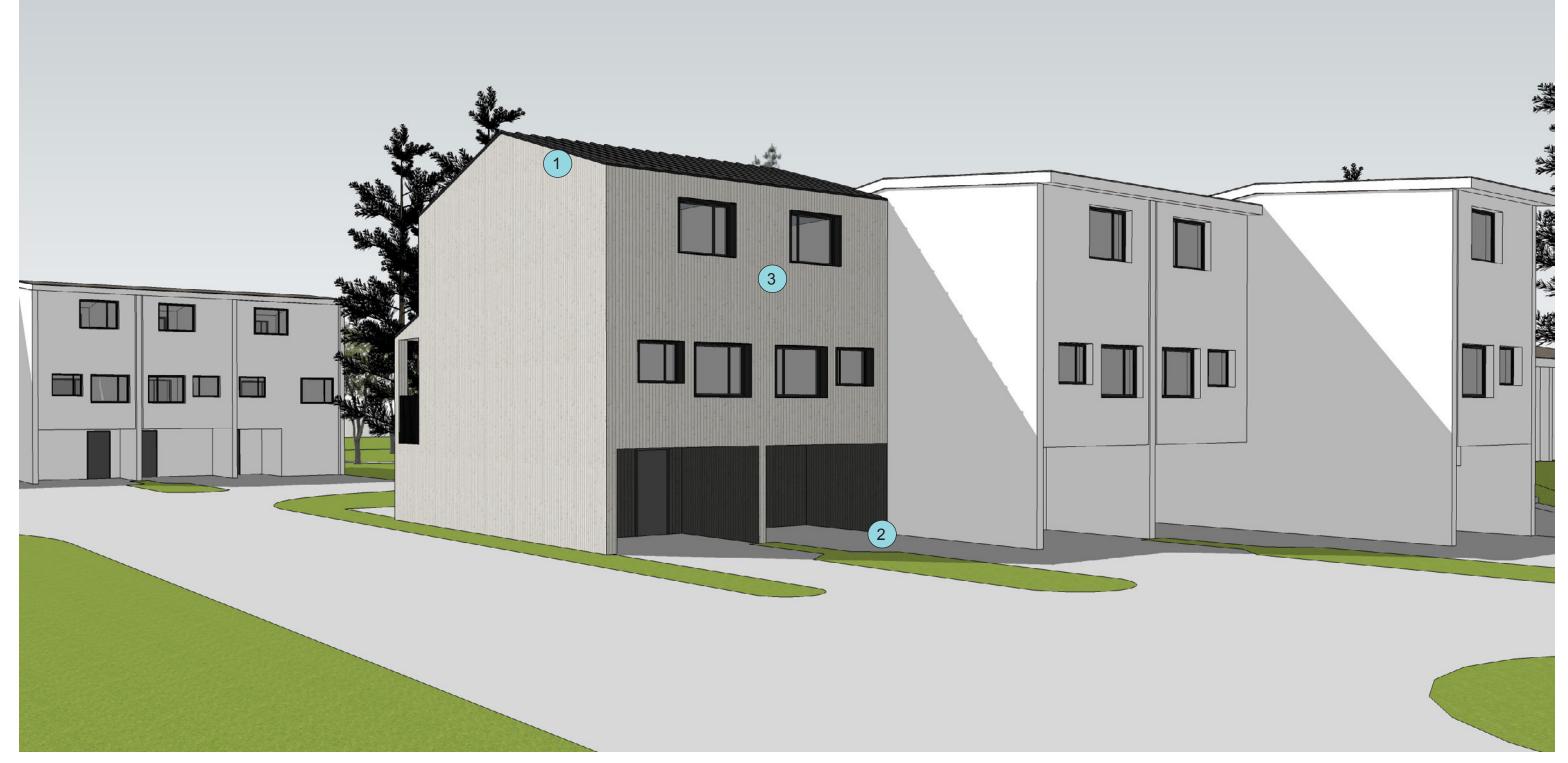
## **OPTION 1: WHITEWASHED CEDAR SIDING**

- By removing the fascia, adding insulation, and running the siding up to the roof flashing a much more minimal roof detail can be achieved.
- The car ports would be clad in a black pine tar coated wood siding, creating a moment of contrast from the rest of the design.
- The windows are replaced with higher performance windows, with a black finish.

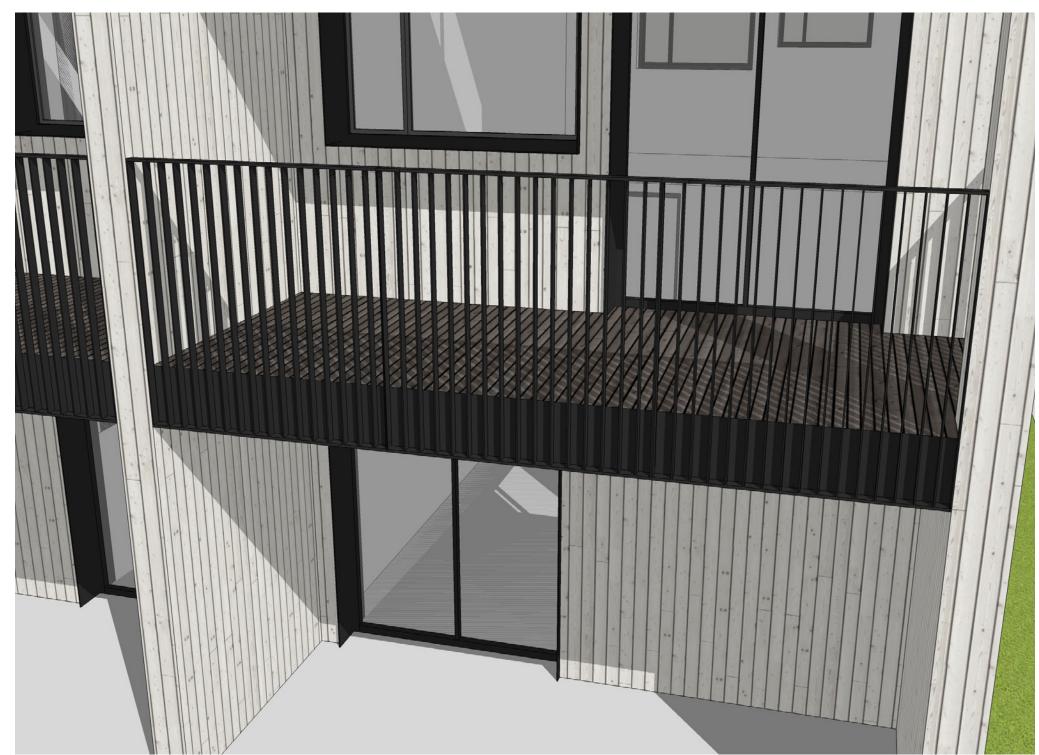
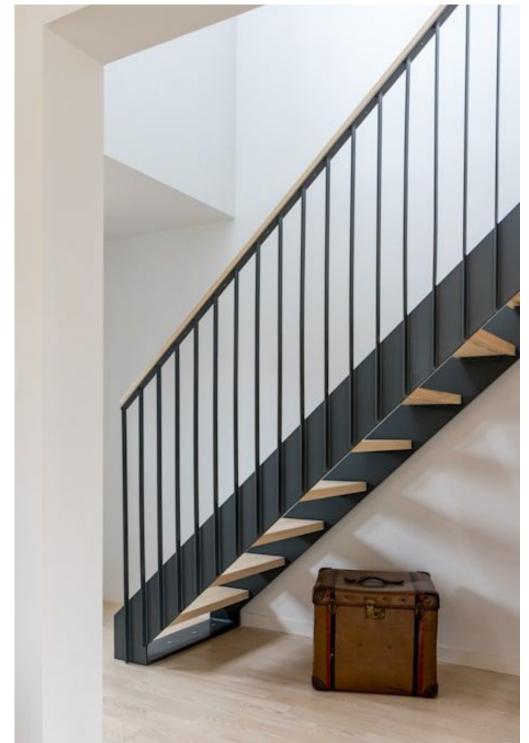
**OPTION 1: BALCONY RAILING UPDATE**

If a deck replacement becomes part of the scope (due to the presently un-treated exposed wood and failing guard rails), we would propose a face-mounted metal picket.

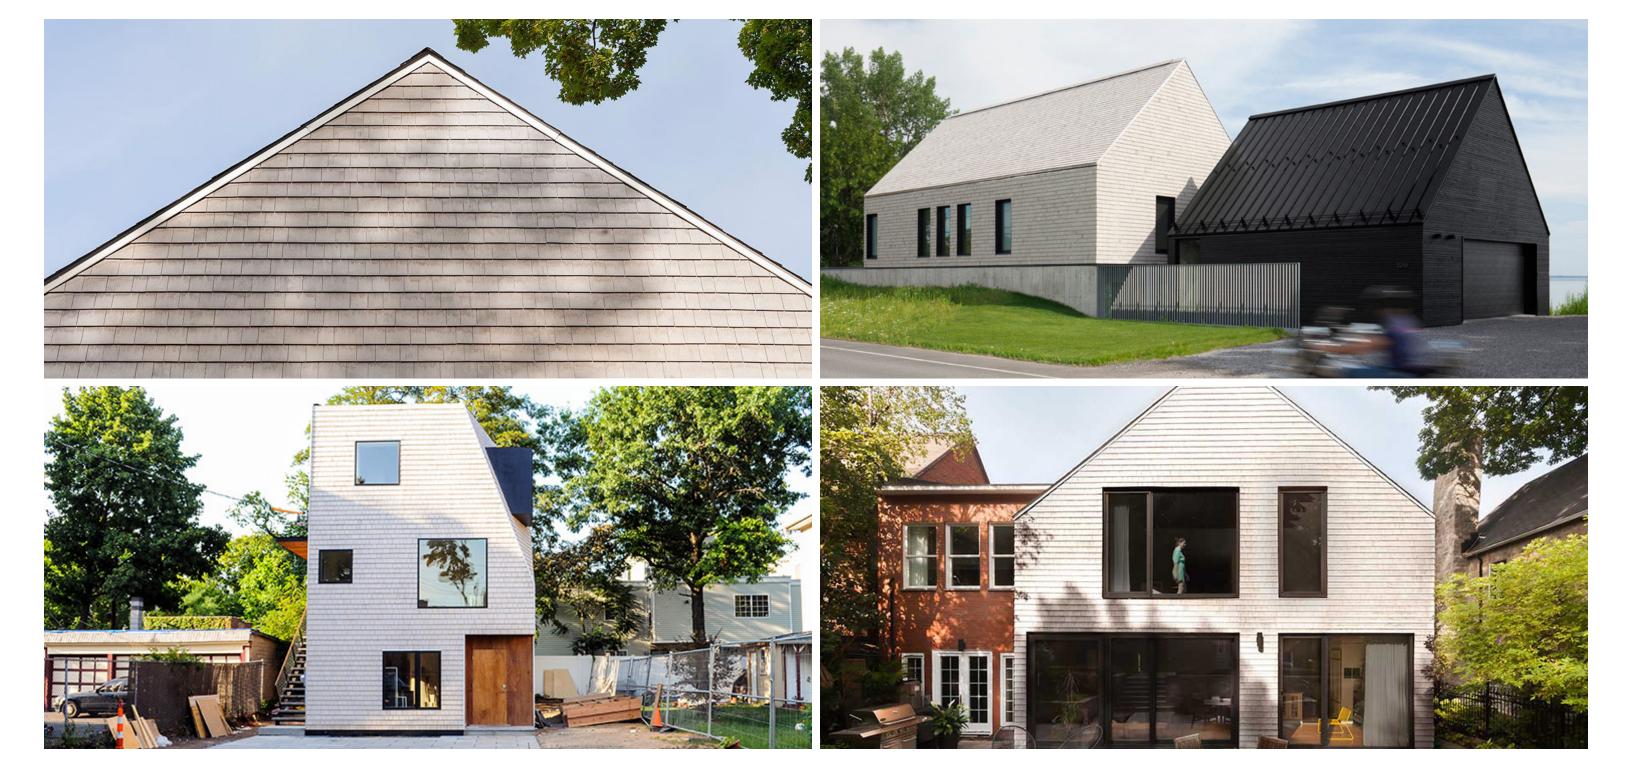
# OPTION 1A: WHITEWASHED CEDAR SHINGLES

Another great material option is cedar shingle - it's durable, timeless, and reflective of the character of sunnyside.

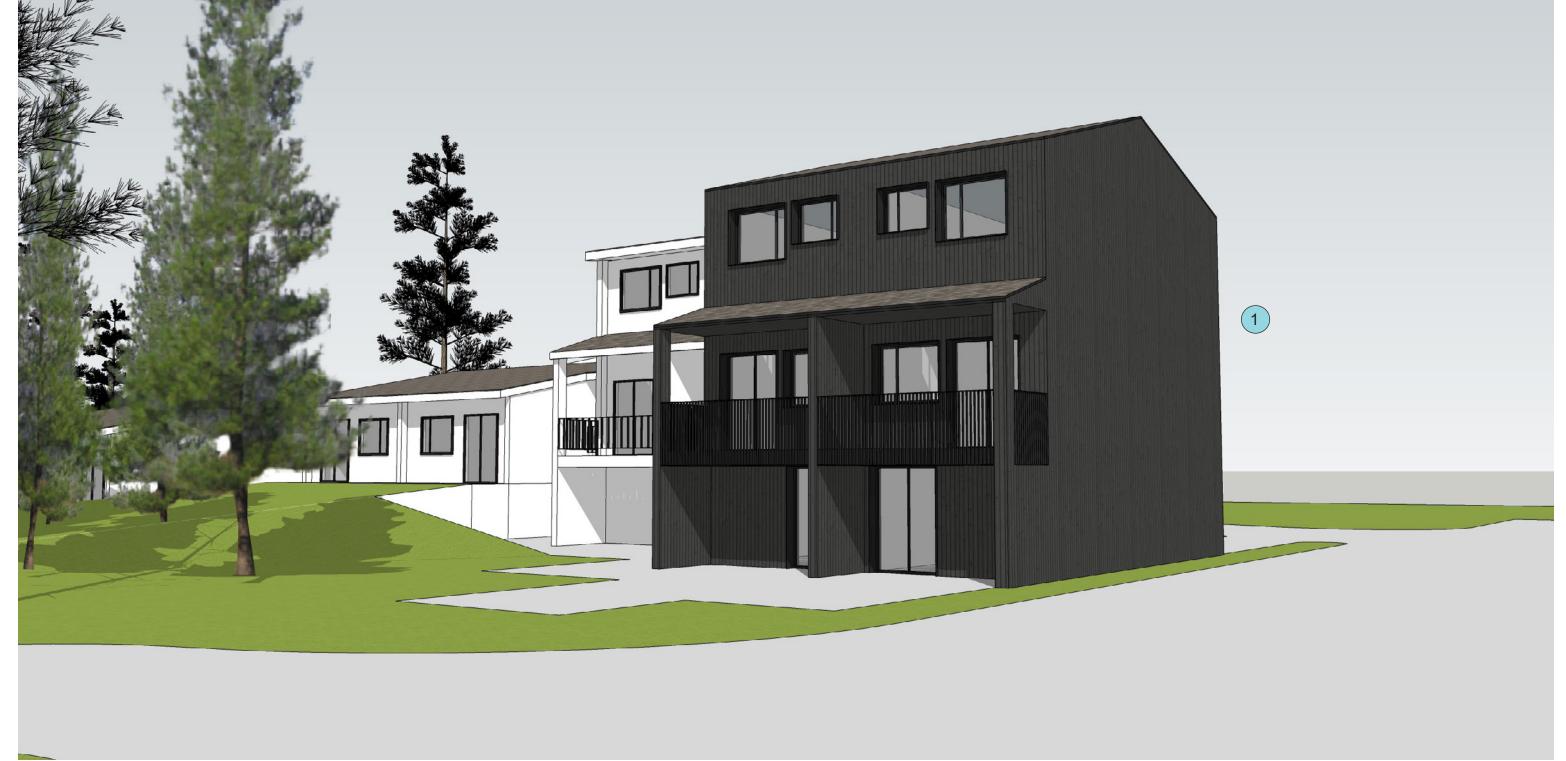
## **OPTION 2: PINE TAR COATED SIDING**

- Pine tar is a traditional scandinavian wood finish dating back over 900 years. It was used to preserve nordic stave churches, as well as viking longship bottoms. It is cheap, easy to apply, and durable.
- This design proposes the same envelope, roofline, and balcony changes as option 1.

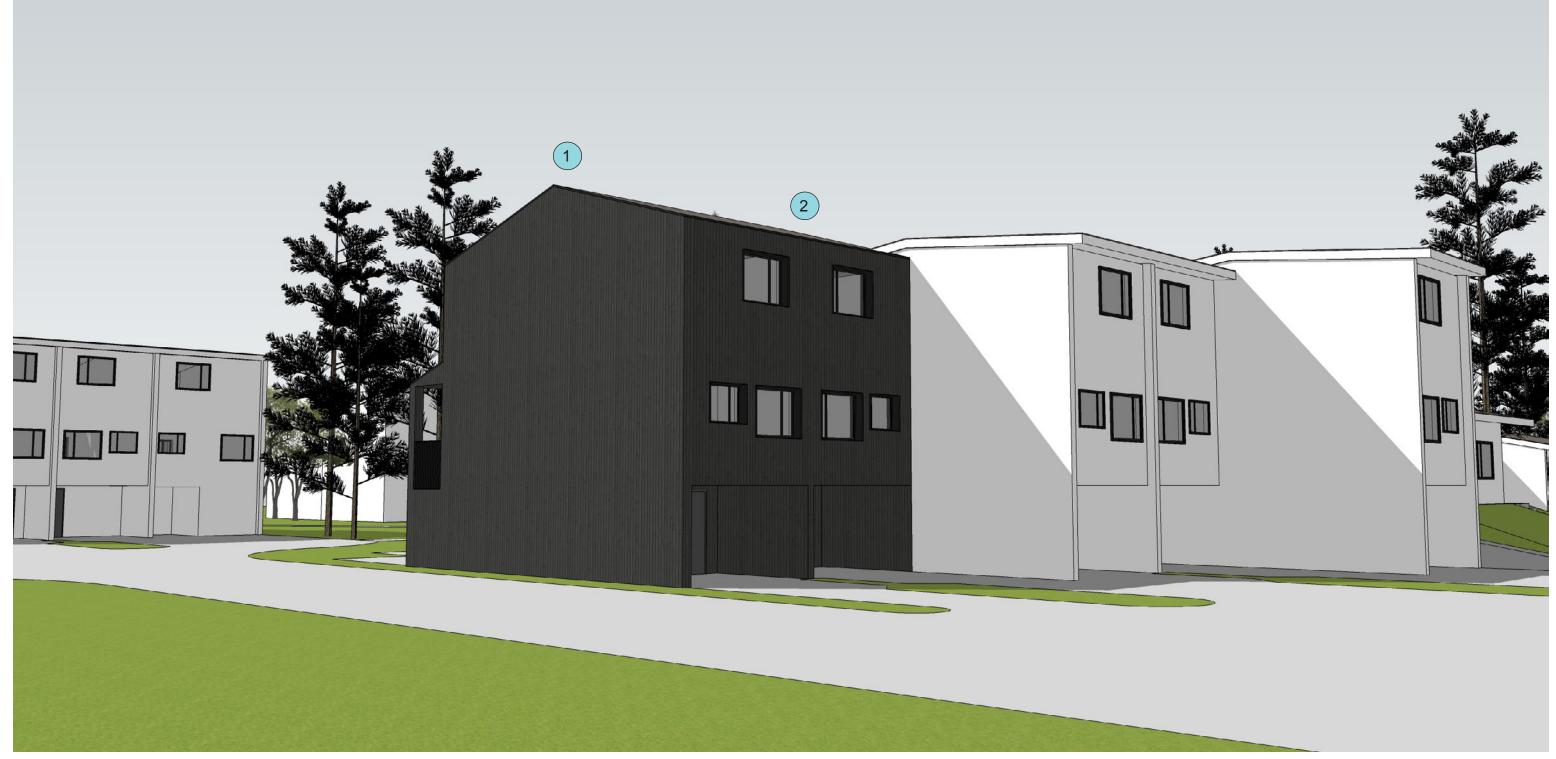
### **OPTION 2: PINE TAR SIDING**

- By removing the fascia, adding insulation, and running the siding up to the roof flashing a much more minimal roof detail can be achieved.
- The black windows paired with the black siding create a less busy facade. There is opportunity to introduce another material through the window trim as well.
- 3 A more costly alternate to pine tar is charred cedar.
