# BUILDING CONDITION ASSESSMENT & RESERVE FUND STUDY

## **Sunnyhill Housing Co-operative 787 - 3rd Street NW Calgary, AB**

June 13, 2018

IRC CB18-037CR-15052

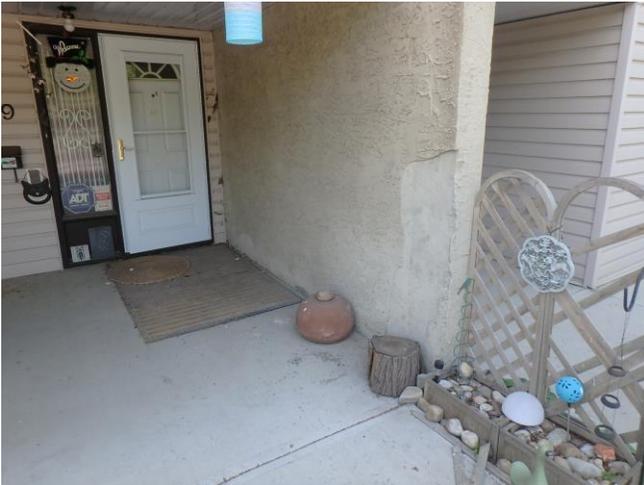
Parging noted to be delaminating from Concrete foundation (non-structural concern).

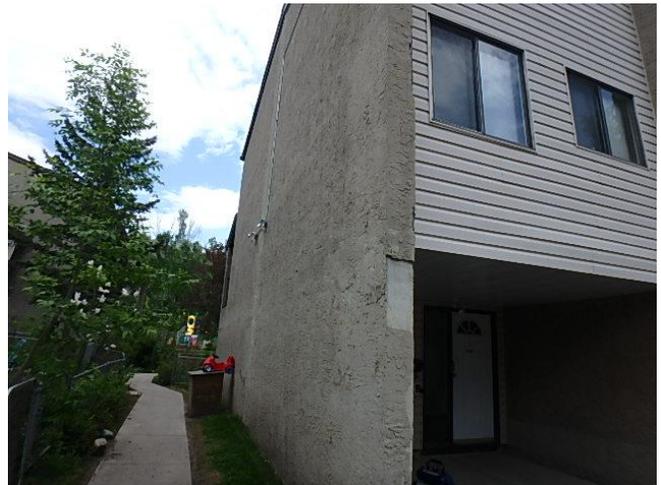
Typical end wall elevation view of ground floor reinforce concrete foundation wall.

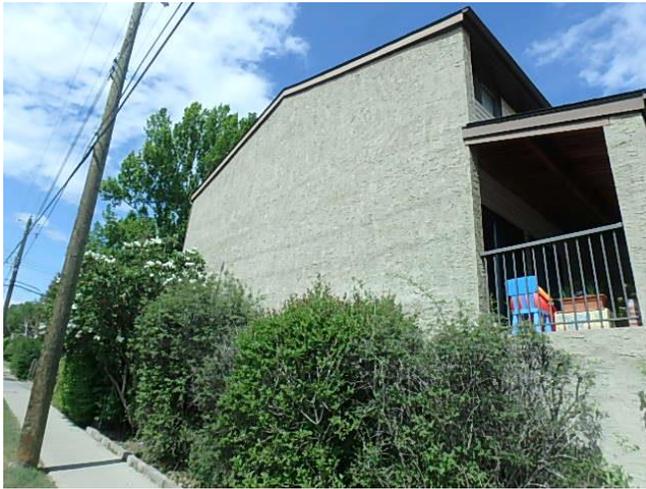
Typical low to moderately sloped roof area.

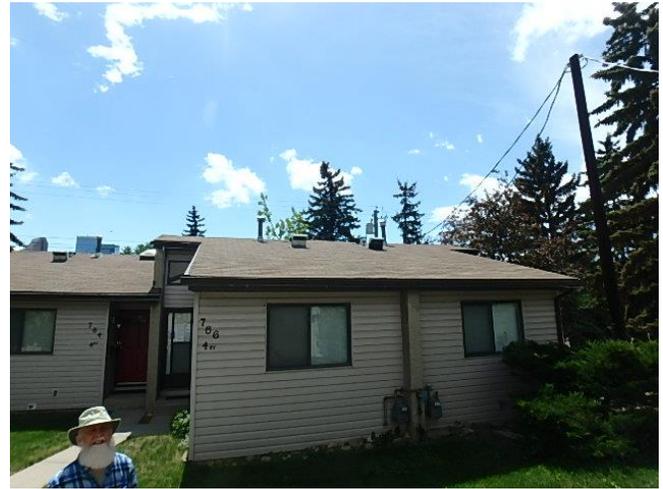
Typical Asphalt roof condition on single storey units.

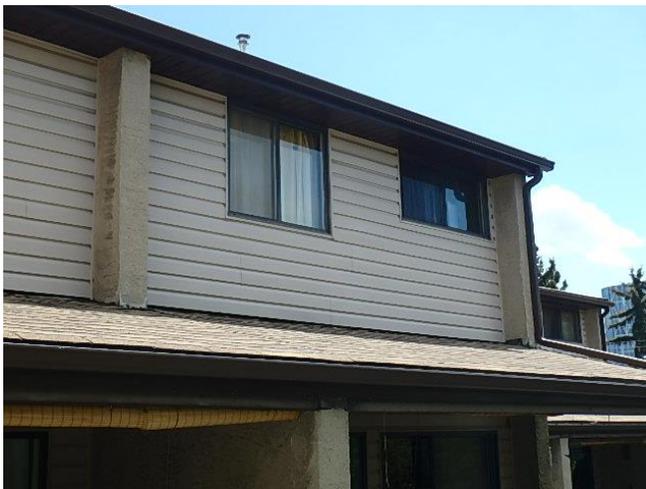
Typical Asphalt condition over balcony areas

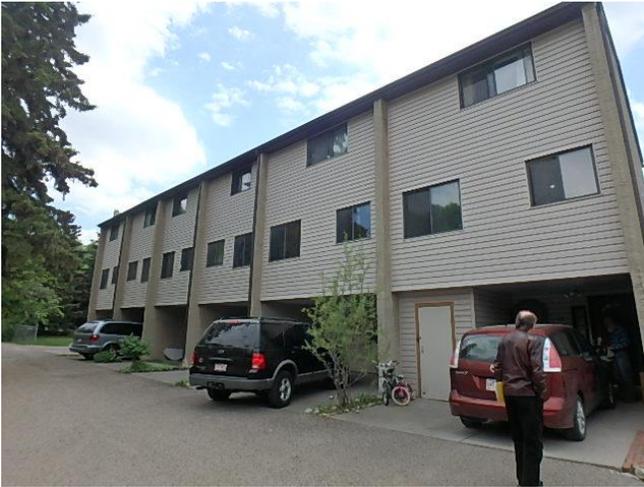
Typical siding configuration / Condition.

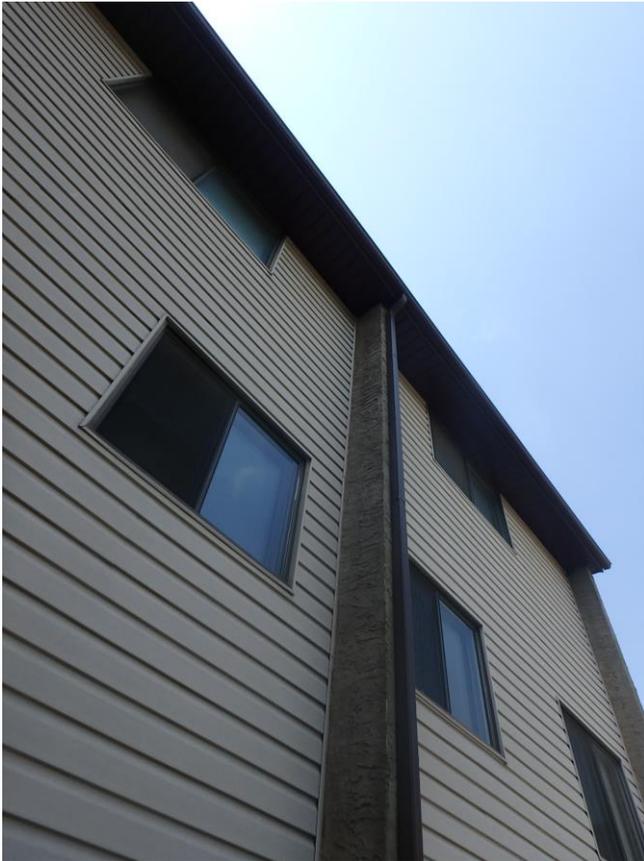
Typical siding configuration around window penetrations.

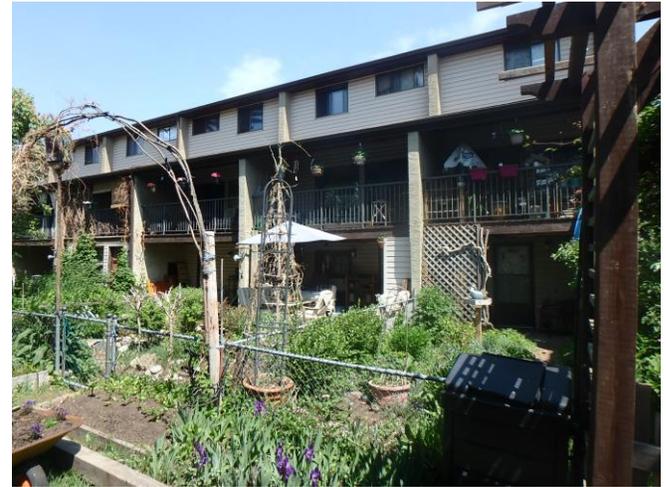
Typical Siding Configuration at Balcony Elevations

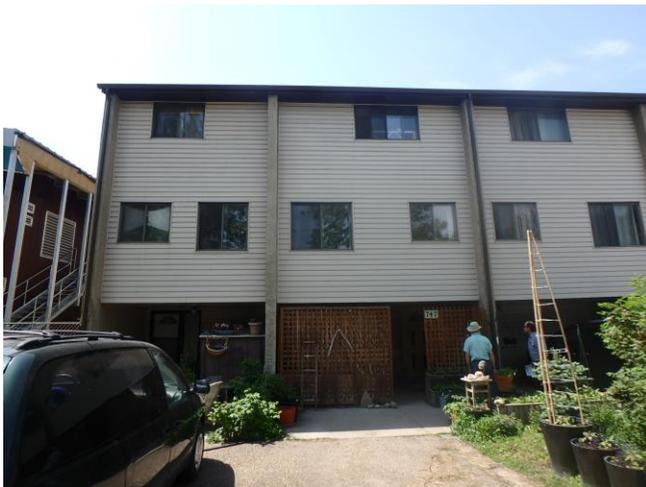
Typical overall sliding window configuration.

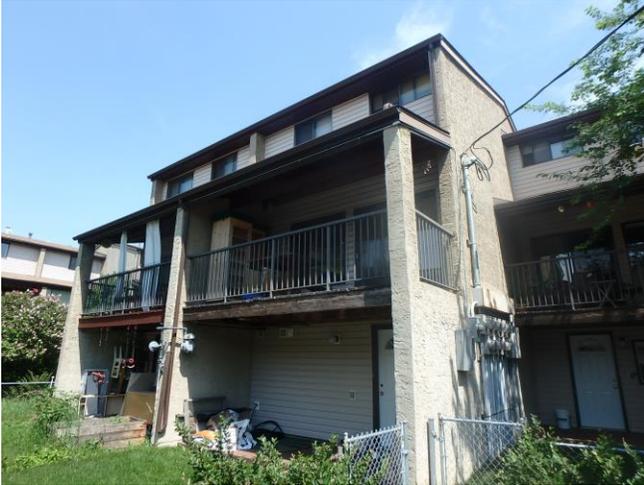
Typical fascias, soffits, eaves troughs and downspouts.

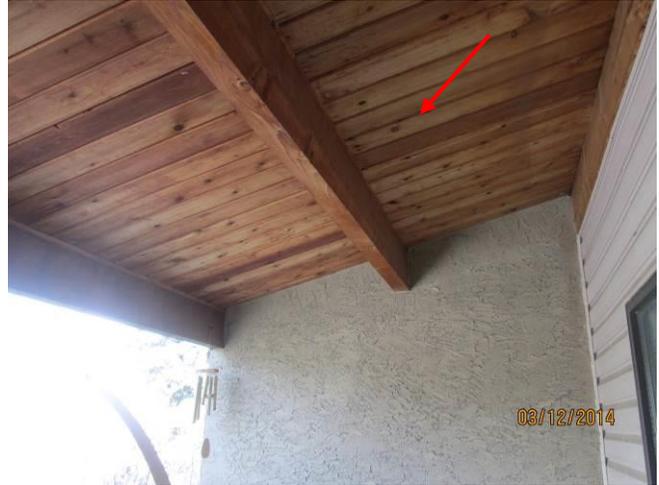
Typical tongue & groove cedar wood soffit above the townhouse unit balcony observed.

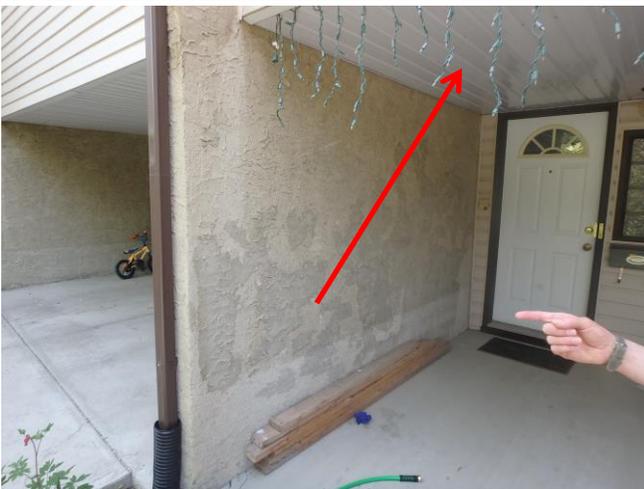
Typical pre-finished aluminum soffit at the main entrance & carport area of a townhouse

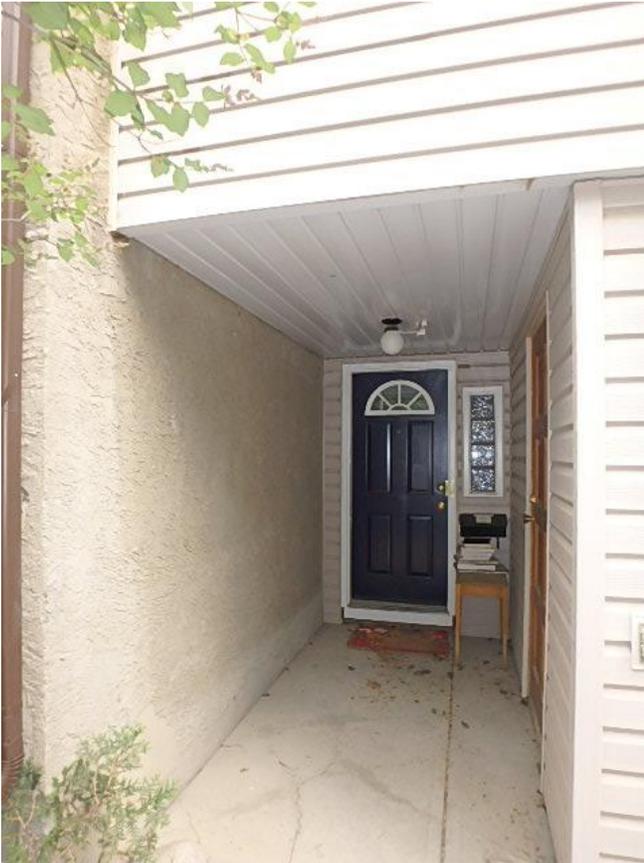
Typical townhouse unit main entrance door.

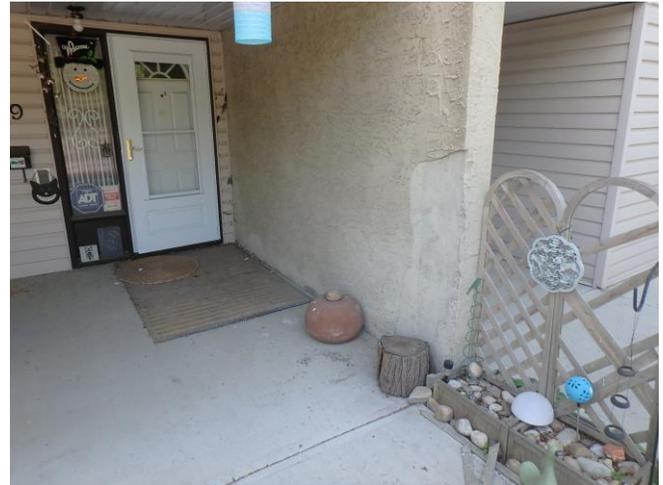
Enhanced Front Entrance Door with Screen Door and Side lite

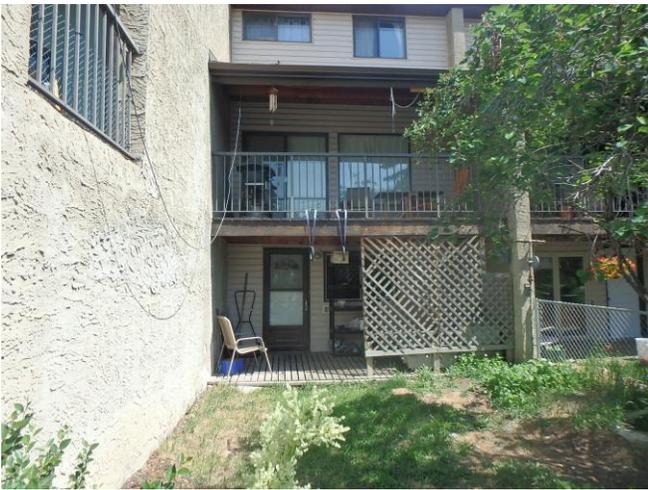
<p>Typical ground floor wood deck.</p>

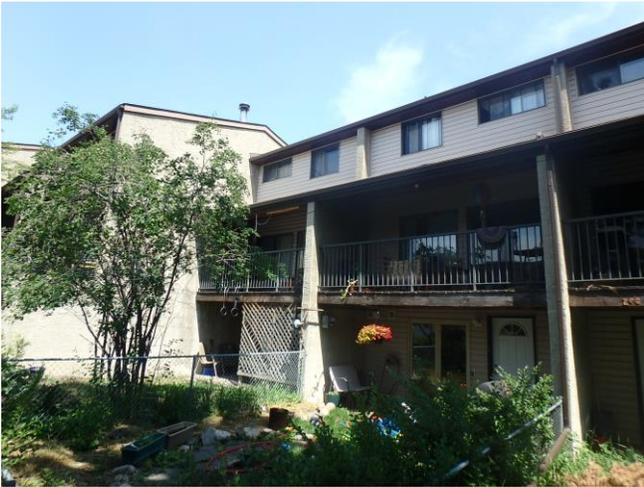
Exterior view of townhouse unit balcony.

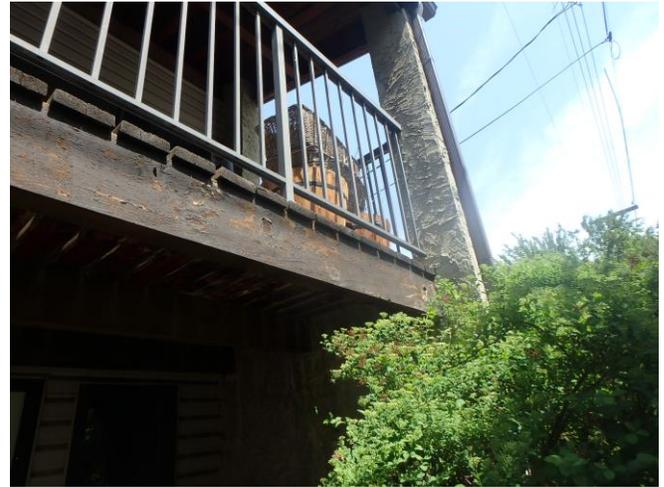
View of weather finishes on deck joist

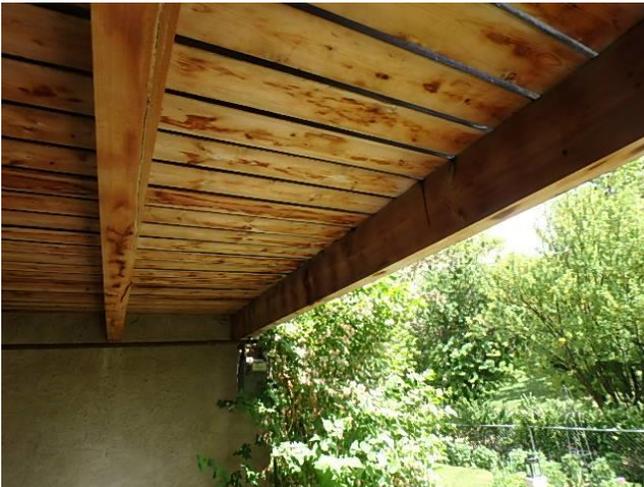
Typical close up view of the balcony wooden planks & joist underside.

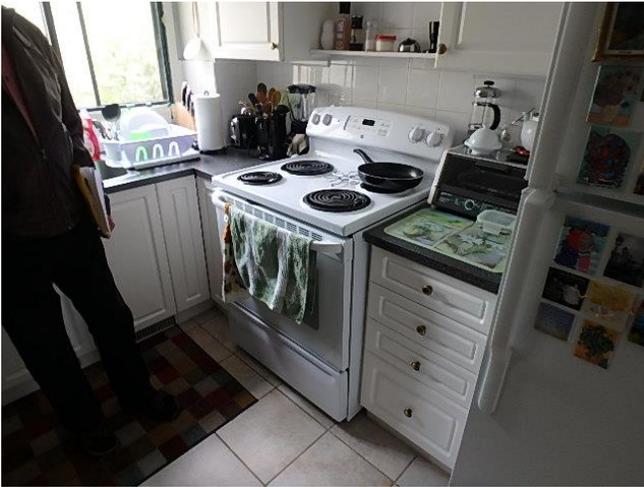
Townhouse kitchen appeared to be in good to fair condition with new cabinetry

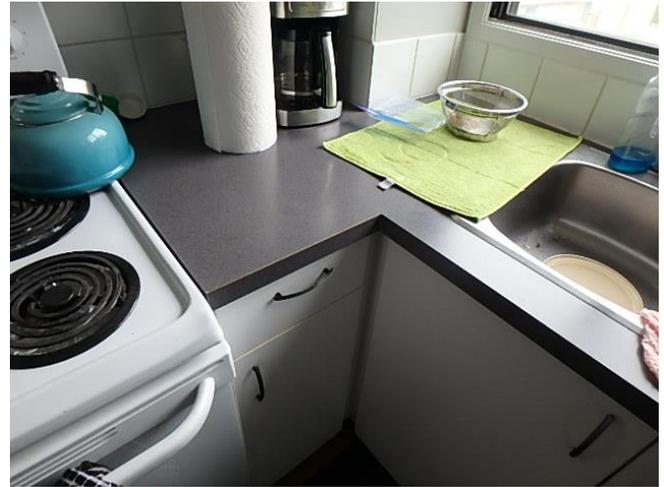
Kitchen Counter tops in some units appeared to be upgraded

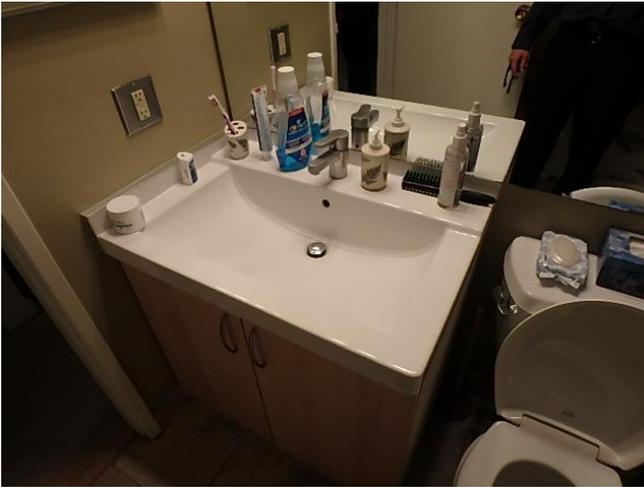
Recently upgraded bathroom components included newer counter top and faucet

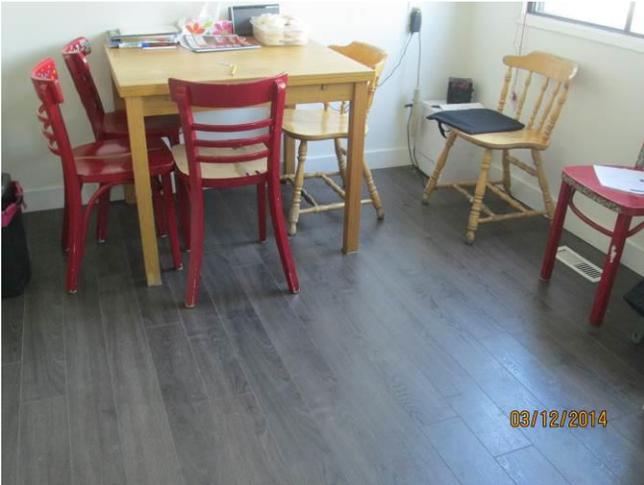
New laminate flooring observed in multiple units reviewed.

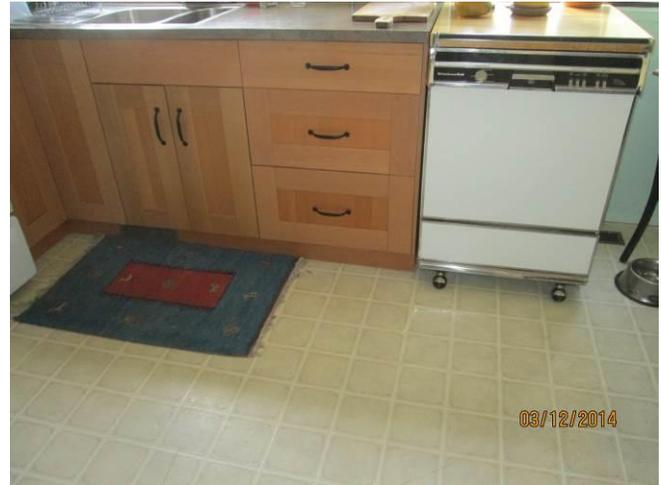
Vinyl sheet flooring in the kitchen of a unit observed.

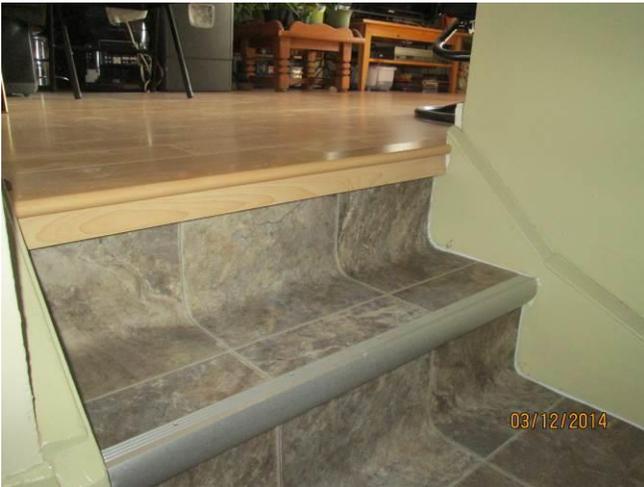
Typical recently upgraded flooring in a townhouse unit.

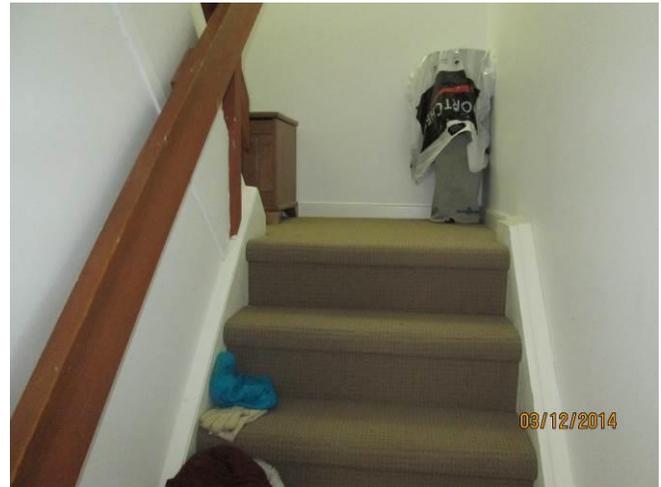
Carpet flooring observed in the unit's staircase at Block 6.

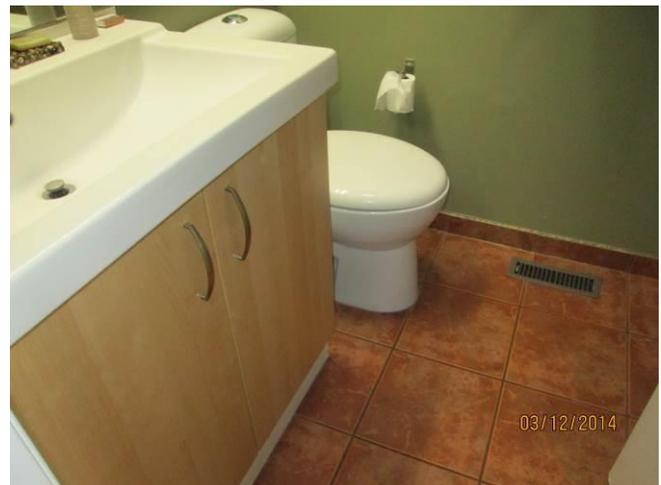
Ceramic floor tiling observed in the bathroom of a townhouse at Block 2.

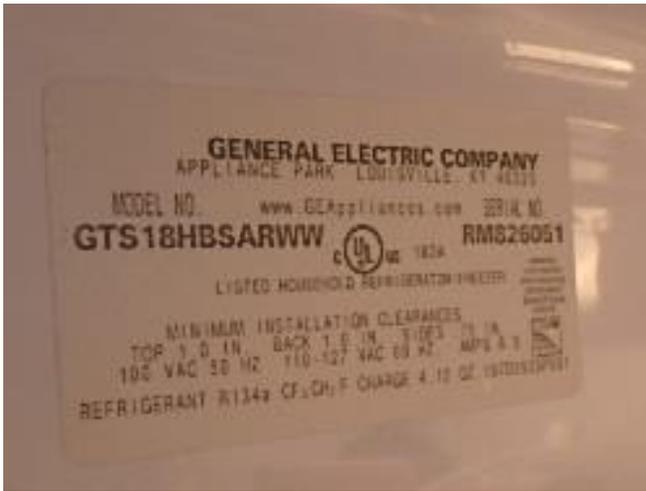
Replacement GE model refrigerator.

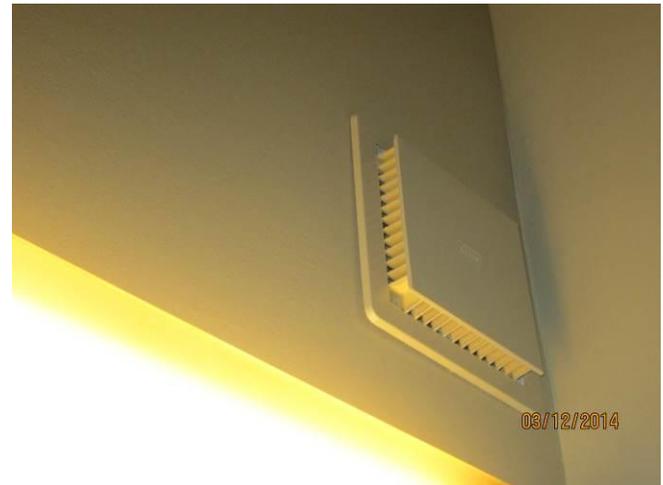
Typical wall mounted bathroom exhaust fan observed in working condition.

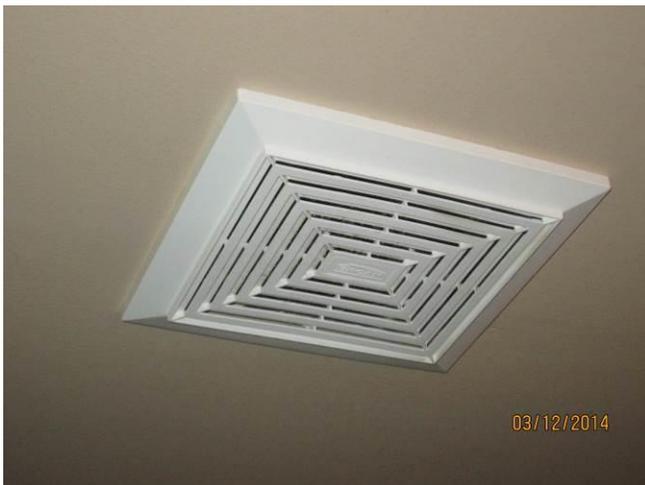
Close up view of soffit mounted bathroom exhaust fan.

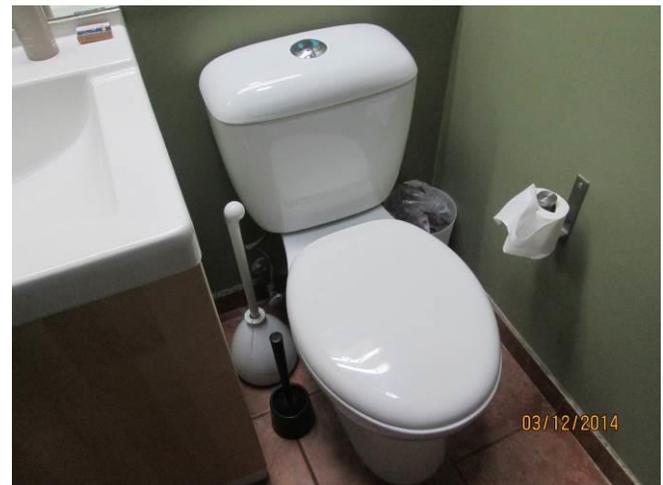
Typical dual flush type toilet observed in a townhouse unit.

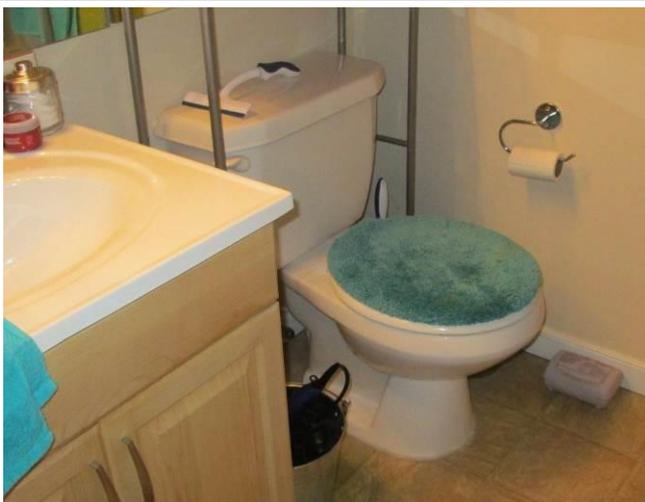
Typical standard flush toilet observed.

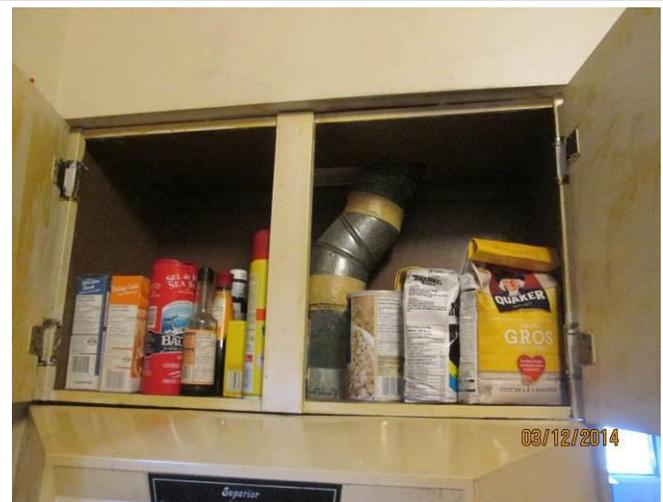
Typical kitchen range hood and ducting observed at a townhouse unit.

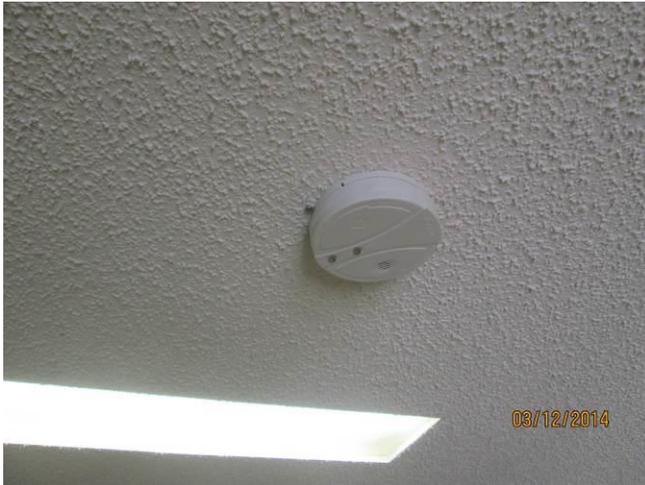
Battery operated Kidde smoke alarm in the Sunnyhill Co-op's office at Block 2.

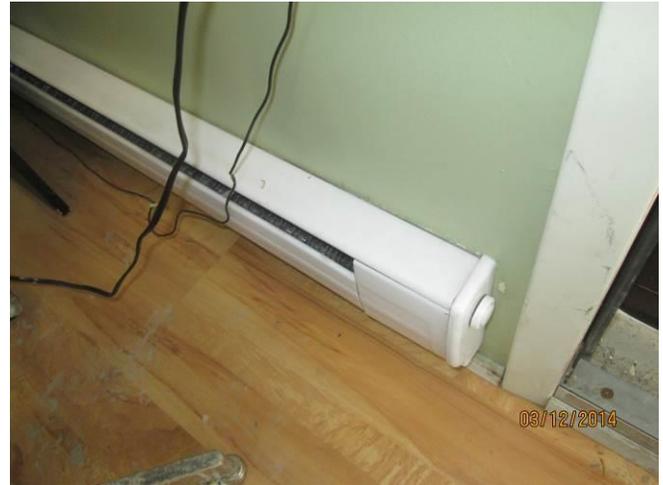
Electric baseboard heater in the office at Block 2 observed.

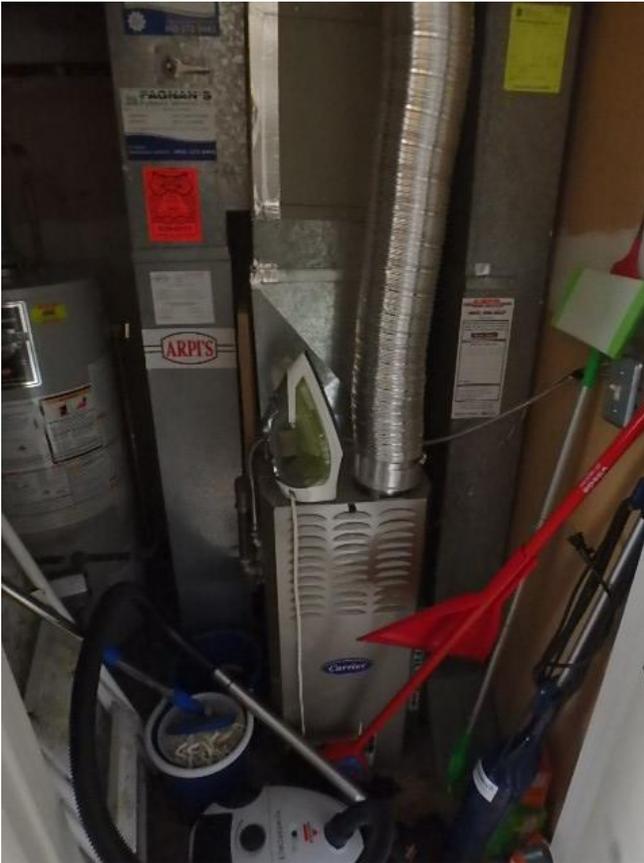
Observations & Recommendations
<ul style="list-style-type: none"> <li>- Furnaces are manufactured by Carrier. It appeared that the furnaces were replaced in the past 15 to 20 years. Furnaces are 80% energy efficiency gas furnace with galvanized sheet steel ductwork.</li> <li>- For energy considerations and long term savings, High efficiency furnaces should be installed at the time of scheduled replacement.</li> <li>- Appliances are installed on the second floor level. The exhaust flue is ducted to the interior through the roof.</li> <li>- IRC was informed that there are yearly inspections for all the furnaces in the townhouse units with some minor repairs</li> <li>- Replacement is generally undertaken of all the appliances during the same period. Costs savings may be achieved by replacing a large total quantity at once.</li> <li>- Based from the visual review of the furnaces, Alberta Home Services performs service &amp; maintenance inspections.</li> <li>- There are no carbon monoxide detectors installed. See Fire &amp; Life Safety Components – Townhouses section of this report for further information.</li> <li>- Replacement costs for the furnaces can be highly variable depending upon the standard and design features selected.</li> <li>- The costs accounted for in the Table of Expenditures account for a similar type of furnace as that installed.</li> </ul>

Typical gas-fired Carrier furnace observed at the 2<sup>nd</sup> floor level of the townhouse unit.

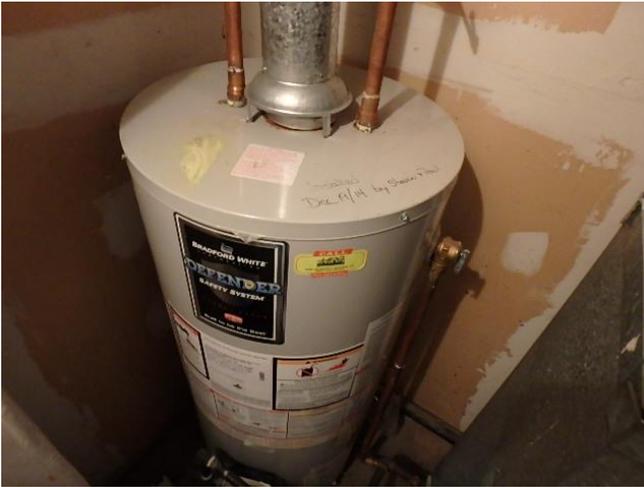
Typical Bradford White Hot water storage tank.

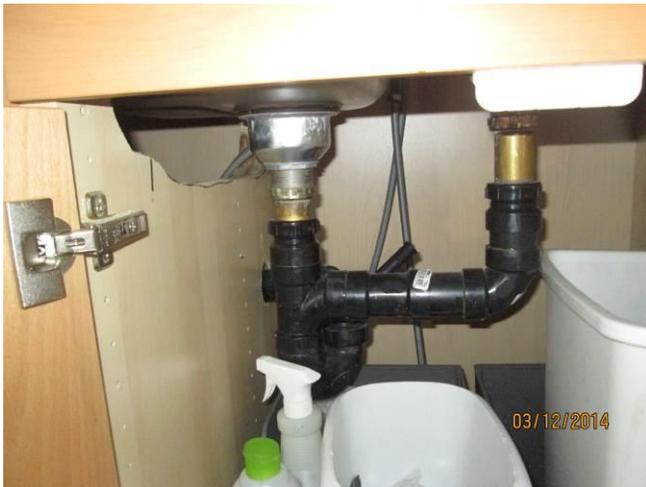
Typical piping layout servicing a kitchen sink.

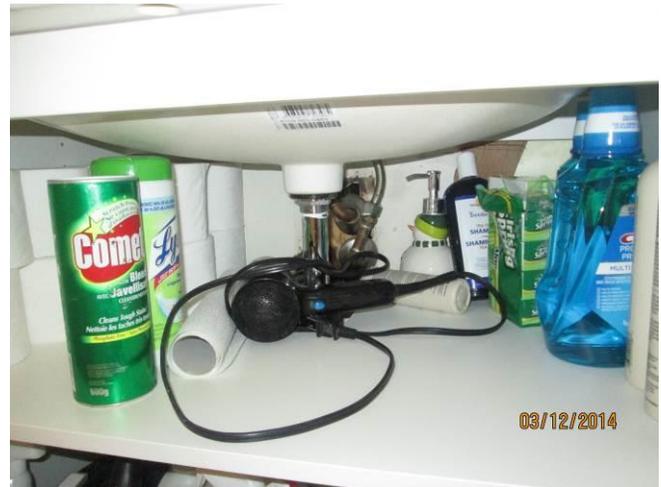
Typical piping layout servicing a bathroom wash basin.

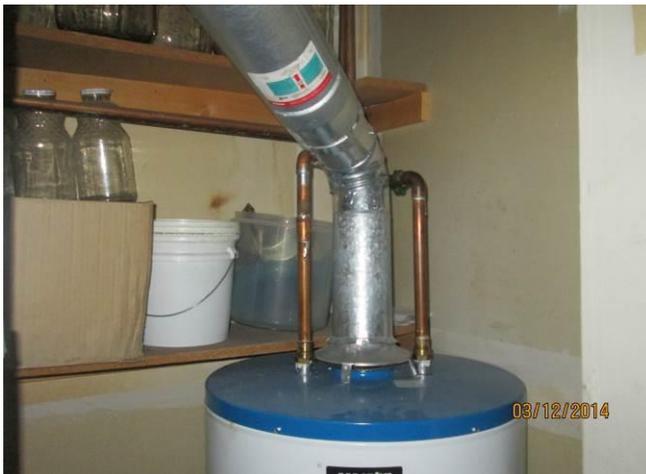
Typical copper pipe connection to an automatic storage water tank.

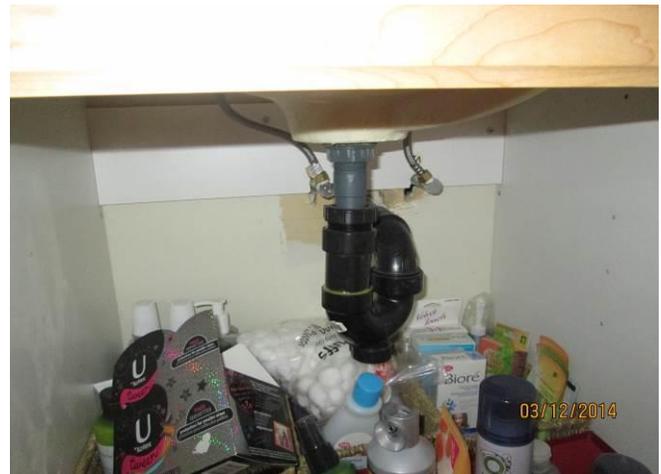
Typical piping layout servicing a bathroom wash basin.

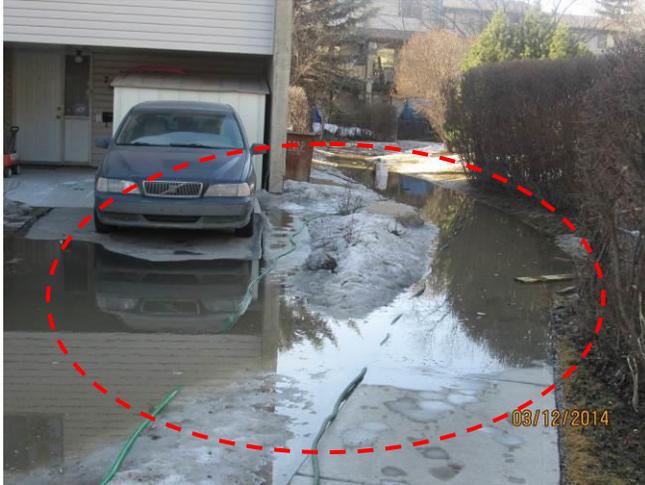
Ponding water observed at the driveway & concrete walkway between Blocks 1 & 2.

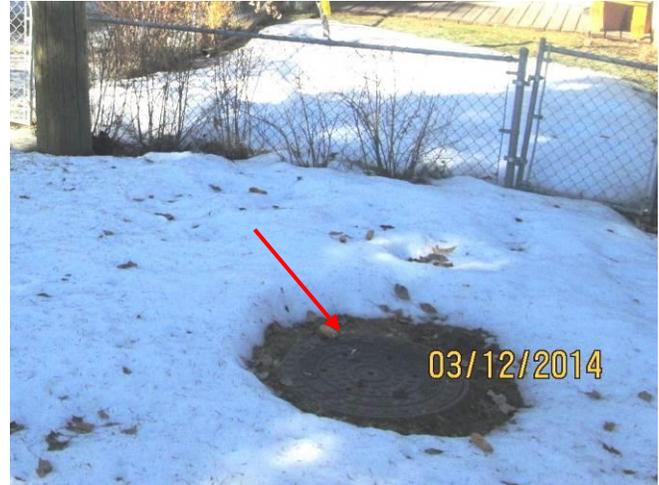
Typical catch basin to storm sewer system observed near Block 4.

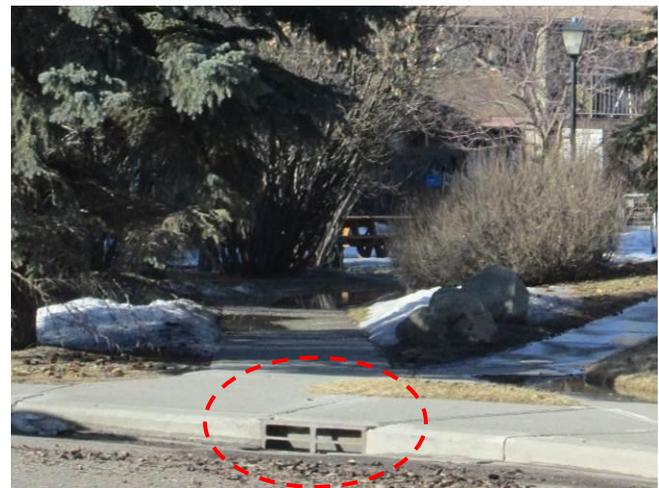
Typical storm sewer system throughout the property.

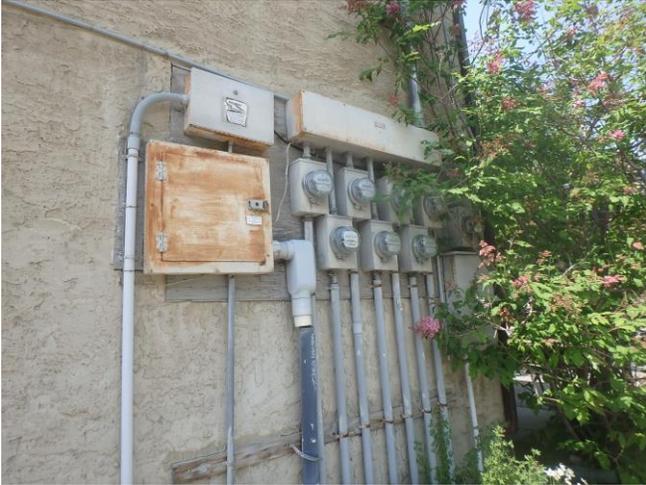
Typical electric meters & electrical panel observed.

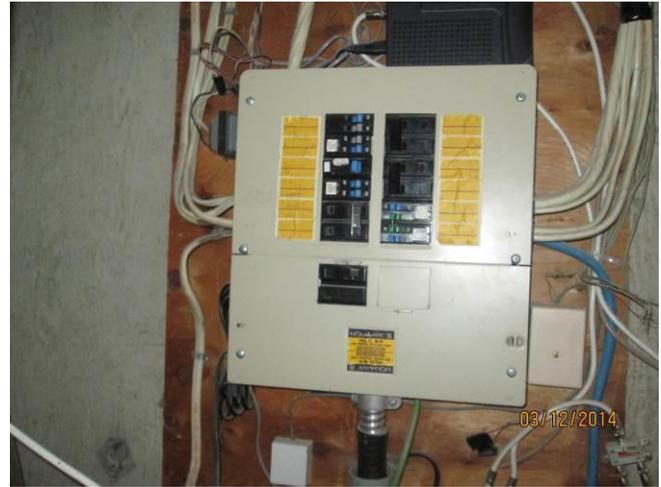
Typical NOVA Line NLC 24 circuit breaker observed.

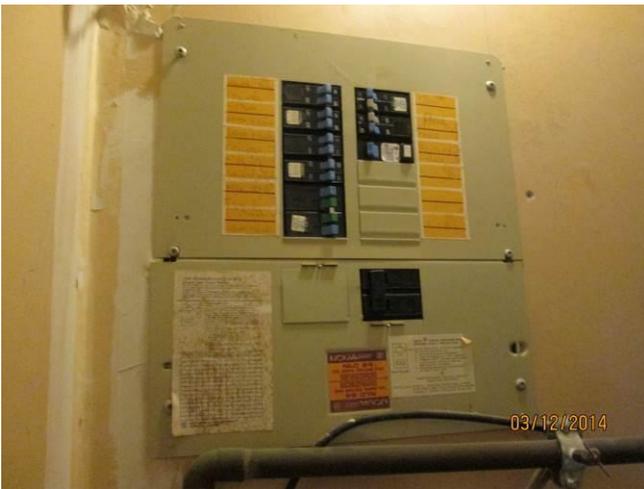
Typical surface mounted Westinghouse NOVA Line circuit breaker observed.

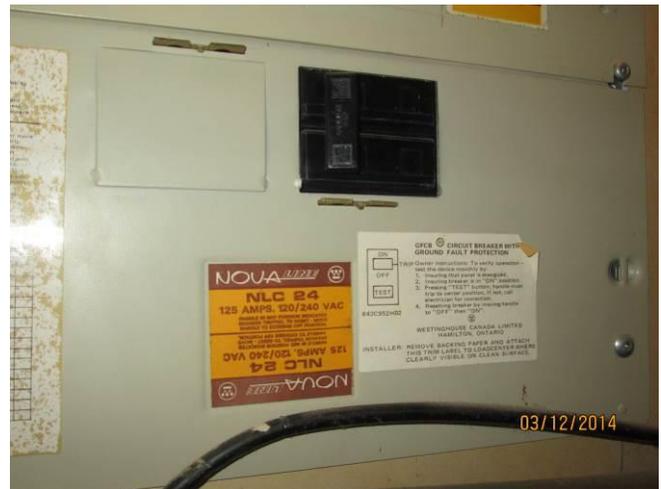
Manufacturer's label observed.

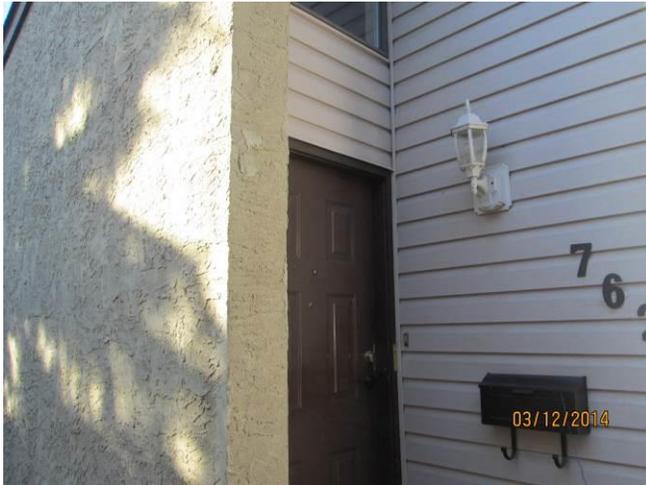
Typical wall mounted light fixture at unit 762 observed.

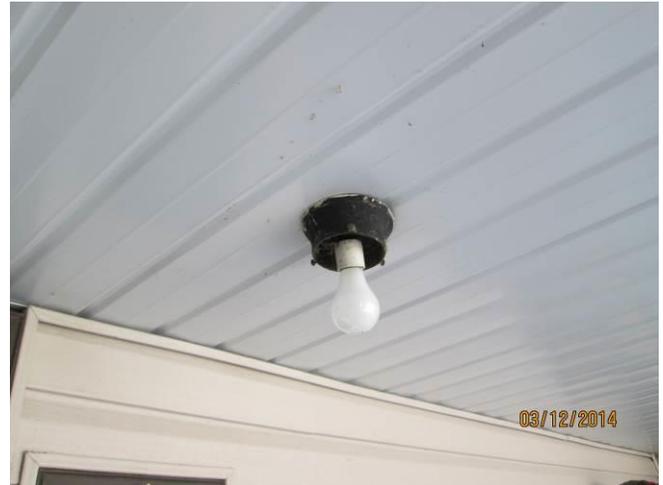
Soffit mounted incandescent light fixture observed at unit 22.

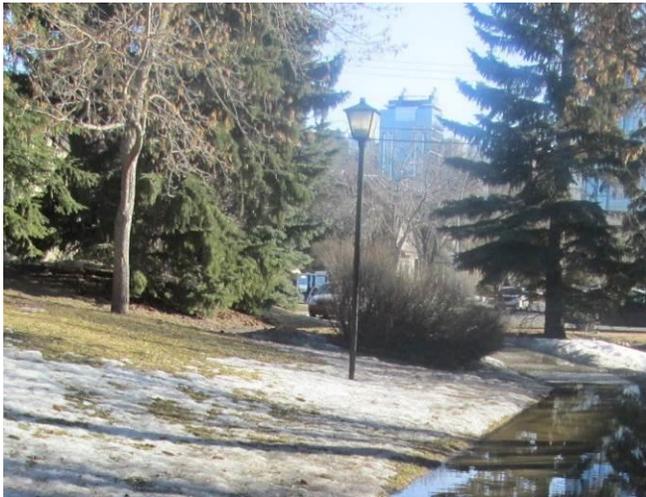
Typical lamp pole with concrete base observed between Block 6 & 7.

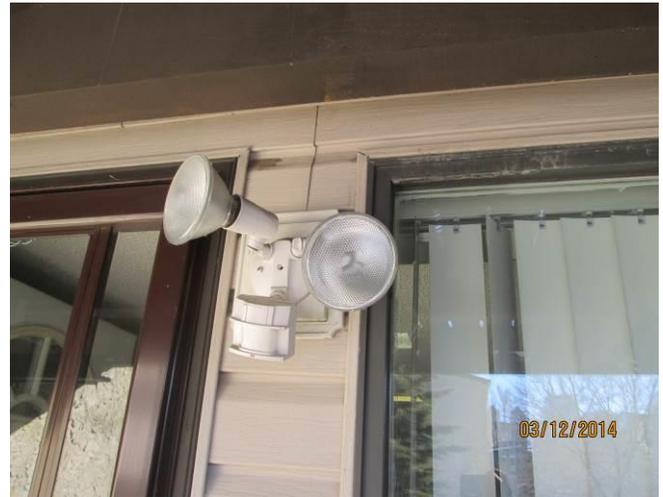
Wall mounted light fixture at with motion sensor observed at the common office at Block 2 observed.

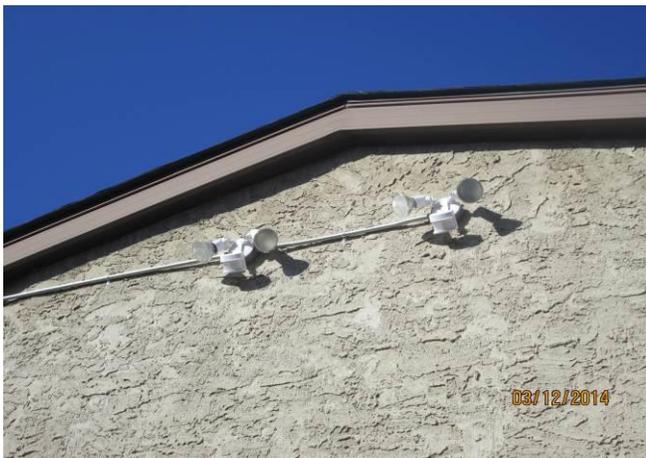
Typical wall mounted building light fixtures with motion sensors observed at Block 6.

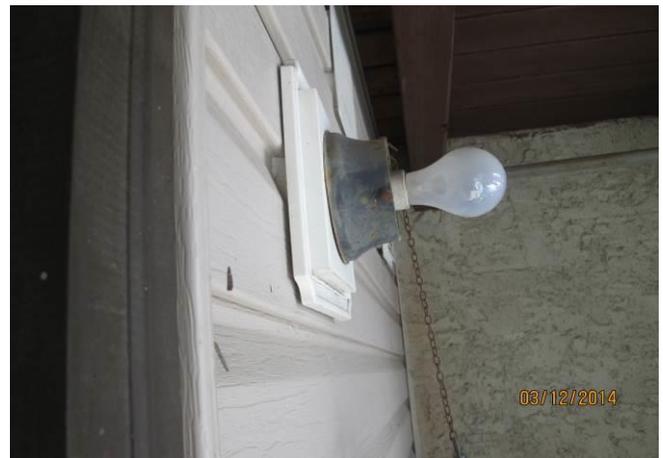
Typical incandescent light fixture at Unit 42 observed.

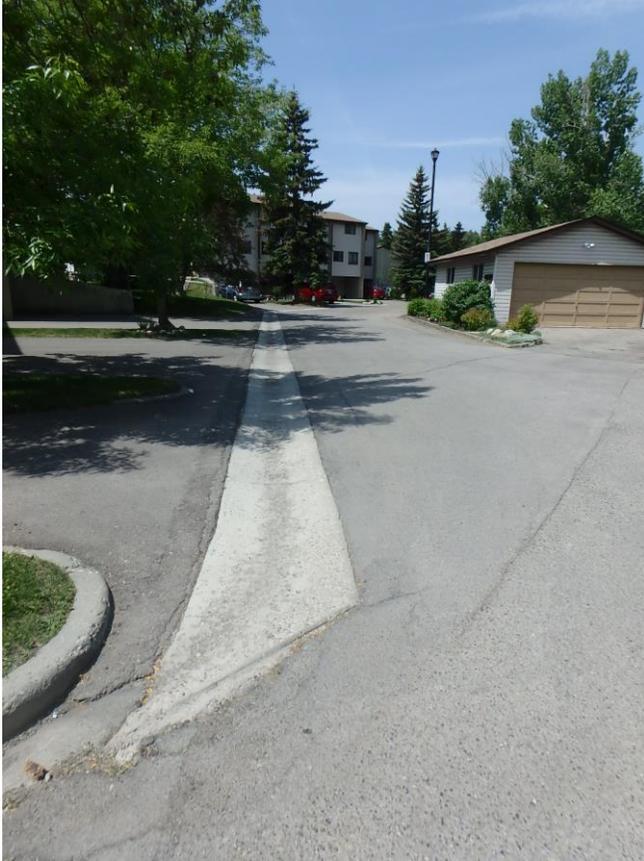
Overview of asphalt paving adjacent Common Garage.

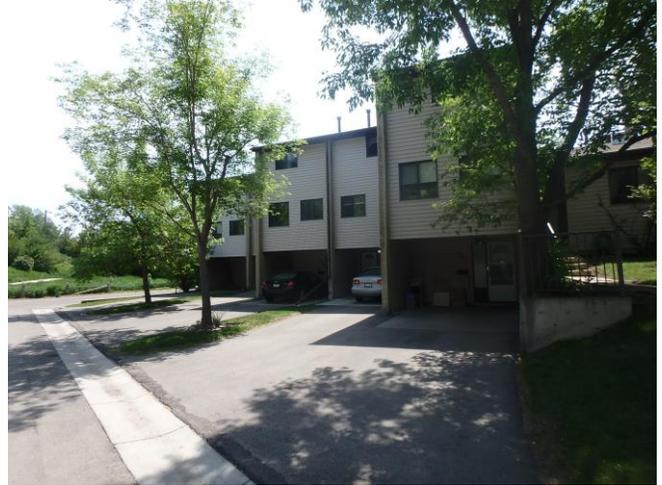
Typical Asphalt Driveway configuration.

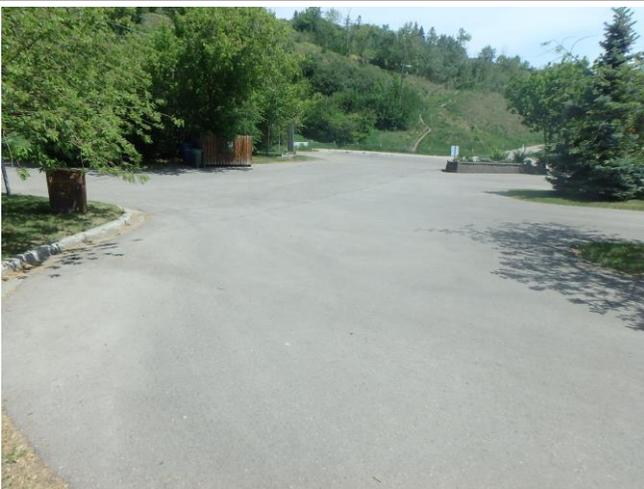
Typical Asphalt condition of main drive lane 6.

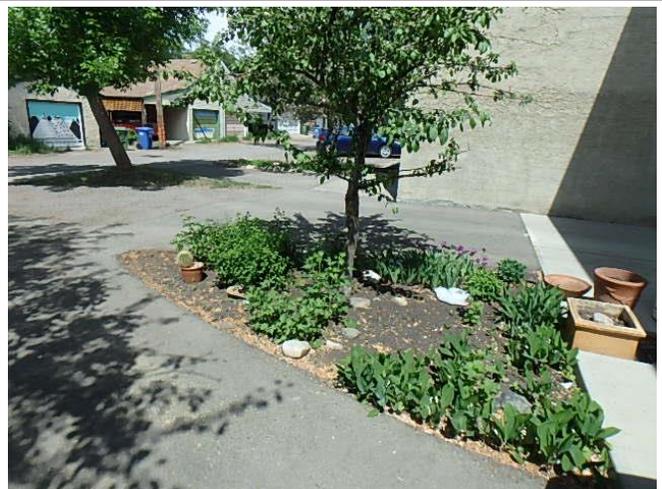
Drive way condition adjacent back city lane way

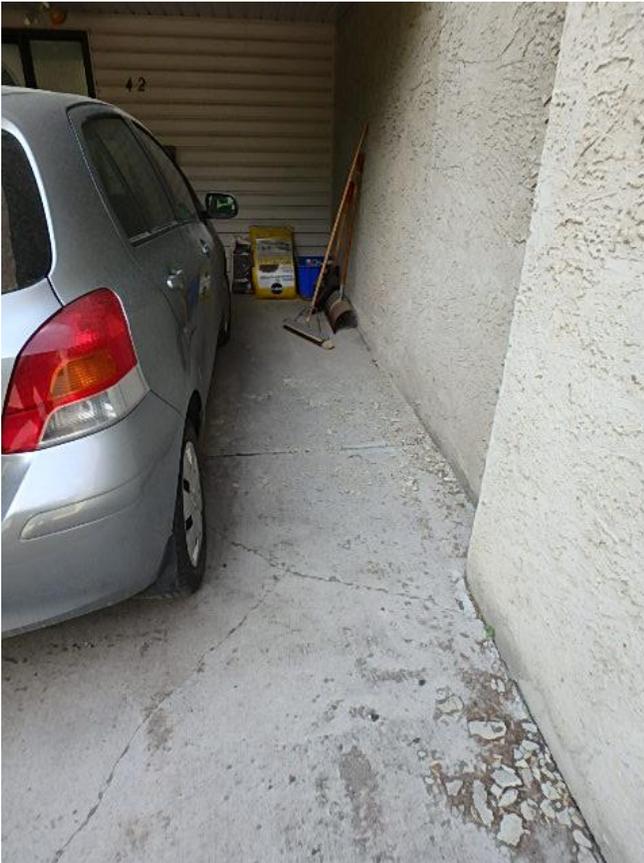
Typical concrete slab at the carport.

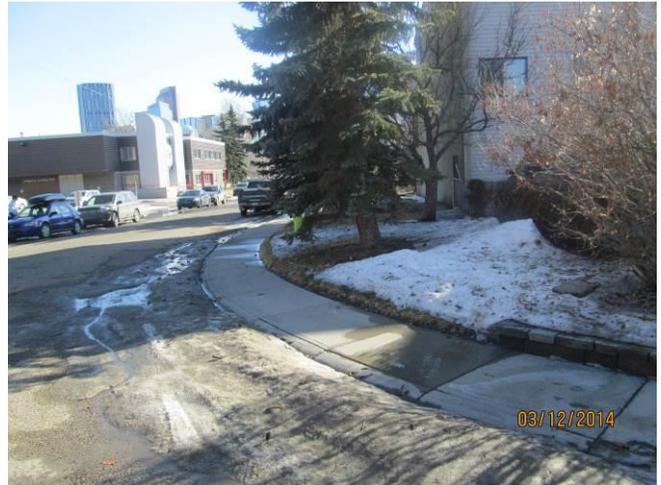
Typical concrete walkways & curbs near Block 2 observed.

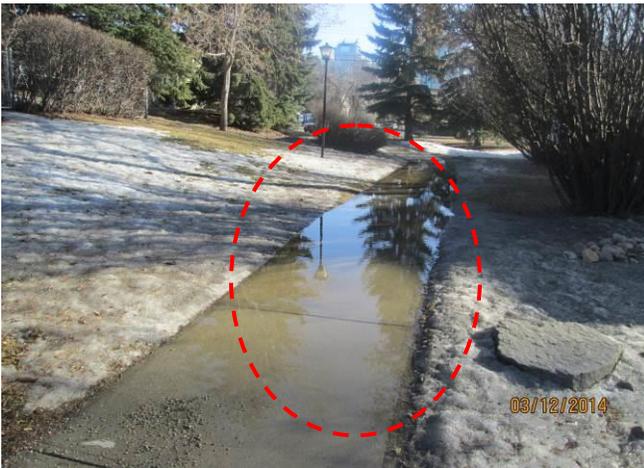
Ponding water on concrete walkway observed between Blocks 6 & 7.

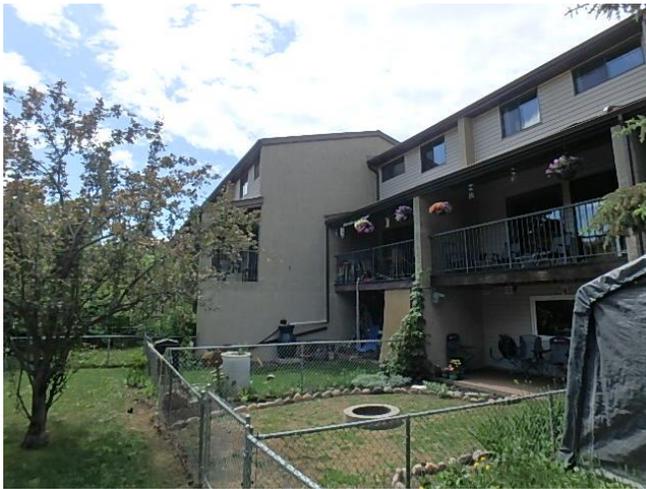
Chain link fencing & gate forming the back yard.

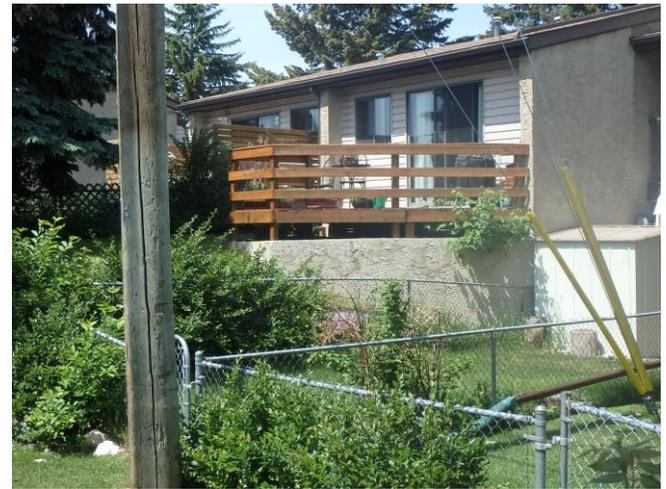
Typical chain link fencing

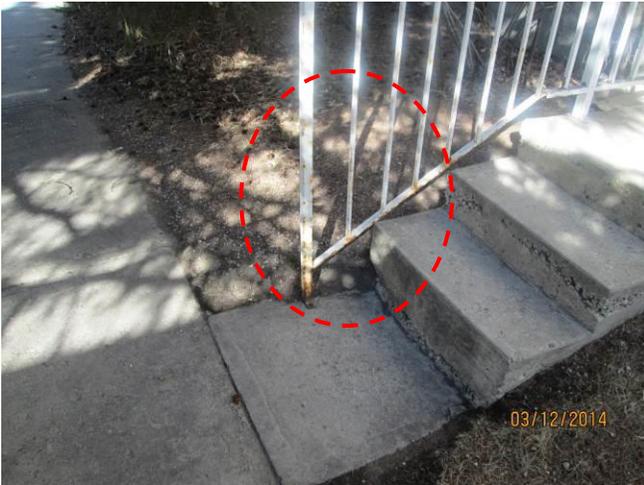
Observations & Recommendations
<ul style="list-style-type: none"> <li>- Metal guardrails and handrails have been installed around concrete entry to townhouse units, courtyard steps &amp; on top of retaining walls.</li> <li>- The metal guardrails &amp; handrails appear to be circa original construction.</li> <li>- Replacement guards would need to be as per design requirements of the Building Code at the time of replacement.</li> <li>- The steel guards exhibit corrosion and need painting; this is covered under the Exterior Painting section.</li> <li>- There are no further recommendations other than as outlined under General Comments.</li> </ul>

Metal guardrail exhibit corrosion at a townhouse unit entry steps.

Summary Budgetary Costs				
Budgetary Cost (2018)	Quantity	Expenditure Recommended	Expenditure Type	Summary Recommendation
\$7,800	195 ft.	5 - 10 Years	Projected	Replace guardrails and handrails
Design & Specification Recommended: <input type="checkbox"/>			Project Management & Quality Control Recommended: <input type="checkbox"/>

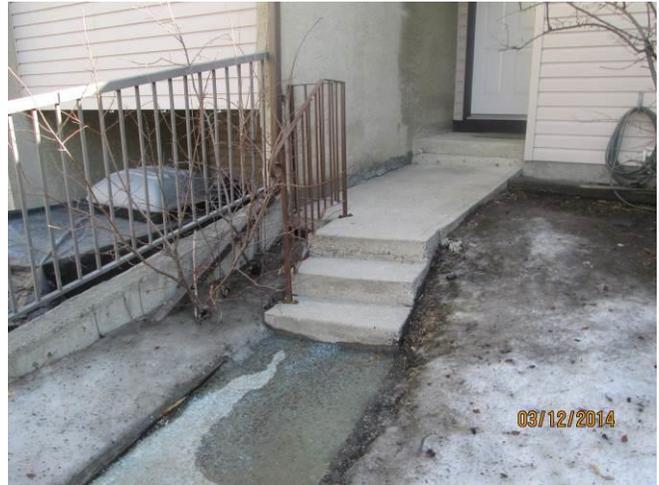
Metal guardrails on top of retaining wall & concrete entry steps at Block 4 observed.
