# BUILDING CONDITION ASSESSMENT & RESERVE FUND STUDY

## **Sunnyhill Housing Co-operative 787 - 3rd Street NW Calgary, AB**

June 13, 2018

IRC CB18-037CR-15052

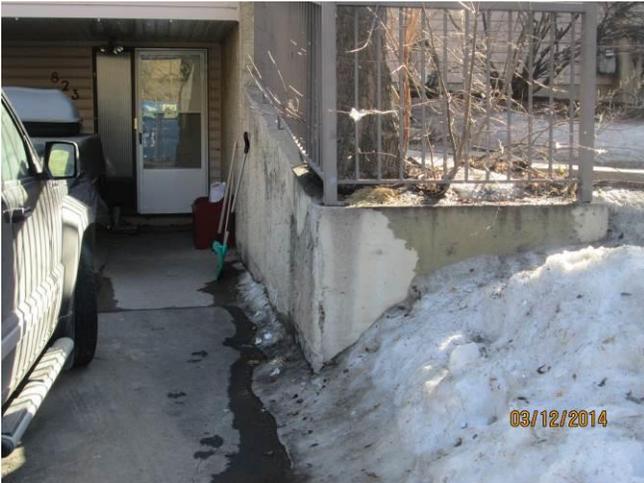
Close up view of metal guardrail on top retaining wall at Block 4.

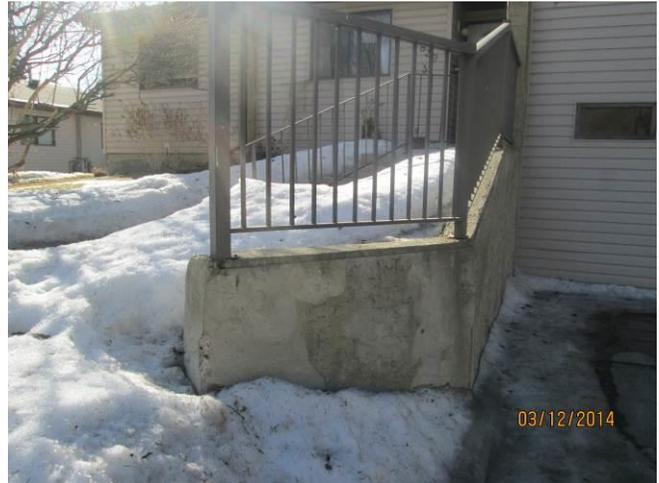
Typical metal guardrail on top retaining wall at Block 6 observed.

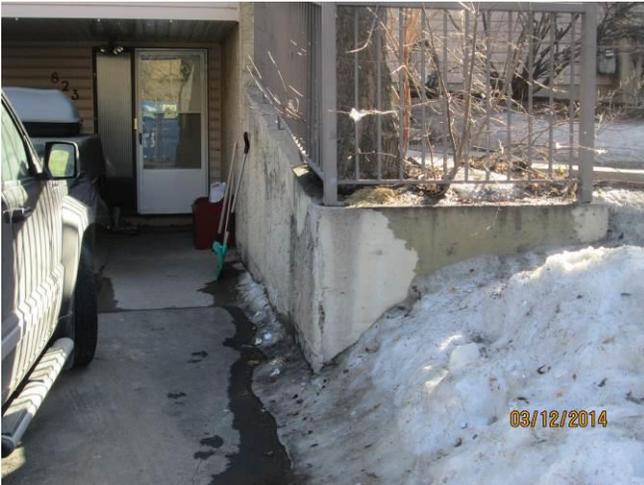
Concrete retaining walls at Block 4 between townhouse units.

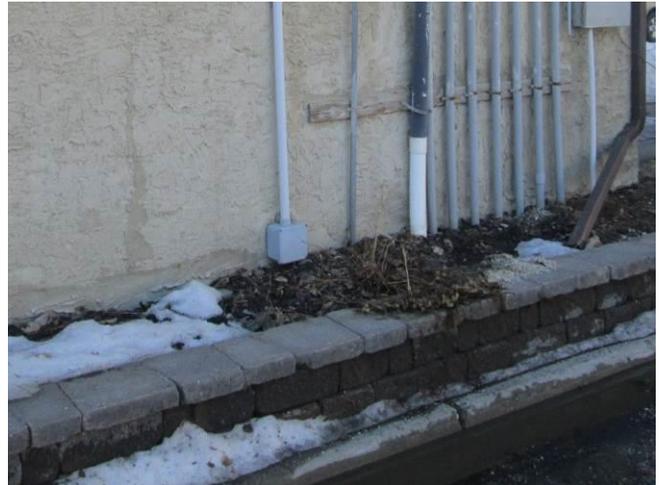
Interlocking block retaining wall around planters at Block 4 observed.

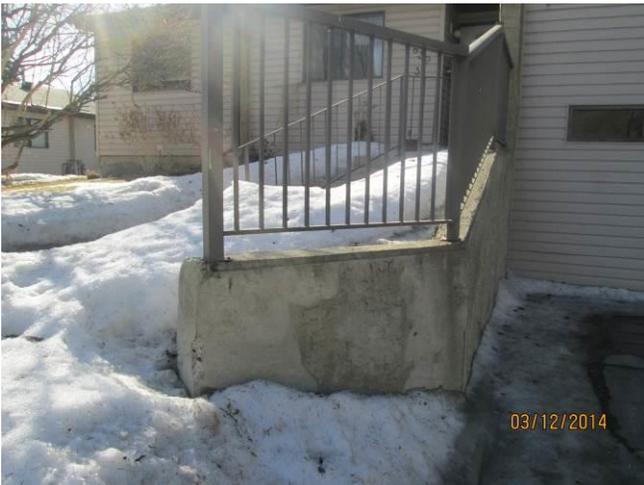
Concrete retaining wall with metal guardrails at Block 6.

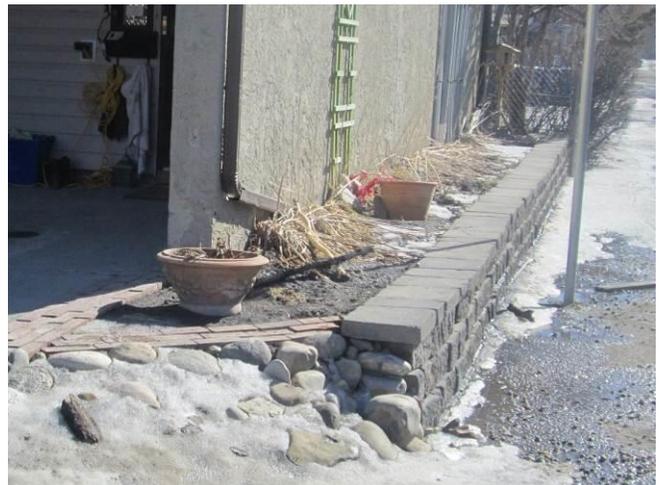
Interlocking block retaining wall around planters at Block 8 observed.

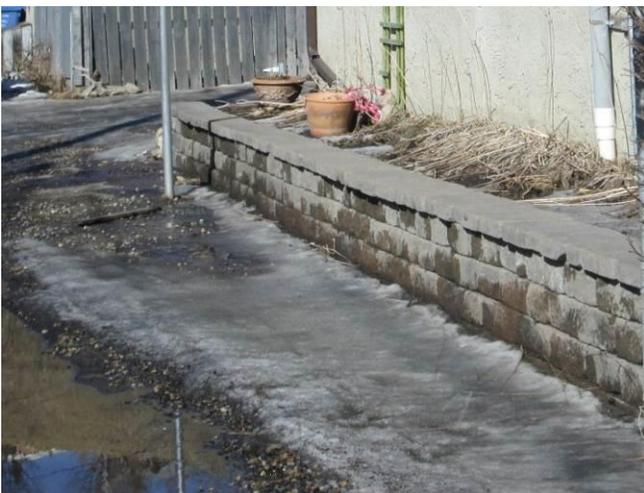
Retaining wall around planter at West end of Block 8 observed.

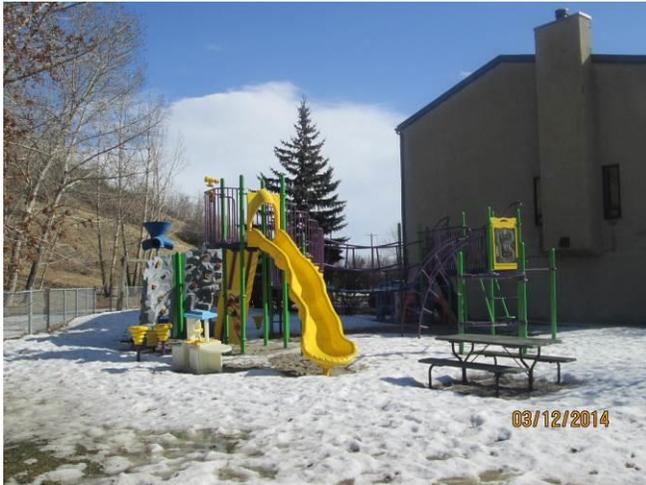
Overall view of playground area with Block 6 in the background.

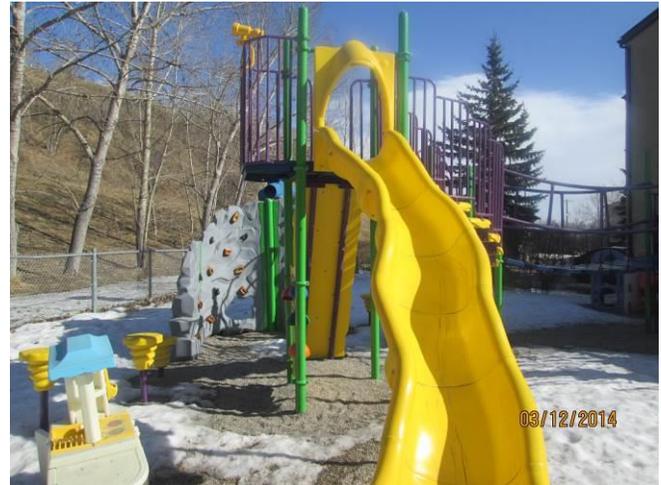
Playground equipment observed.

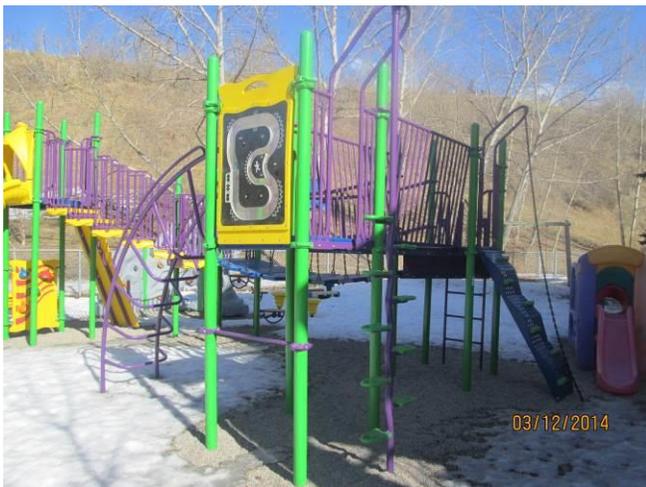
Multi-activity climber at the playground area observed.

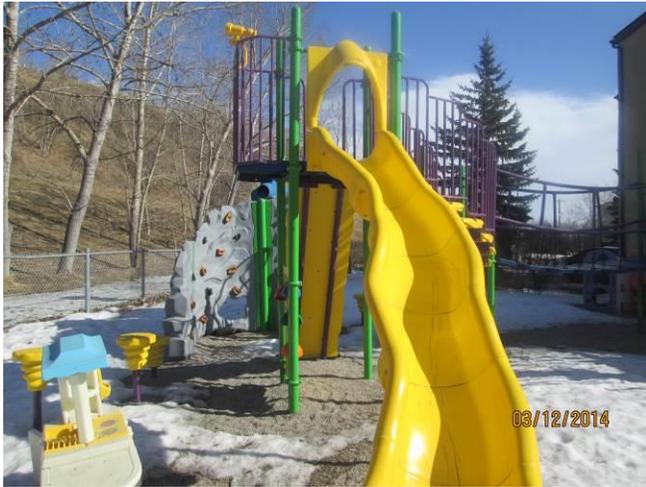
Overall view of playground area with pea gravel surfacing.

Summary Budgetary Costs				
Budgetary Cost (2018)	Quantity	Expenditure Recommended	Expenditure Type	Summary Recommendation
\$13,190	1507 sq. ft.	5 - 10 Years	Projected	Install rubber mat playground surfacing
n/a	Item	As required	Operating	Replace rotting wooden edge containment
Design & Specification Recommended:		<input type="checkbox"/>	Project Management & Quality Control Recommended: <input type="checkbox"/>

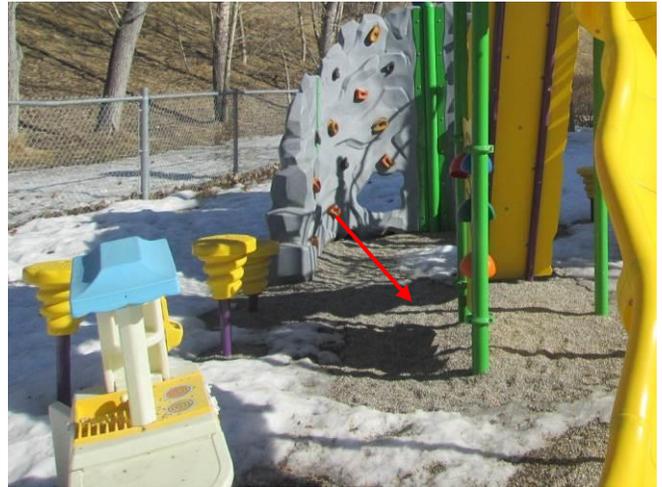
Playground pea gravel surfacing observed.

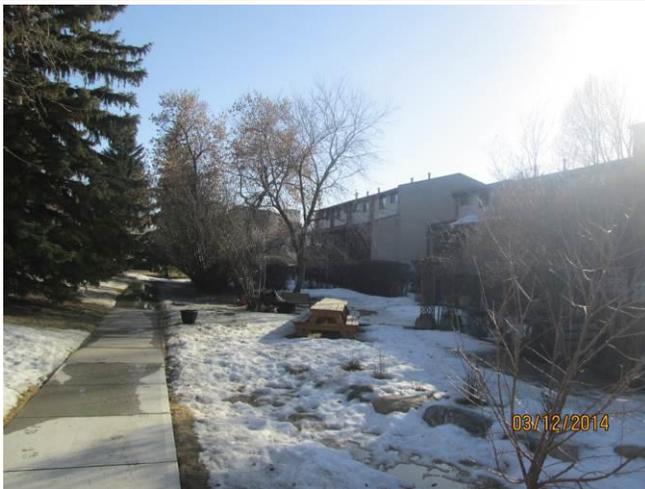
Landscaping at the courtyard of the property observed.

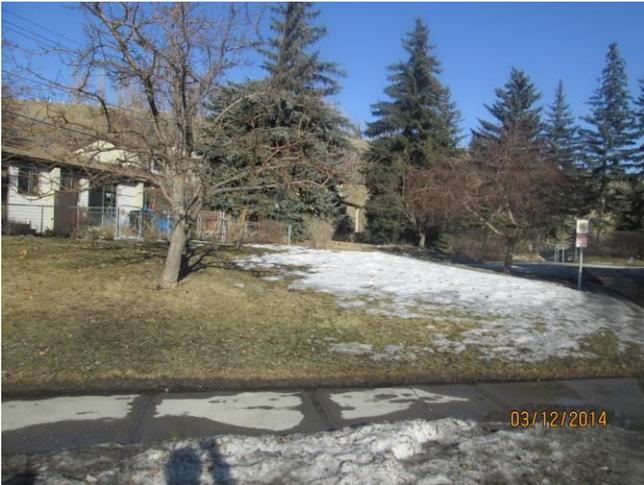
Typical landscaping observed near Block 4.

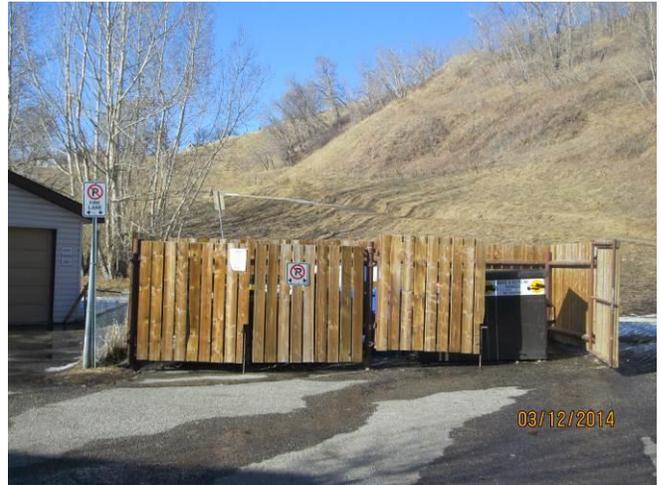
Garbage bin enclosure at the North end of Block 4 observed.

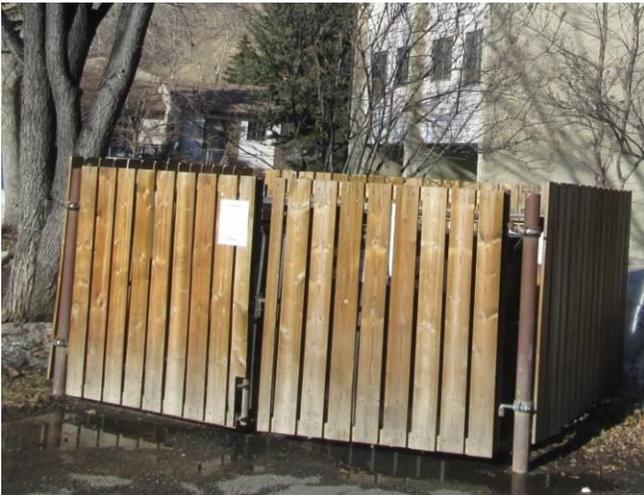
Garbage bin enclosure near Block 3.

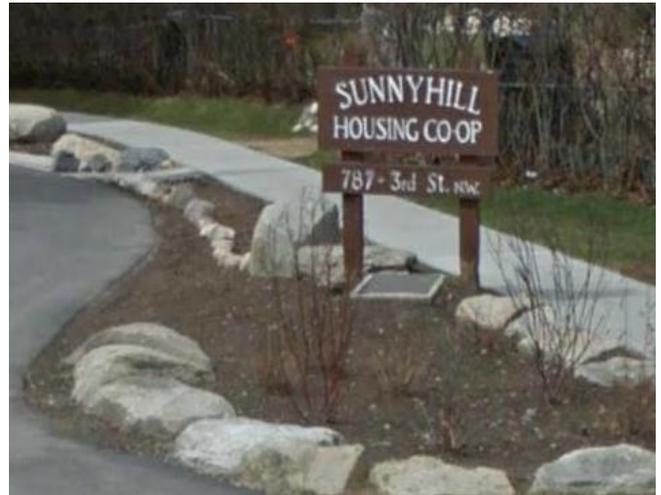
Site signage near Blocks 1 & 2.

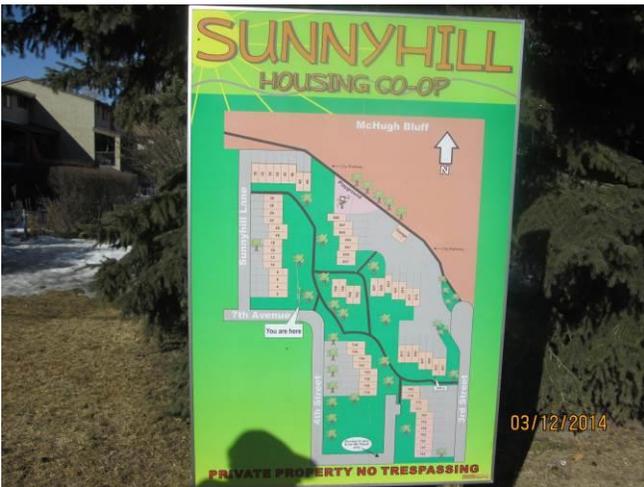
Signage showing site plan of the property near Block 7.

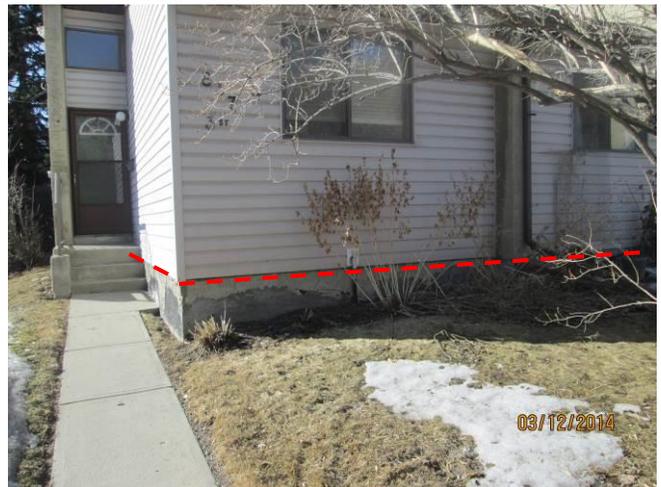
Typical foundation walls of a townhouse unit reviewed.
